### 3.0 OBSERVATIONS AND DATE COLLECTION

This research conducted in high lightning zone in Sri Lanka. Few Telecommunication base stations are selected in Rathnapura, Horana, Galle, Ambalangoda, Kaduwela, Weliweriya, etc for the analysis.

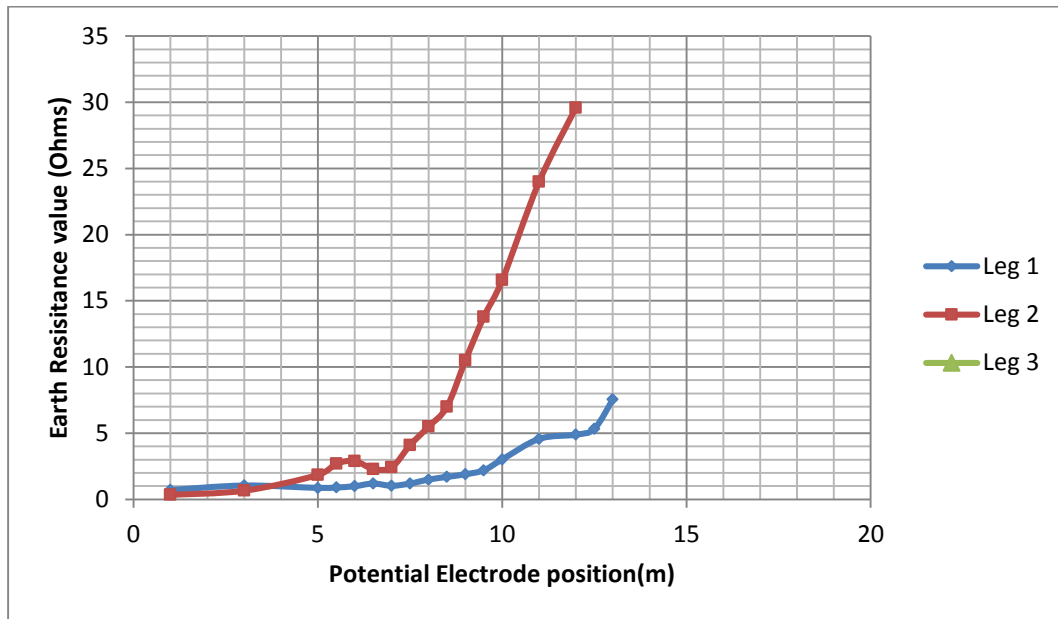
Figure 3.6: Fall of potential curves for Keselhenawa Radio base station  
(Source: Author)

In Kehelhenawa measurements, the current electrode can be placed at maximum of 16m away from the system earth. But 61.8% rules tell the earth resistance as 3.02 ohms at one leg and 16.57 Ohms at another leg. Table 3.2 shows the Earth resistance measurements data and Figure 3.6 shows the fall of potential curves for Keselhenawa Radio base station.

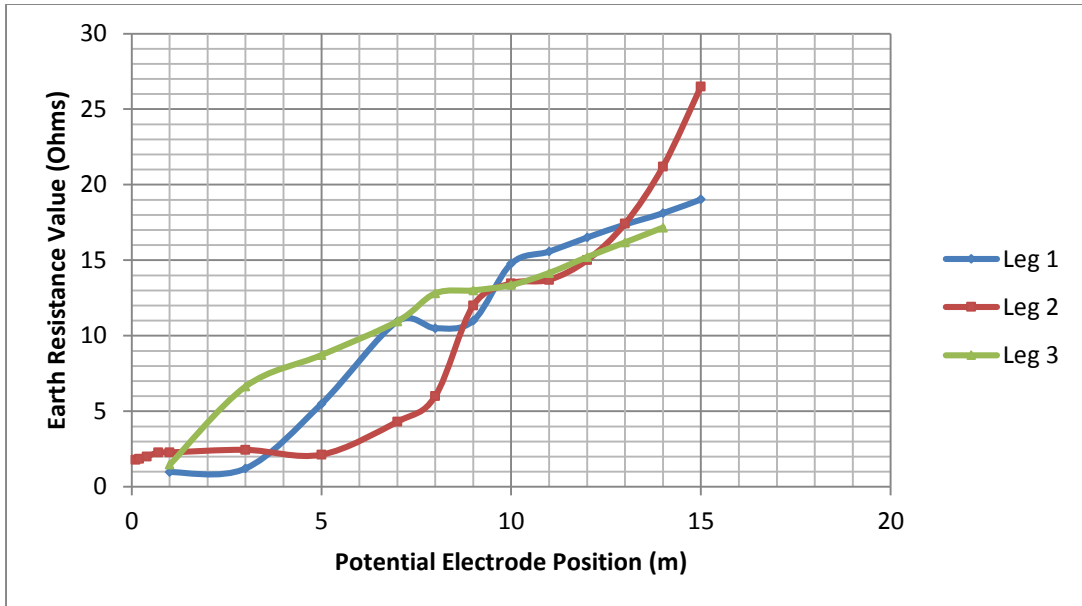
Figure 3.7: Fall of potential curves for Moragahakanda Radio base station

Below table and Figure shows the same thing done in Moragahakanda radio base station. In this case also current electrode can be placed at maximum of 16m away from the system earth. In here the earth electrode resistance can be estimated by examining the curves or field data at the 61.8% point as it shows the Non-Overlapping behavior. 14 Ohms is the figure shows as per the 61.8% rule. Table 3.3 shows the Earth resistance measurements data and Figure 3.7 shows the fall of potential curves for Moragahakanda Radio base station.

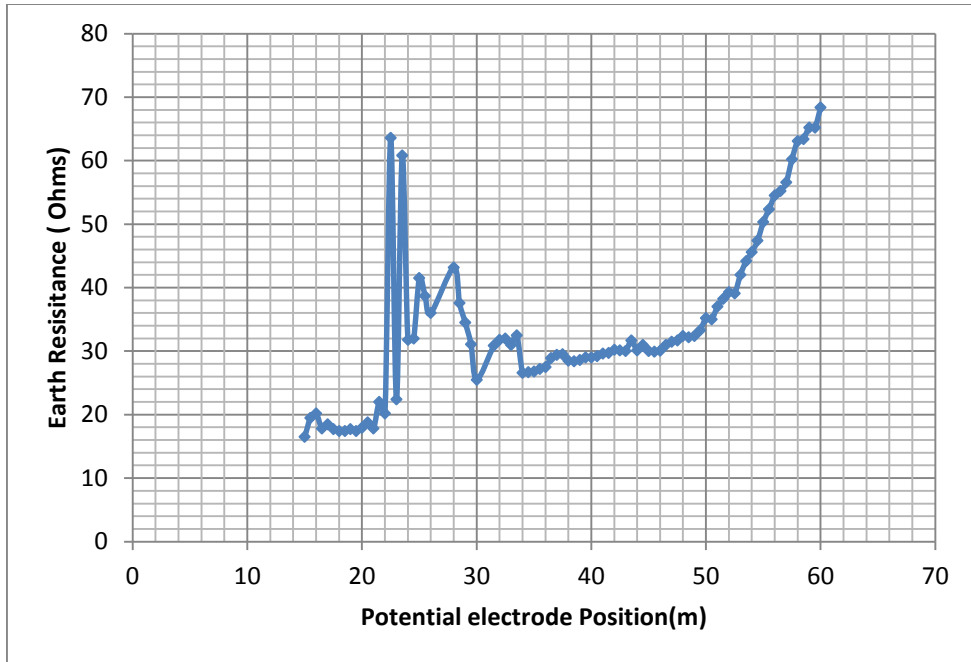
Figure 3.8: Fall of potential curves for Erathna Radio base station

The table 3.4 and Figure 3.8 shown the results of earth measurement done in Erathna Radio base station. There we have managed to keep distance between earth system and current electrode. But we can see an irregular behavior in between potential electrode distance 25m to 35m. But totally we can see a non-overlapping behavior and conclude that the earth resistance value is around 30Ω. Table 3.4 shows the Earth resistance measurements data and Figure 3.8 shows the fall of potential curves for Keselhenawa Radio base station.

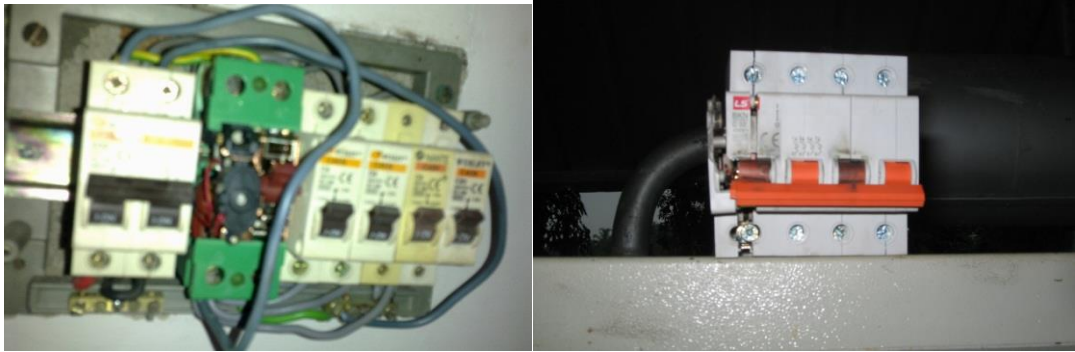
Figure 3.14: MCB damages reported in homes located near the Madampegama Radio Base station

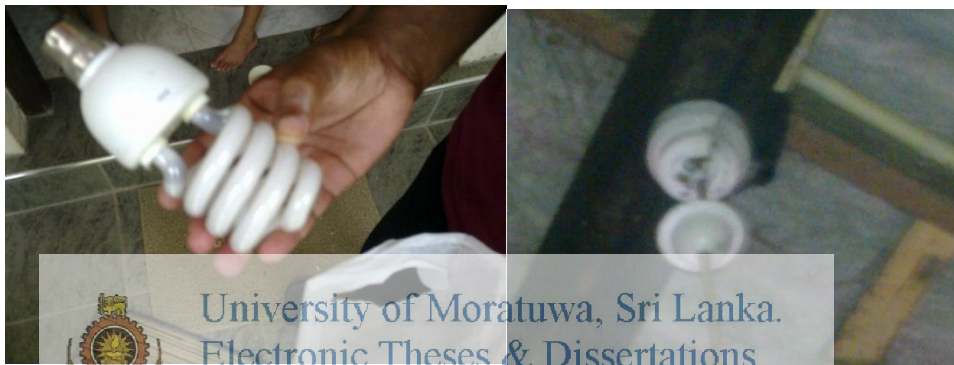
Figure3.15: Electrical Bulbs and Holder damages reported in homes near the Madampegama Site

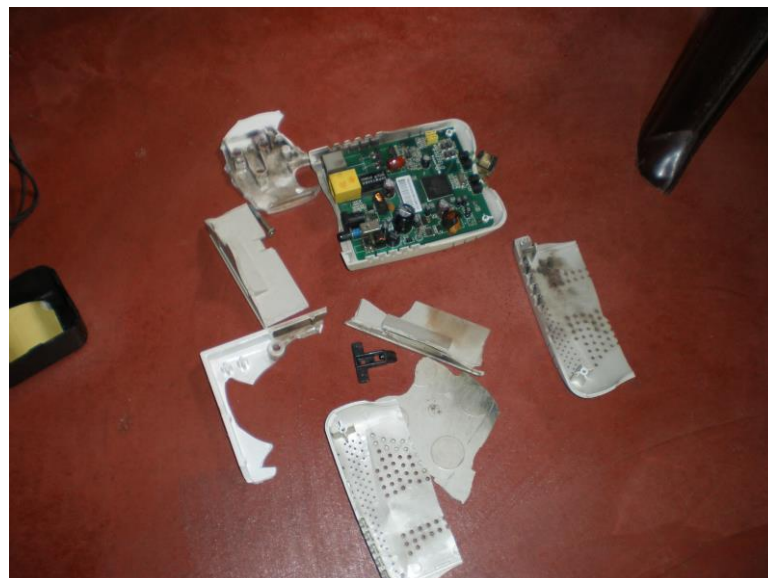
Figure 3.16: ADSL router damaged in home near the Thihariya site

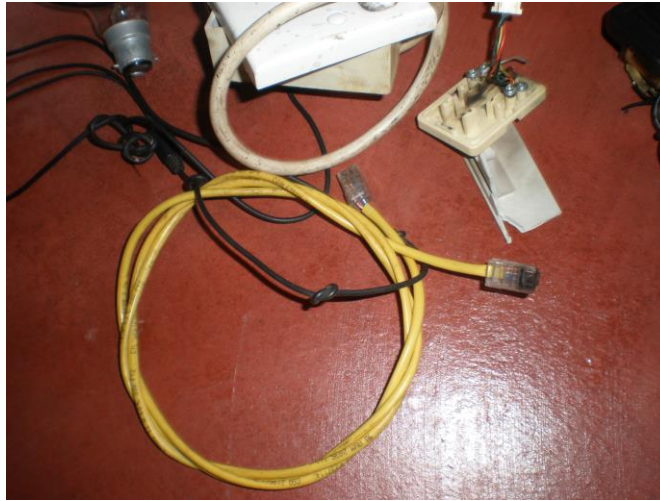
Figure 3.17: Computer damaged in home near the Thihariya site  
(Source: Author)

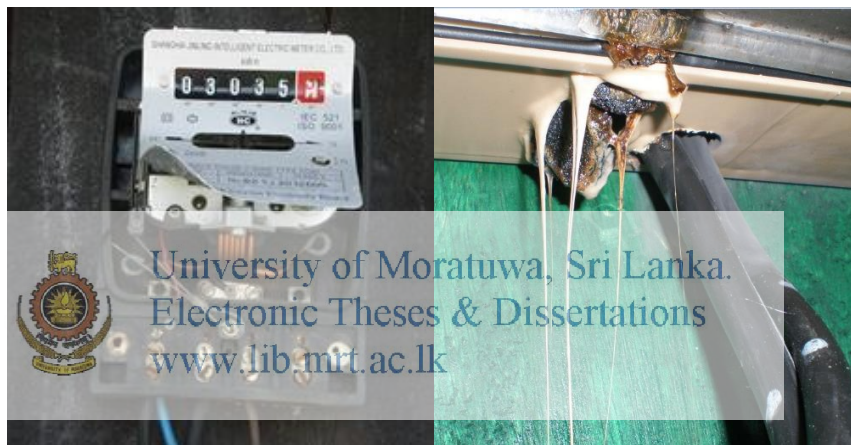
Figure 3.18: Energy meter and cable damages reported near the Keselhenawa telecommunication tower  
(Source: Author)

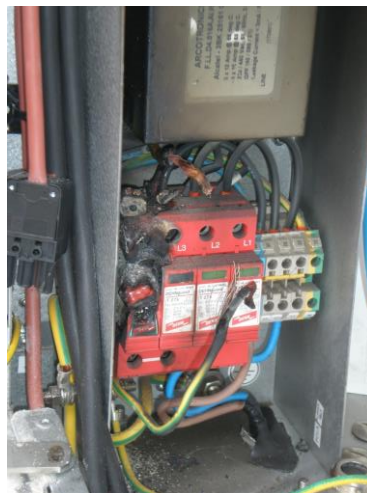
Figure 3.19: Neutral to earth surge arrester damaged in Magalle radio base station  
(Source: Author )

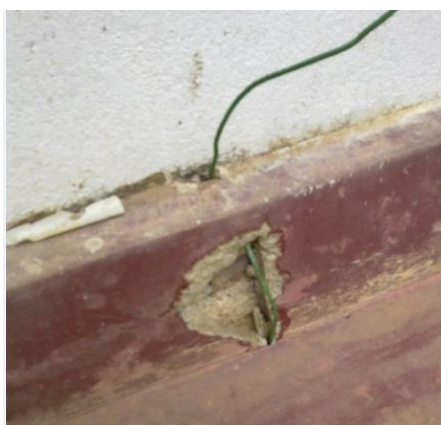
Figure 3.20: wall damages reported in homes near the Madampegama telecommunication tower

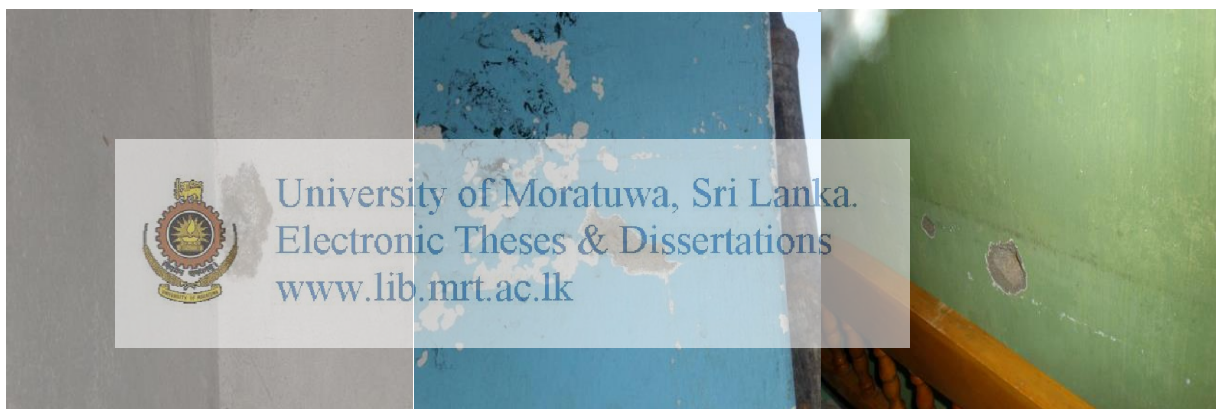
Figure 3.21: wall damages reported in homes near the Nakiyadeniya telecommunication tower

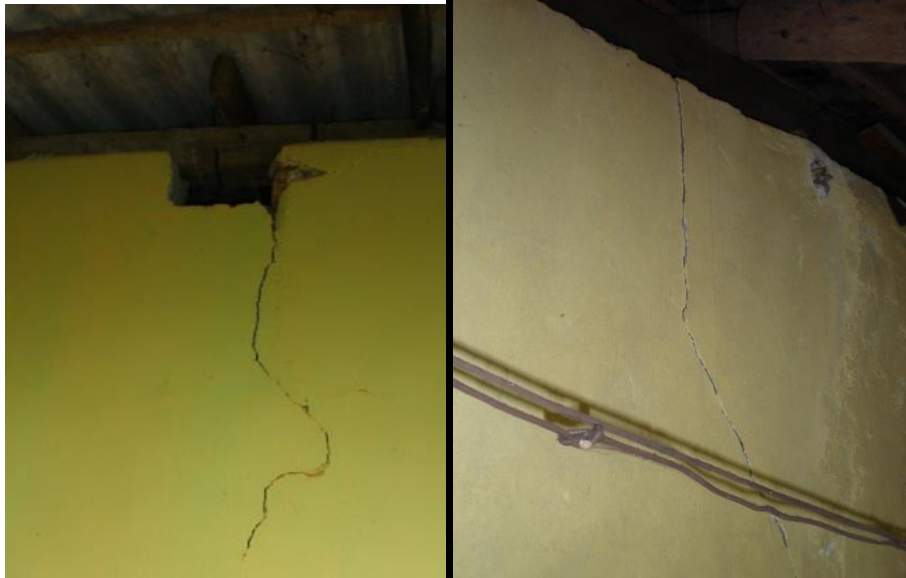
Figure 3.22: wall cracks reported in homes near the Keselhenawa telecommunication tower  
(Source: Author )

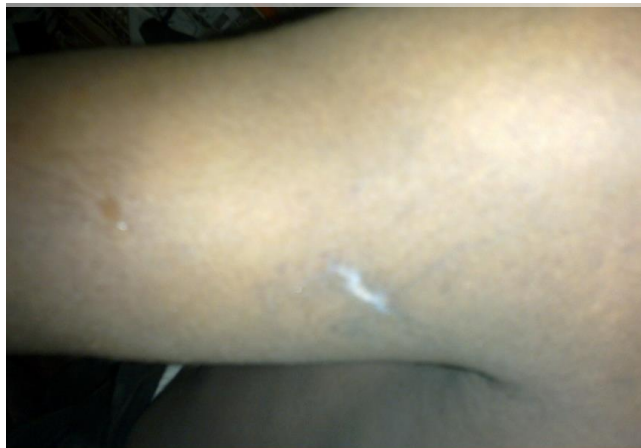
Recently few incidents reported with regards to the Telecom towers and mobile phones. Below incident reported at Madampegama site in Ambalangoda, when a person sleeping on the ground floor with the mobile phone under his arm in his home after the lightning incident to the Telecom Tower.

Figure 3.23: Human damages reported in home near the Madampegama Telecommunication Tower  
(Source: Author)

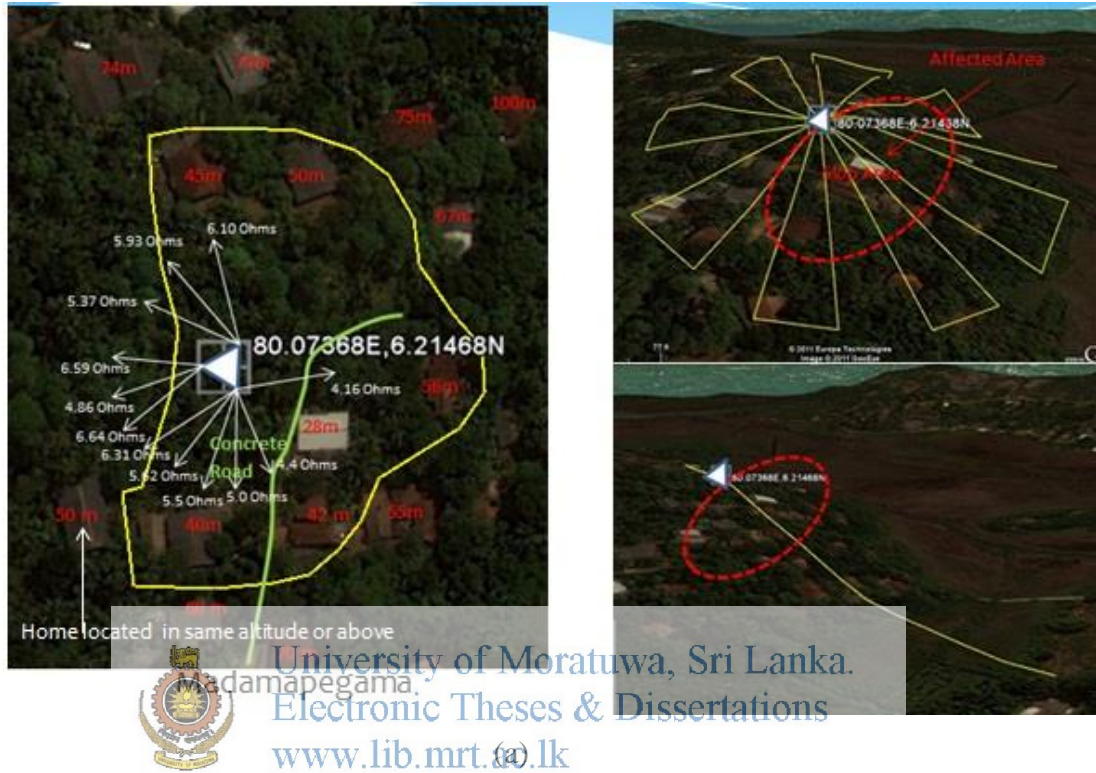
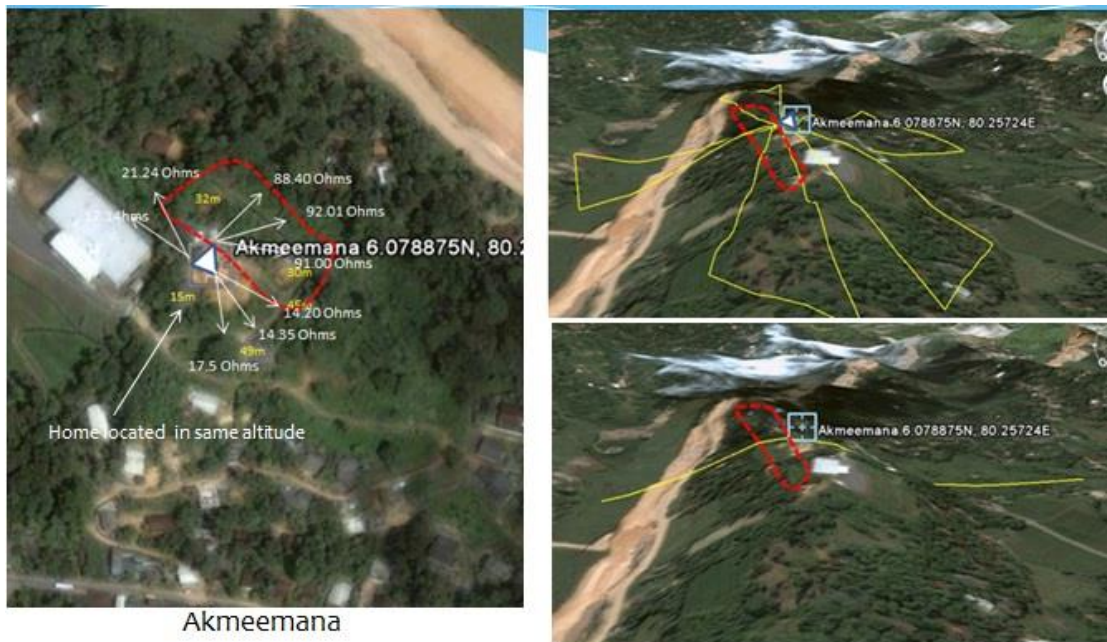
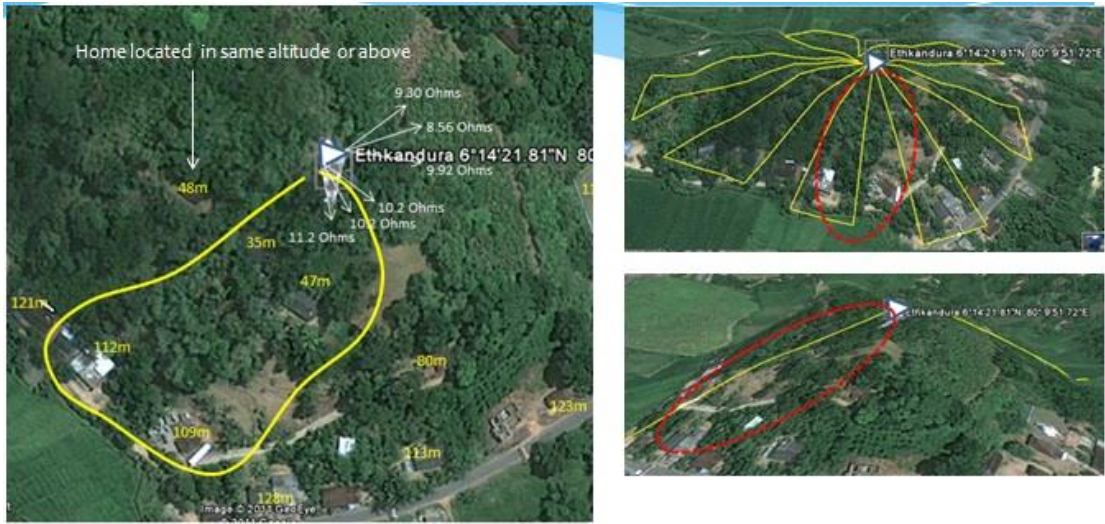
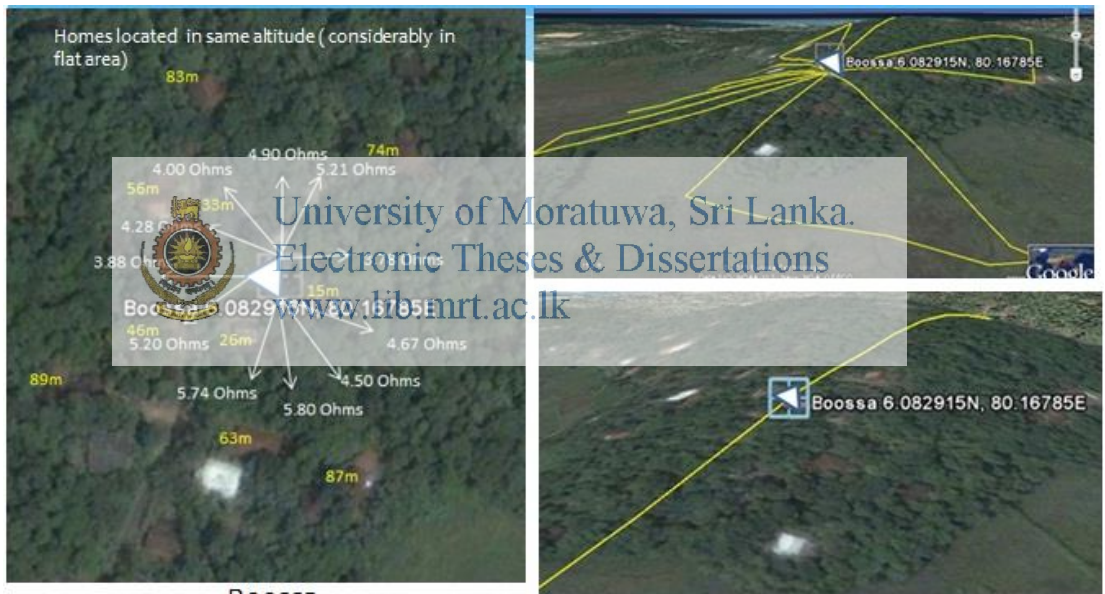
Figure 3.24: Earth profiles of (a) Madampegama (b) Akmeemana (c) Ethkandura (d) Boossa  
(Source: Author)

One remarkable feature highlighted throughout this research regarding the reported damages and elevation of those homes with respect to the elevation of the tower. It is highlighted that damages reported in homes where elevation is less than the tower

The tower surrounding earth profile of Madampegama, Akmeemana and Ethkandura are rather steep and damages reported only in homes located in same steep area ( Figure 3.24 (a), (b) and (c) ). But the surrounding earth profile of Boossa is rather flat and there were no any damages reported either to Tower equipment or neighbourhoods.
