5.0 DISCUSSION

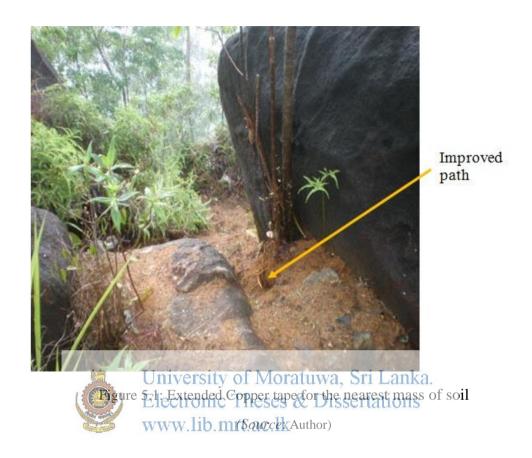
It is also noted that the measured earth resistance values are very high in hard rock areas where high resistivity exist and it is difficult to carry out grounding system improvement. In some cases the access to the nearest large mass of soil required a metal extension for more than 100 m. Therefore copper tapes were extended parallel

from the tower site to this location. We have done such two improvements to the Nakiyadeniya and Galapatha sites. Please see the figure 5.1.
