**BACK ANALYSIS OF SLOPE FAILURE AT
WALIPANNA, SOUTHERN EXPRESS WAY**

Degree of Master of Science in Foundation Engineering and Earth
Retaining Systems

Cut slope at chainage of 42+340 to 42+400 in Walipanna at southern expressway failed after few days of rain. The back analysis of failure indicated that the safety margin is less than unity when saturated shear strength parameters of soil were used in the analysis. Infiltration of the rainfall that was recorded in nearby rain gauges was modeled using the SWCC and permeability function derived from the tests conducted on undisturbed samples recovered from the site.

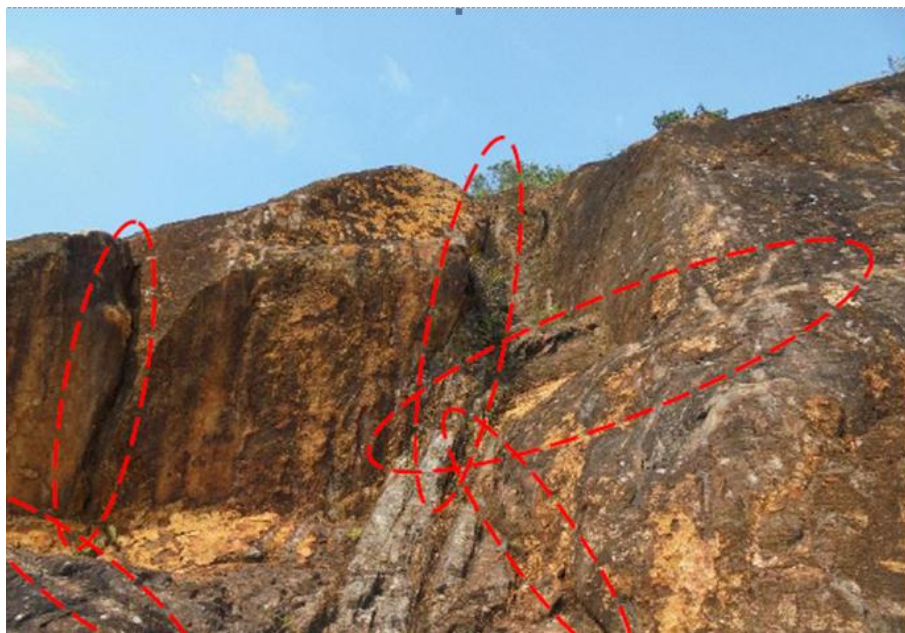
Type of the bedrock is garnet biotite gneissic. Outcrops of the bedrock can be seen at the top of the slope at 42+350 to 42+400. The bedrock is dipping into the slope at a very steep (80°) angle. Five different joint systems were identified in the rocks in the area as Figure 3.2.

Figure 3.2 – Joint sets in the bedrock exposed at the top of the slope

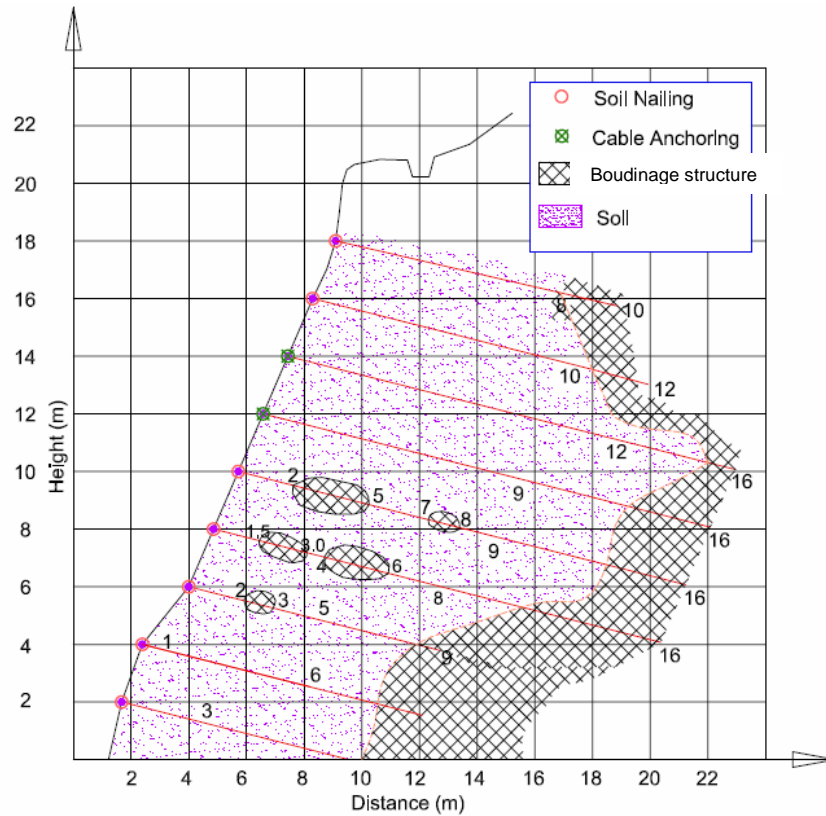
Residual soil had been formed as a result of the weathering of the gneissic rock. Due to weathering under high ambient temperature, high rainfall conditions and due to the differences in the mineralogical structure in the Metamorphic parent rock the weathered product is highly variable. As result, rocks with no or very slight weathering can be seen embedded in a matrix of soil. These are referred to as boudinage structures. This boudinage structures could be identified during the drilling for soil nailing in rectification process. A typical condition with boudinage structures encountered during drilling is presented in Figure 3.3.

Figure 3.3 – Typical drilling records indicating boudinage structures

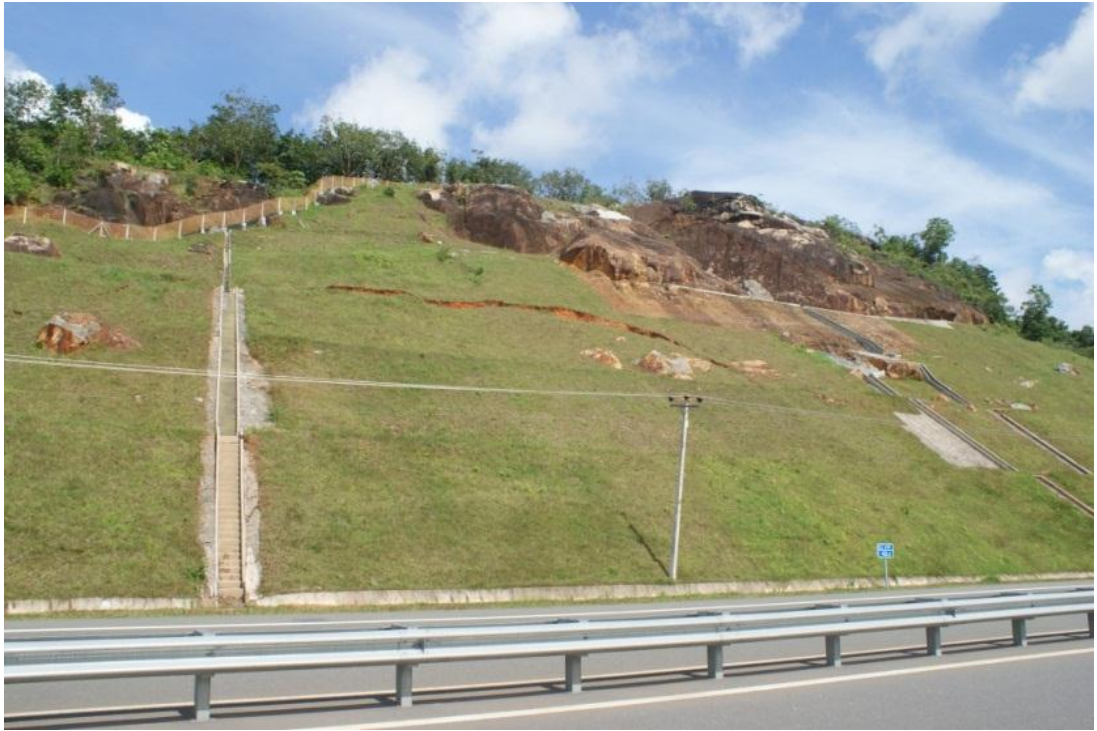
expressway was closed and public were warned after the observation of the initial crack.

Figure 3.8 – Initial Crack and downward movement of soil

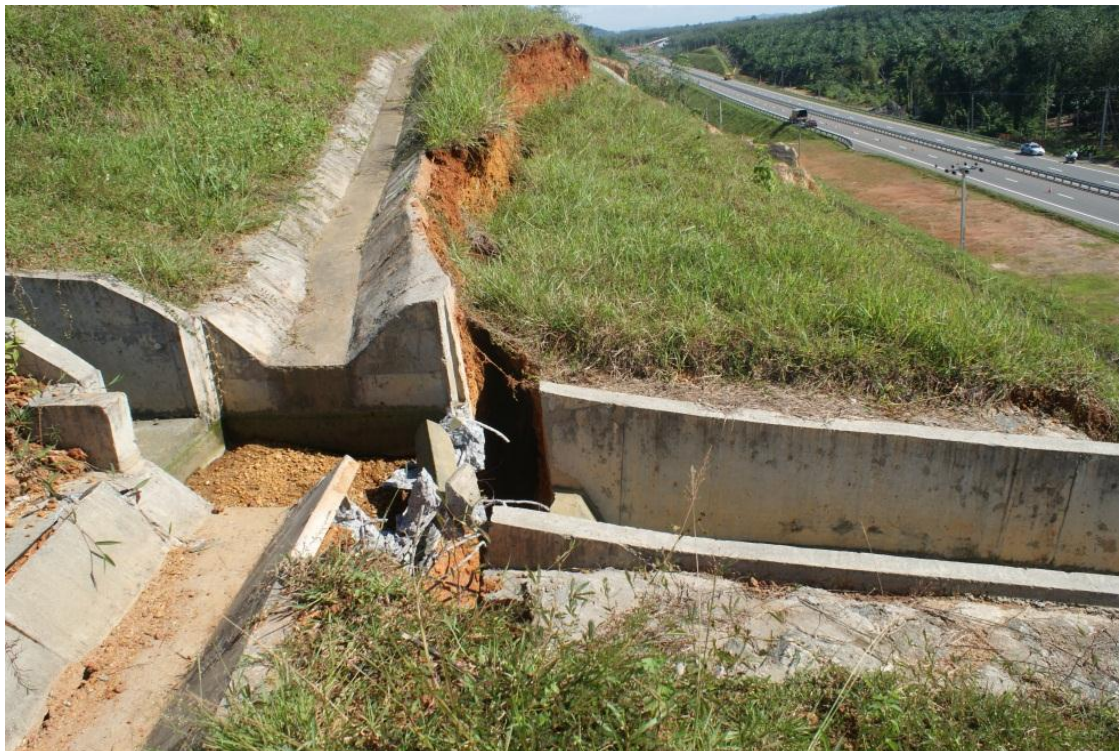
Figure 3.9– Movements of soil at the top and Movement of Cascade Drain

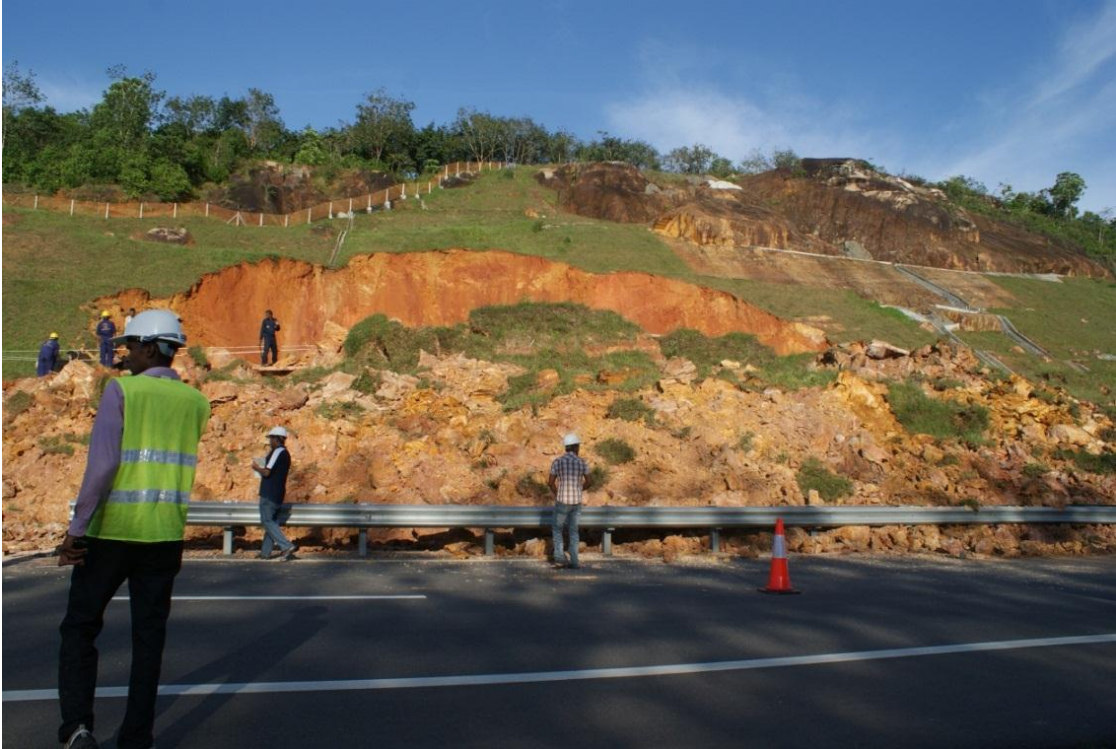
Figure 3.10– Debris of Failure Has Covered the road section towards the Galle

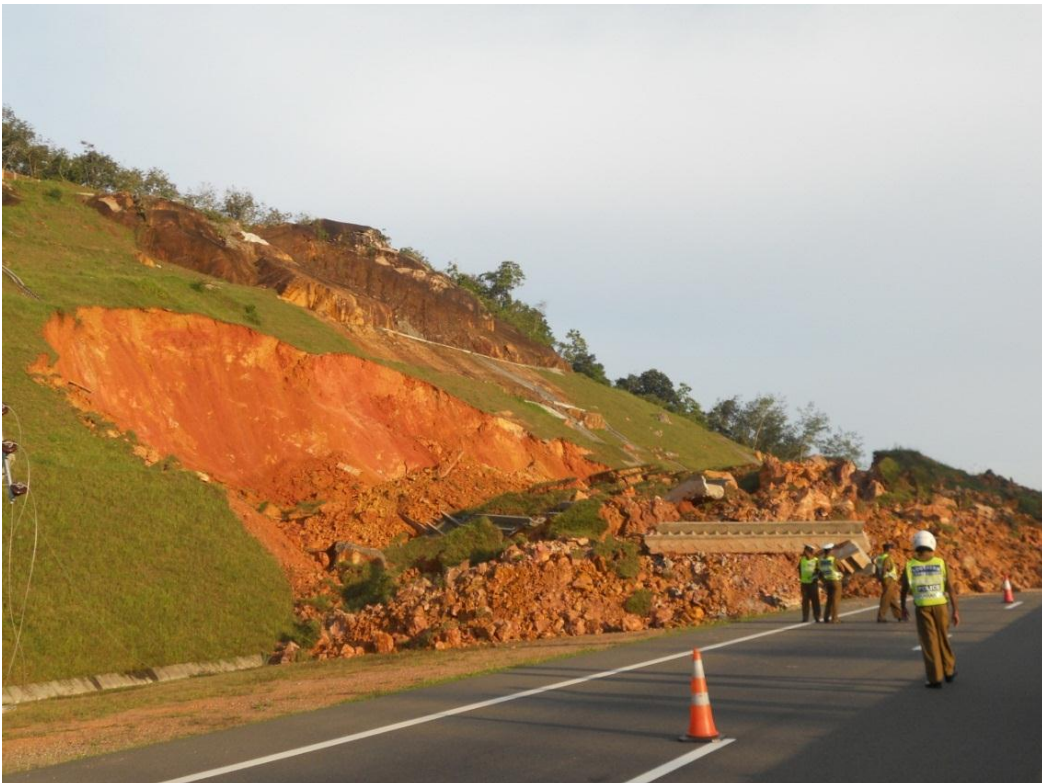
Figure 3.11 – Debris of Failure Has Covered the road section towards the Galle

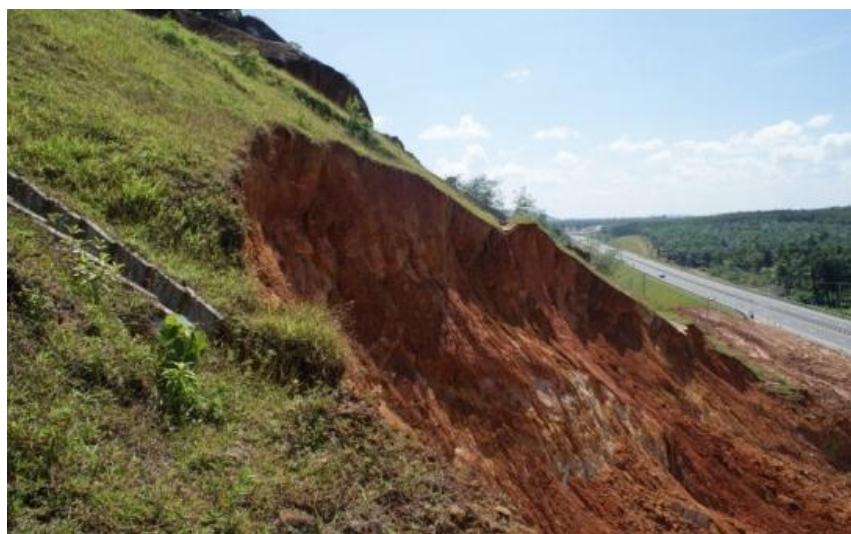
The failure also has been facilitated further by excessive infiltration of rainwater into a system of adversely oriented relict joints. Relict joints would be filled with loose material /weak material which was observed in the failure escarpment and water infiltrated into relict joints could facilitate saturation of the slope material. Further, there would be pore pressure built up in relict joints. In such situations the sliding will take place along the critical failure surface and the ground water table need not rise to higher level. The observation after the failure was similar. The debris were not having lot of moisture. However, just prior to the failure water getting released under high pressure or oozing out of water near the toe has been observed. This could be attributed to the perched water table condition developed closer to the toe of the slope.

Figure 3.12 –A Zone of whitish Feldspar rich clay in the failure surface

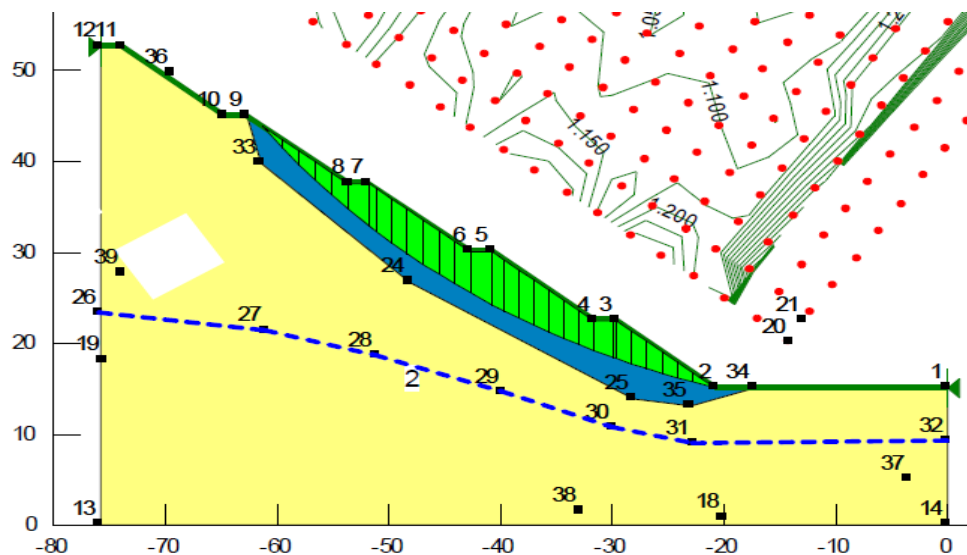
State of the stability of slope during failure was back analysed using SLOPE/W 2004 software. It was not possible to model the infiltration and account to the complete process at this stage. For the back analysis the unsaturated nature of the soil, that reduction of the apparent cohesion was simulated approximately by assigning weak zone of soil near the surface. Shear strength parameters of this weak zone was reduced to $c'=7 \text{ kN/m}^2$ and $\phi'=30^\circ$. Based on the experimental results obtained other areas were idealized to be formed of a uniform material of $c'=10 \text{ kN/m}^2$ $\phi'=32^\circ$. The most critical failure surface obtained was having a factor of safety of 0.993 (Figure 3.13). The obtained failure surface is shallow and somewhat close to that actually observed.

Figure 3.13 – Simulated failure surface (Rectification report – NBRO)
