INVESTIGATION OF STRUCTURAL DEFECTS IN GOVERNMENT HOSPITAL BUILDINGS IN SRI LANKA

Degree of Master of Engineering in Structural Engineering Designs

Department of Civil Engineering

September 2017

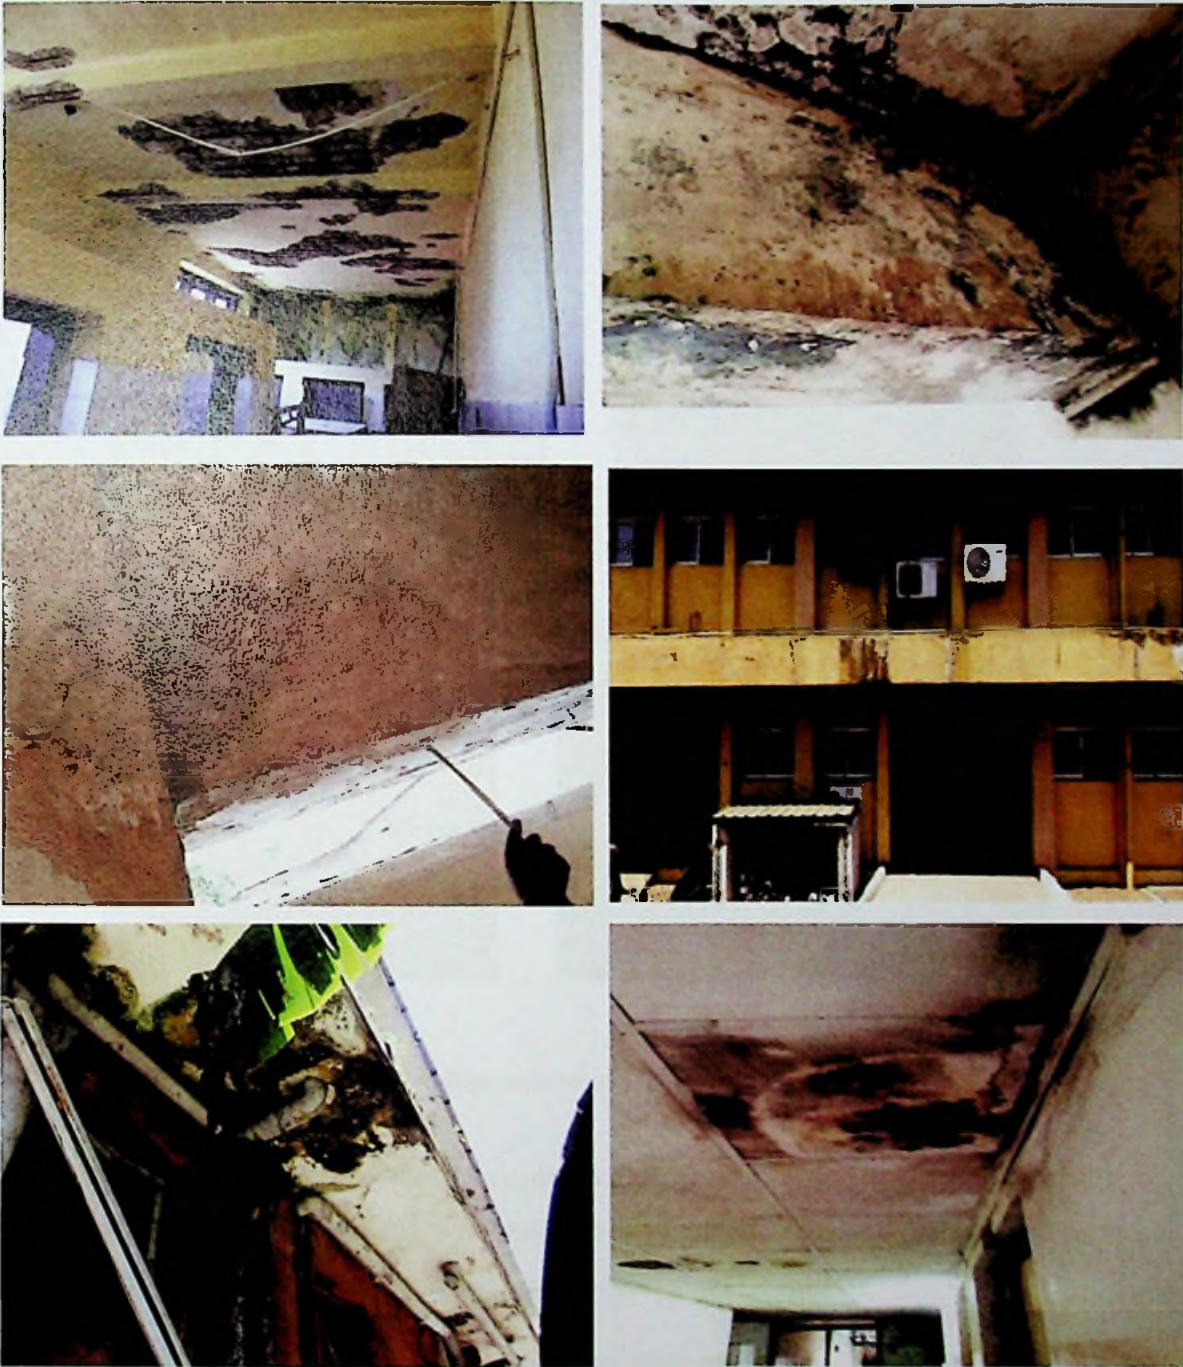
Figure 1.2: Deteriorated situation of GHBs

Considerable deterioration of both structural and non-structural elements can be observed related to most of the GHBs as illustrated in Figure 1.2.

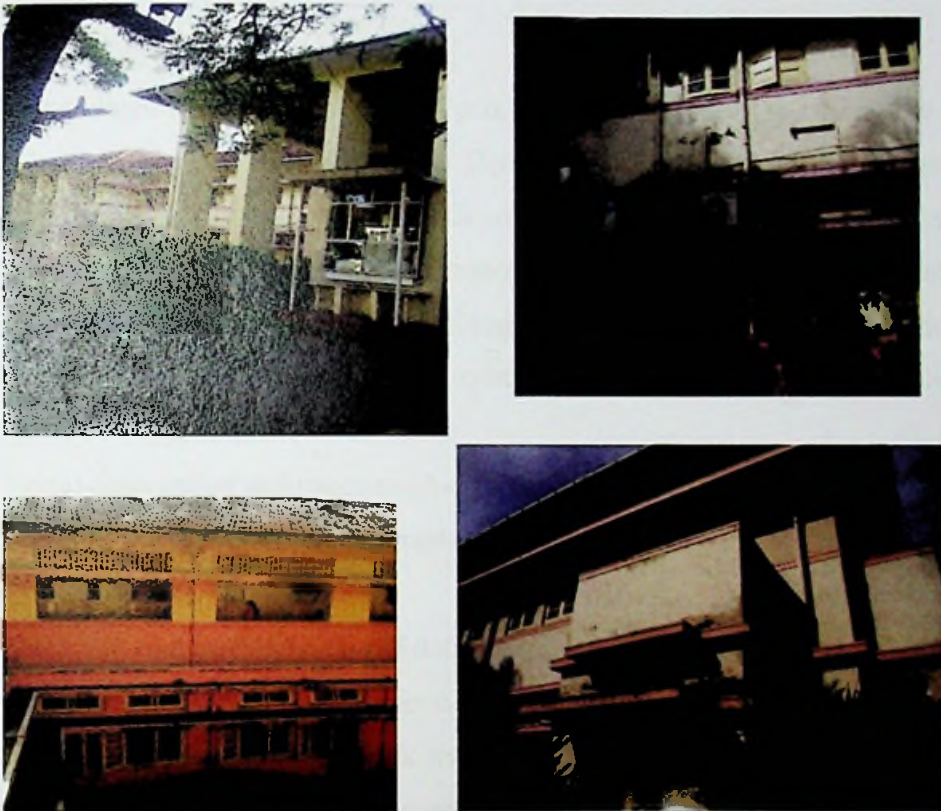
Figure 1.3: Appearance of OPD building of LRH

Also, Srilankan health sector infrastructures were affected due to the long term war situation existed. Figure 1.3 below shows the poor appearance of OPD building of Lady Ridgeway Hospital witnessing that upgrading of aesthetic aspect of GHBs is a long await need.

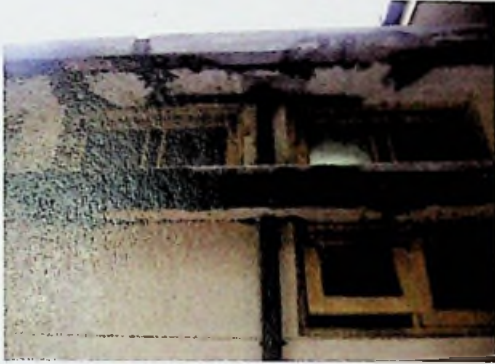
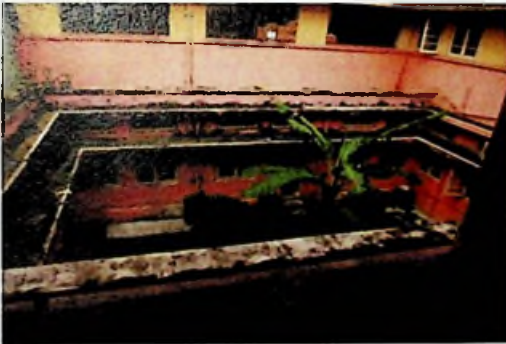
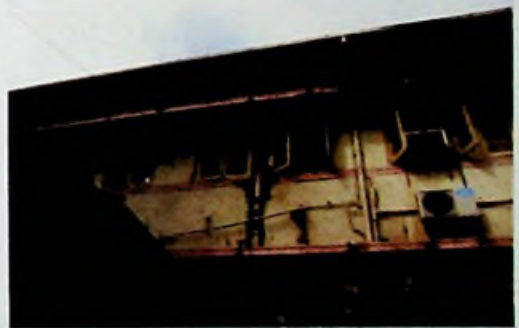
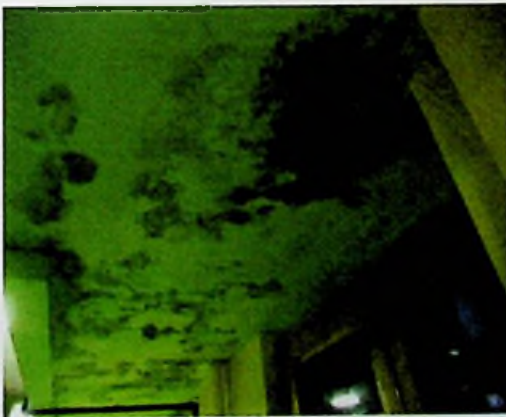
This situation was observed in both old and newly constructed buildings. Figure 3.2 shows the formation of fungi at canopy areas of OPD building and peeling off and blistering of paints in slab soffits of OPD building and the areas affected in newly constructed nine- story building.

Figure:3.2: formation of fungii,peeling off and blistering of paint at LRH

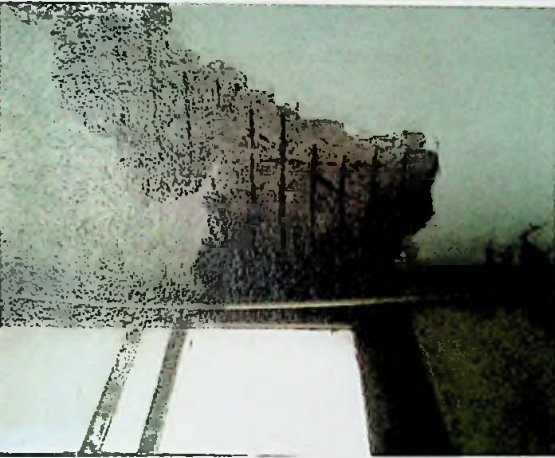
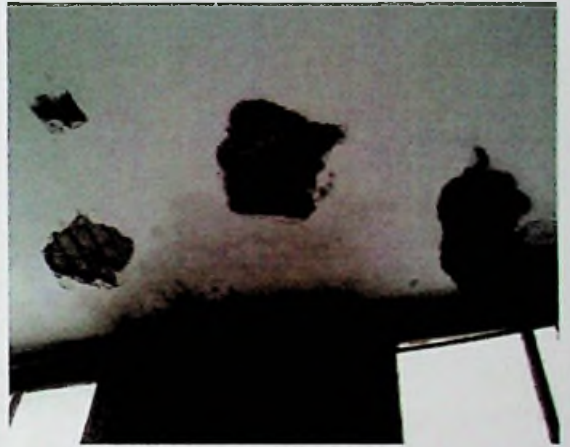
Slab soffits of old buildings were subjected to severe corrosion of reinforcement and spalling of concrete. The situation observed in the OPD building of LRH is shown in Figure 3.3 below. Improper rectification work to such defect in the same building is shown in Figure 3.4. Soffits under toilet areas, canopy slabs etc. had been undergone this situation.

Figure 3.3: Corrosion of reinforcement of slab soffits of OPD building of LRH

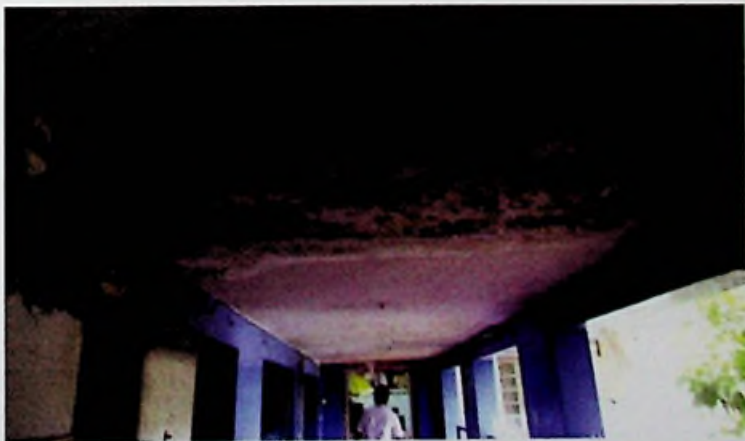
Figure 3.4: Improper rectification work to corroded slab reinforcement

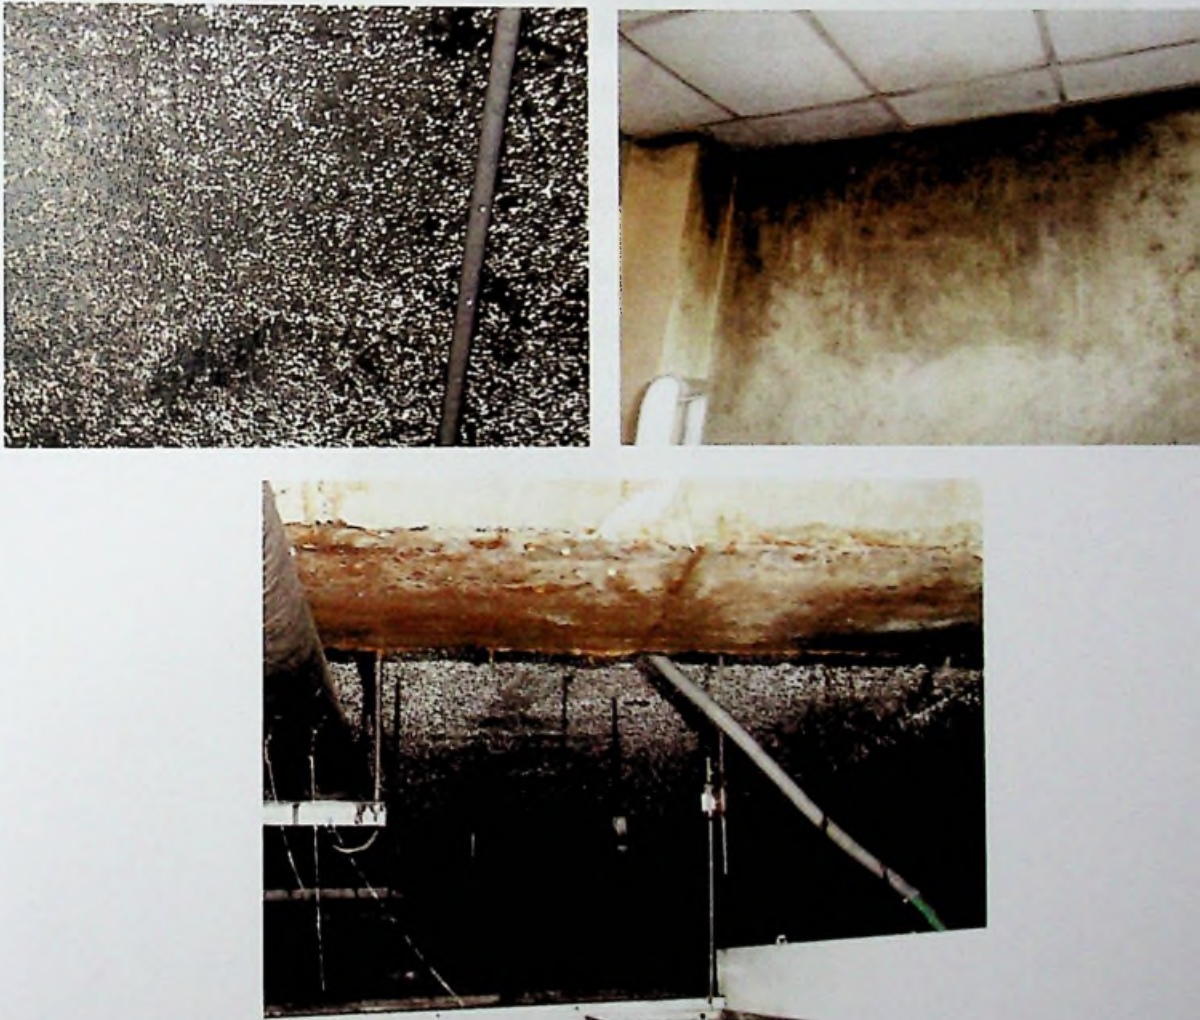
Accumulation of large amount of water under slab soffits and adjacent walls by condensation was observed at the non-air conditioned areas adjacent to operation theatres which operates at low temperatures below about 18°C . Figure 3.5 shows this situation clearly observed at the NINDT at Colombo 10. Ceilings and wall finishes were considerably affected by this situation, and Figure 3.6 shows such affected areas observed at the nine- story building in LRH.

Figure 3. 5: Condensation and accumulation of water under slab soffits at NINDT

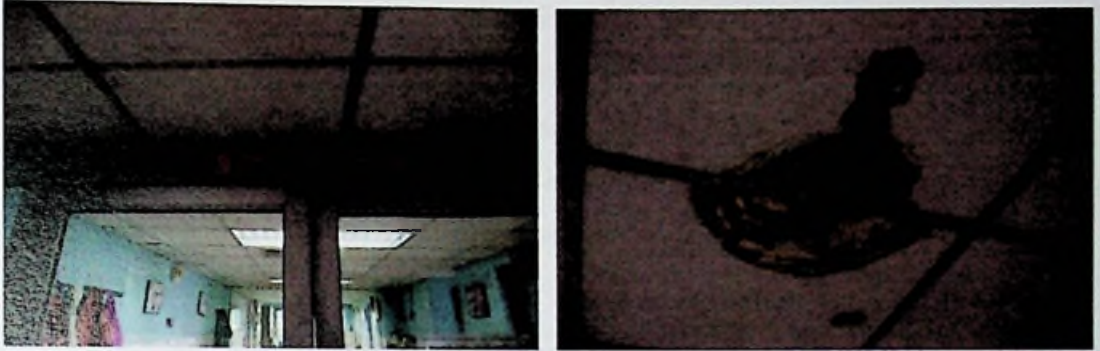
Nine-story building - LRH

Mineral fibre Ceiling sheets had been used for the affected ceiling shown in figure 3.6 below.

Figure 3.6: Ceiling affected due to condensation

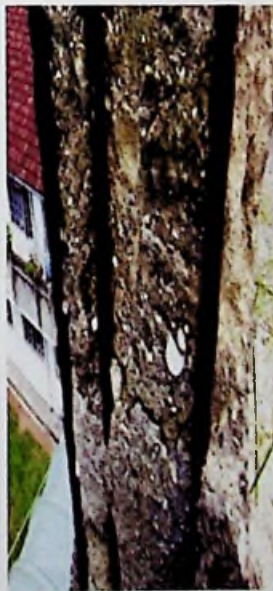
Figure 3.7 shows a very critical and unacceptable situation such that sea sand had been used for structural concrete work at NCTH, Ragama and observed severe corrosion of main reinforcement.

Fig 3.7: Severe corrosion of reinforcement of column concreted using sea sand at NCTH - Ragama

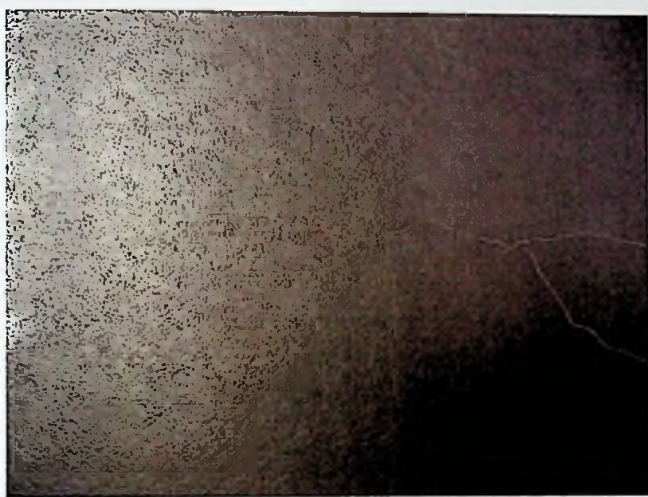
Most commonly occurring defects such as cracking, fretting and fungi formations etc. were observed regarding masonry walls. As far as concerning Lady Ridgeway Hospital most of the horizontal, vertical and random cracks were observed in block masonry walls in recently constructed buildings as shown in figures 3.11 and 3.12 rather than in old Buildings. Vertical crack shown in figure 3.12 penetrate the full width of the wall and these type of cracks occur due to temperature variations

Figure 3.11: cracks in Eye Unit LRH

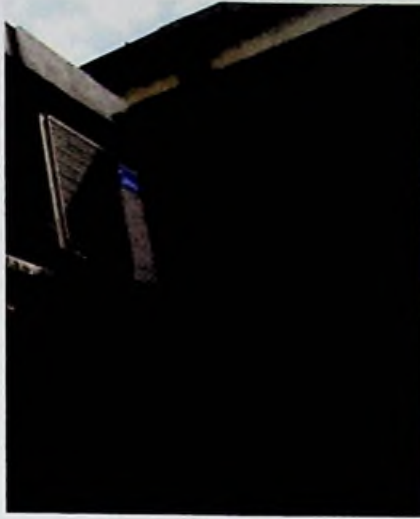
Almost all the walls adjacent to toilet areas showed water dampness and severe formation of fungi were observed in the areas of waste sewer and water supply lines, near the A/C out door units as shown in Figures 3.13 and 3.14.

Figure 3.14: Deterioration associated with plumbing lines and A/C outdoor units at LRH

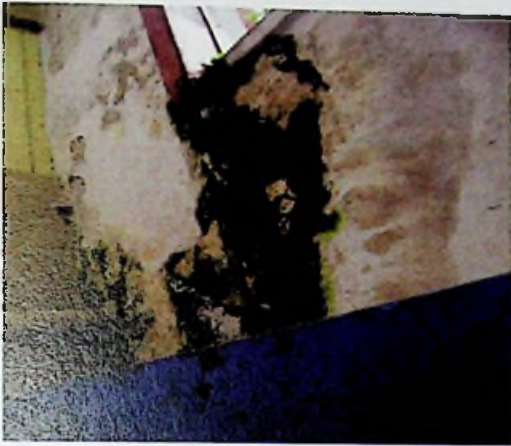
When observing the other affected wall and ceiling surfaces, it was noticed that different layers of paints were present and underneath layers also had been peeled off with the top most paint layer.

Figure 3. 15: - Fungi and deterioration of wall plasters of OPD Building -LRH

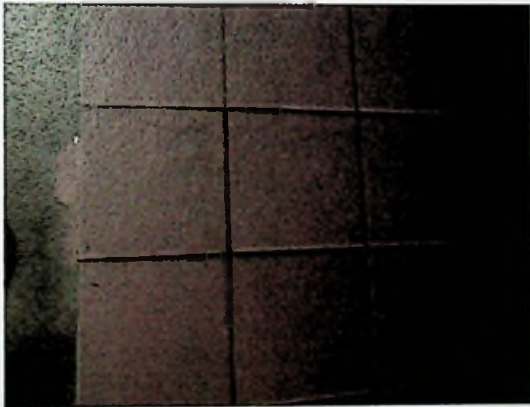
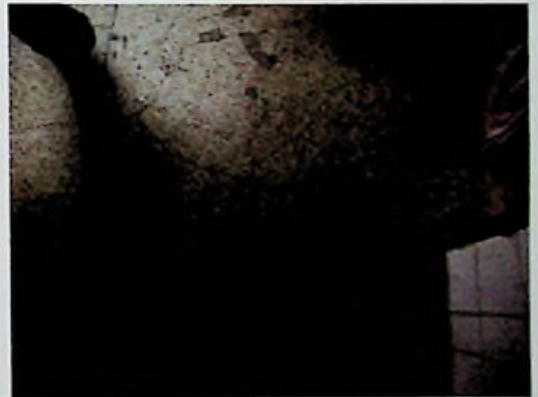
Further the figure 3.16 illustrates the cracks on wall and floor tiles in nine- story building at LRH.

Figure 3.16: Cracks in wall and floor tiles of nine-story building at LRH

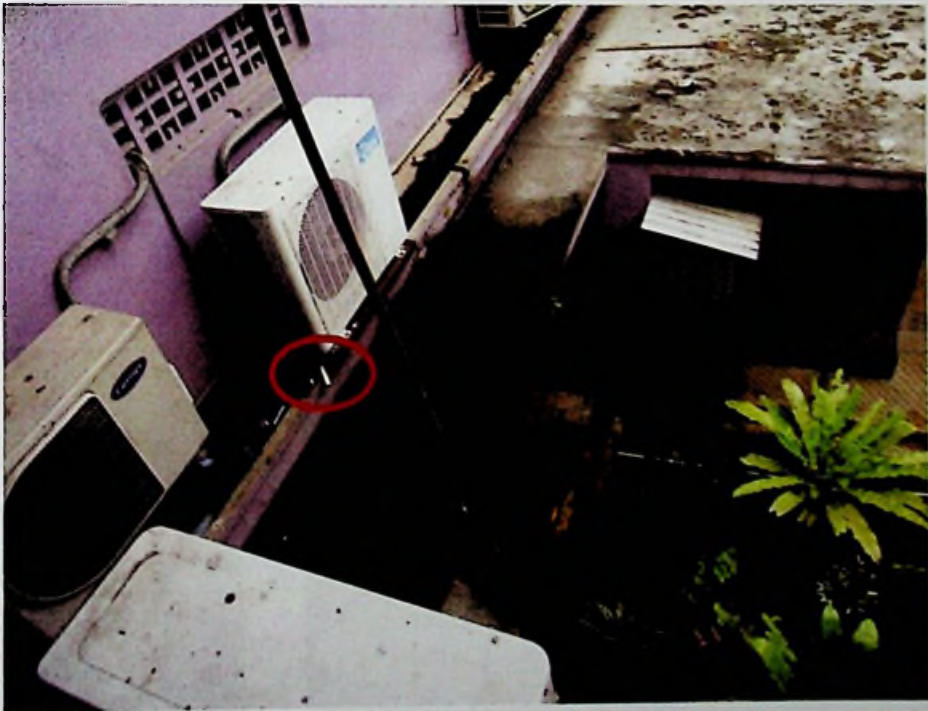
Figure 3.17: Improper arrangement of A/C Outdoor units

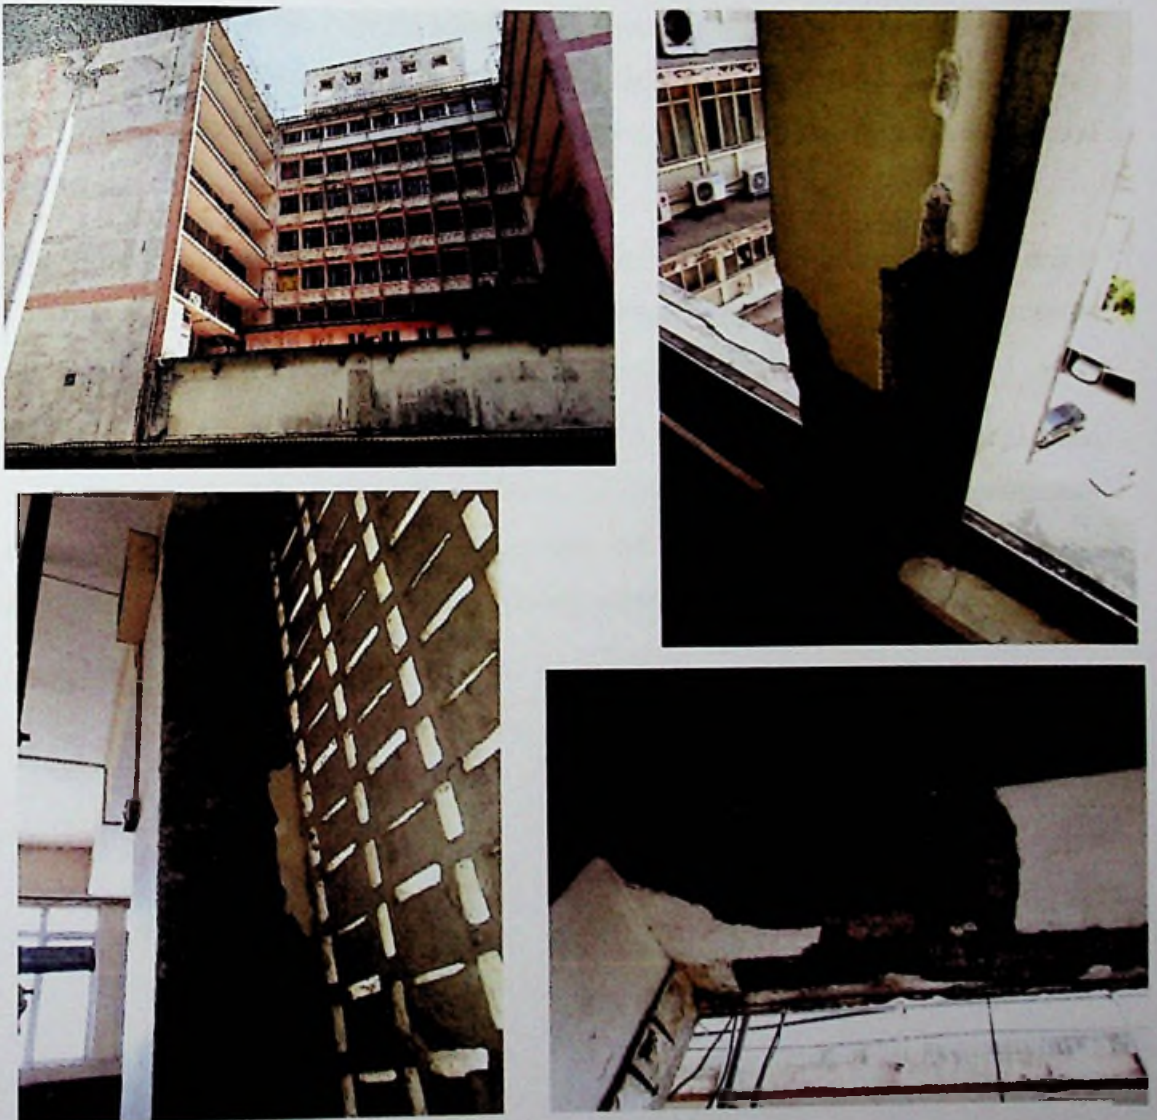
It was clearly obvious that the degree of deterioration of CEB head office building is critical than the condition of GHBs observed. Figure 3.20 shows the existing condition of CEB head office building which is located at Sir. Chittampalm A. Gardiner Mawatha, Colombo 02.

Figure 3.20: Condition of CEB Head Office Building
