Analysis of Geological Structures for Road Cut Failures: A Case Study Along Balangoda - Haputale Main Road

Department of Earth Resources Engineering, University of Moratuwa

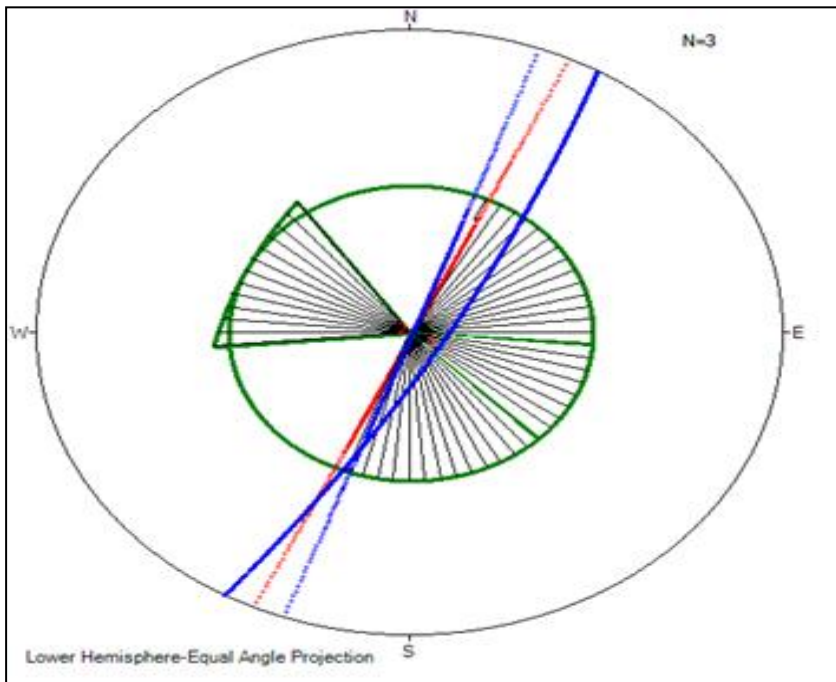
Figure 2: Stereonet of LH16

Original details of L16

Observation - rock fall

Failures from software

Plane set - 2

Wedge set - 1

Slope angle	90 ^o	80 ^o	70 ^o
No of plane failure set	2	0	0
No of wedge failure set	1	0	0

Slope direction	105 ⁰	95 ⁰	85 ⁰	75 ⁰
No of plane failure set	2	2	1	0
No of wedge failure set	1	0	0	0
