4.0 RESULTS, ANALYSIS AND ACTIONS

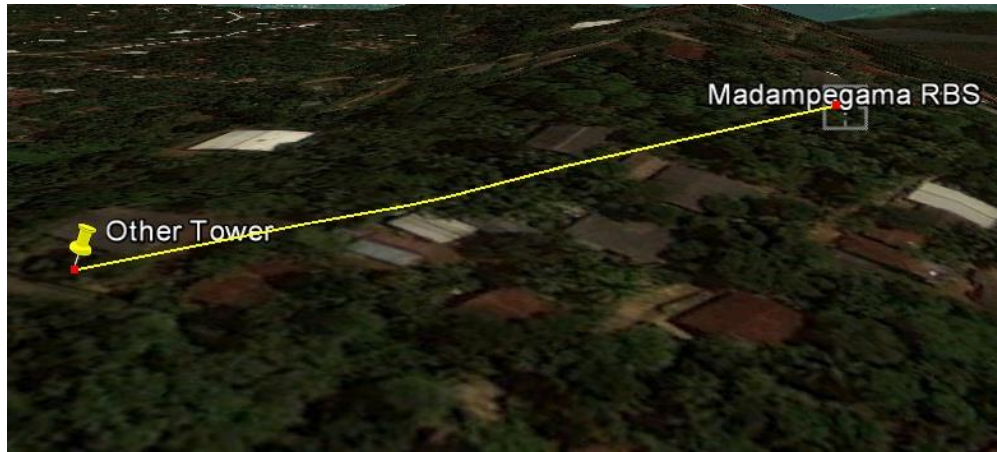
Figure 4.1: Elevation of Madampegama site with respect to other operator site

There are two incident that we observed damages occurrence and non-occurrence with the tower erection. For an example: We have observed frequent lightning damages and complain near Madampegama RBS from the date of tower erection. But there is a tower near the Madampegama RBS with the same tower height and from the 150m of air distance. But elevations of the two tower locations are different and Madampegama Tower is located on around 10-20m higher elevation as you can see in below google maps. The Other operator site is located in mentioned area for more than one year before Madampegama tower erection. But there were no such lightning incidents reported with regards to that tower. Therefore simply we can conclude that erection of tower has considerable effect for lightning incidents and also there is a correlation with the tower elevation from the sea level or effective height. Also it is noted that the area is residential having around 26 homes around 100m of perimeter.

The reason for this can be explain using iso keraunic level and tower height from the sea level. Grounded vertical objects produce relatively large electric field enhancement near their upper extremities so that upward-moving connecting leaders from these objects start earlier than from the surrounding ground and therefore, serve to make the object a preferential lightning termination point. With increasing height of an object an increase in the number of lightning discharges is observed with an increasing percentage of upward initiated flashes [12].

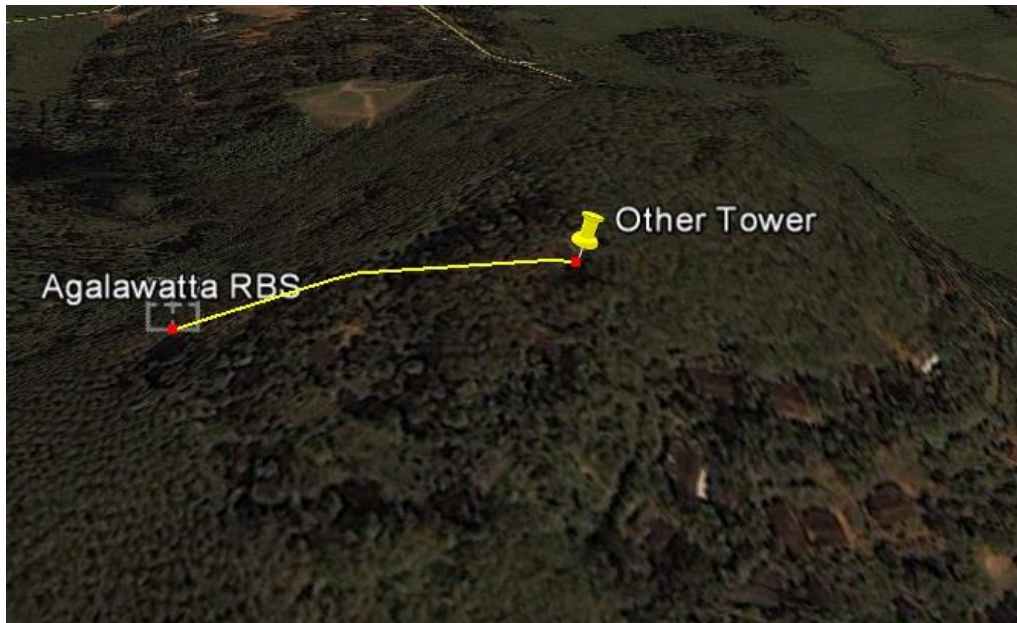
Figure 4.3: Elevation of Agalawatta site with respect to other operator site

The other incident is reported near Agalawatta RBS. There was lot of damages reported near Agalawatta RBS. But we have observed that there were no damages reported to this RBS after the other operator tower erection near this are. We can see that the other operator site has same tower height and located from the 125m of air distance. Same as the Madampegama case, the elevations of the two tower locations

are different and Agalawatta Tower is located on around 10-20m lower elevation as you can see in below google maps.

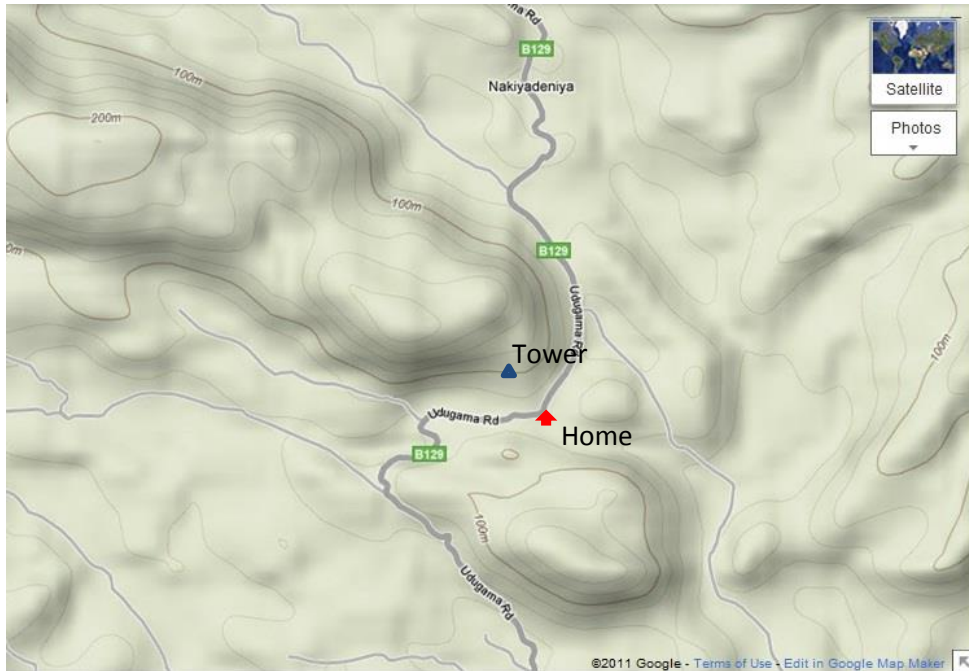
Figure 4.5: Tower location and the home location in Nakiyadeniya lightning incident
 (Source: Author)

A one of home located in Nakiyadeniya radio base station has damages due to some of side flashes occurred in the tower. This can happen as there may be shielding failure rate, e.g., the 2% (maximum) of low energy strikes in a 98% lightning protection design as shown above [15]. As per the damages it is obvious that the damages are due to CVM by pass.

If we consider the total mountain as one structure height of 250m (above sea level) and we have installed an terminal on the top of mountain. The home can be considered as a point on the structure that is on the lower part of the structure and that point has been damaged due to CVM bypass as similar as lightning incident happen in Villaputri Building, downtown Kuala Lumpur in year 2005.

Tower Air terminal height with reference to the sea level is around 250m and home located around 110m above the sea level. Therefore it is obvious that we can expect such bypasses even there lightning protection zone due to a telecommunication tower. In such cases we have taken care of protecting neighborhoods by creating protection zone for them.

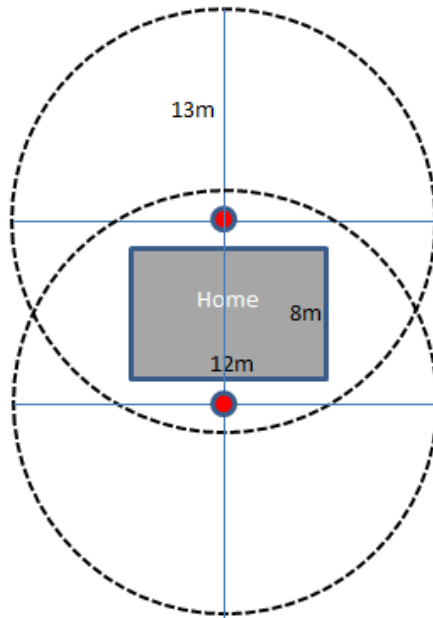
Figure 4.8 Shielding areas proposed around the damaged home

A lightning rod mounted on 10m GI structure selected for the protection of home. Then for the high risk, we have selected 6.5kA peak current, and then radius of protection is 13m. For more safety we can put 2 lightning rods and have large collected volume.

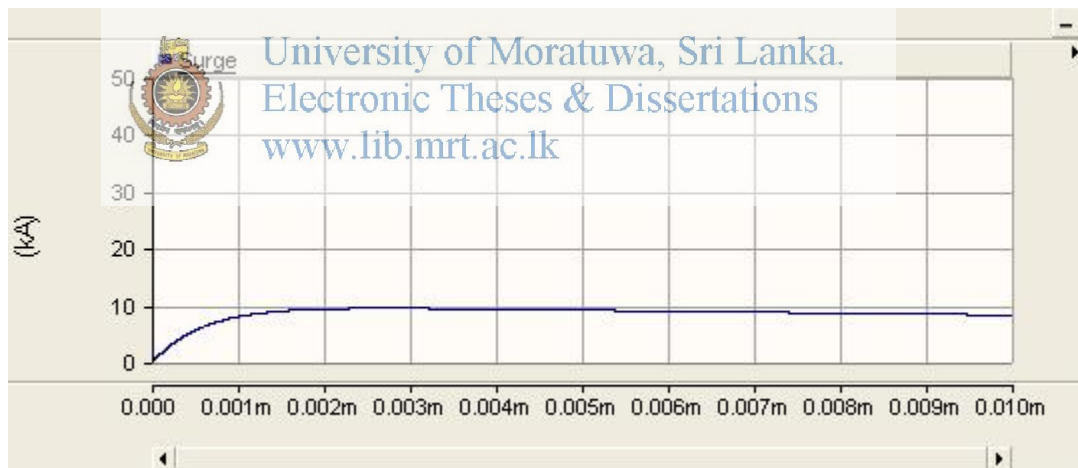
Figure 4.13: Surge wave model

For the purpose of surge calculations, it is only the heavy current flow during the return stroke that is of importance. During it has been found that the waveform can be represented by a double exponential of the form

The parameters of the lightning current surge were taken according to the International Standard IEC 61312-1 [12] for the III and IV protection levels as 10/350 μ s 10 kA. The Surge generator and wave shown in Figure 4.12 and Figure 4.13 respectively

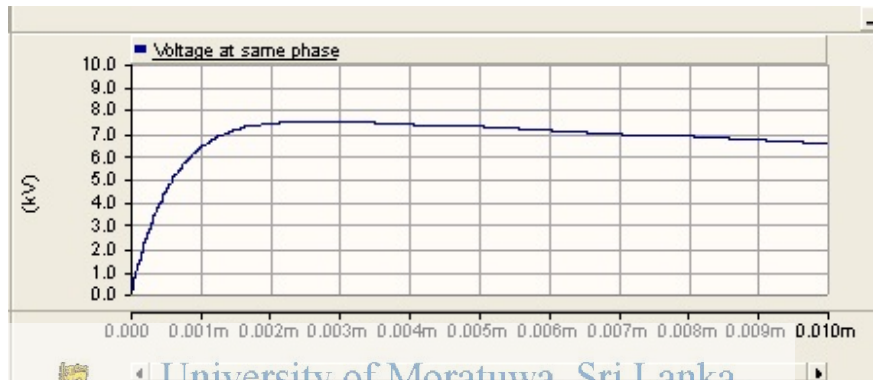
Figure 4.15 Voltage rises in (a) at load (b) Phase to neutral (c) at separate phase (d) Site power input phase (e) at neutral for 100 Ohms earth resistance system

With the effect of the lightning strike to the tower, we can see around 7.5kV voltage rise at the power input phase to the SRF, Neutral, Power output from the SRF and at Separate phase from the transformer with respect to the ground and there is no voltage difference in Phase to neutral in RBS having 100 Ohms earth resistance system.

By considering the simulation results we can see that the considerably high voltage built up in power lines not only in RBS power in, but also in other transformer feeders. This will cause to lot of electrical equipment damages. During the research data collection, we can see that the earth resistance values in most of the sites are

greater than 5 Ohms. With this we can see there may a possibility of more than 7kV voltage rise in electrical systems with respect to the earth. This is basically high value compared with BIL of electrical items and therefore will cause to equipment failures.

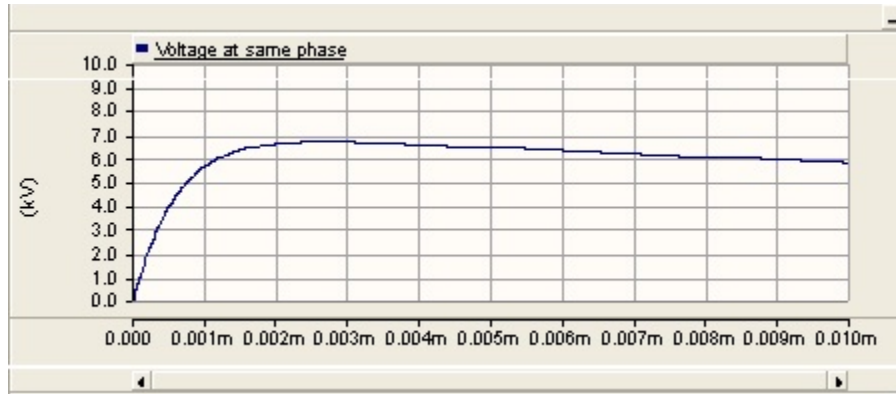
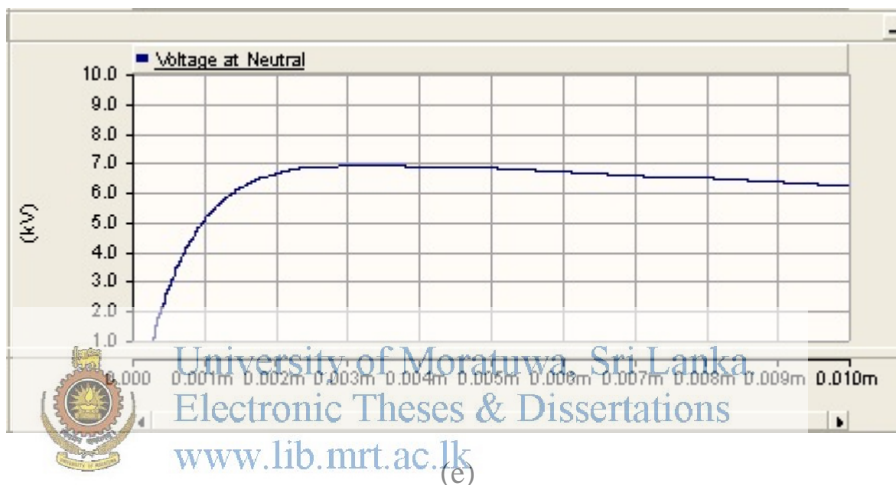
Figure 4.16 Voltage rises in (a) at load (b) Phase to neutral (c) at separate phase (d) Site power input phase (e) at neutral for 10 Ohms earth resistance system

With the effect of the lightning strike to the tower, we can see around 7 kV voltage rise in power input phase to the SRF, Neutral, Power output from the SRF, Separate phase from the transformer with respect to the ground and there is no and voltage difference in Phase to neutral. This is not a considerable reduction in voltage rise compared with 100 Ohms earth resistance system.

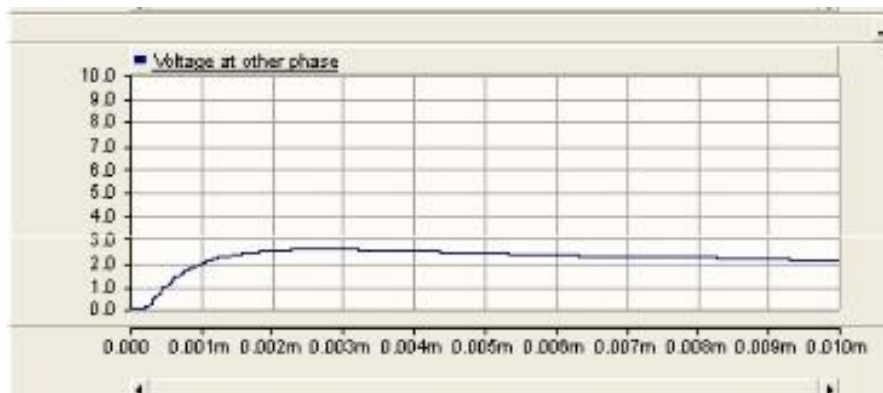
Figure 4.17 Voltage rises in (a) at load (b) Phase to neutral (c) at separate phase (d) Site power input phase (e) at neutral for 10 Ohms earth resistance system

With the effect of the lightning strike to the tower, we can see around 2.5 kV voltage rise in power input phase to the SRF, Neutral, Power output from the SRF, Separate phase from the transformer with respect to the ground and there is no and voltage difference in Phase to neutral. This is a considerably low value compared with 100 Ohms and 10 Ohms earth resistance system.

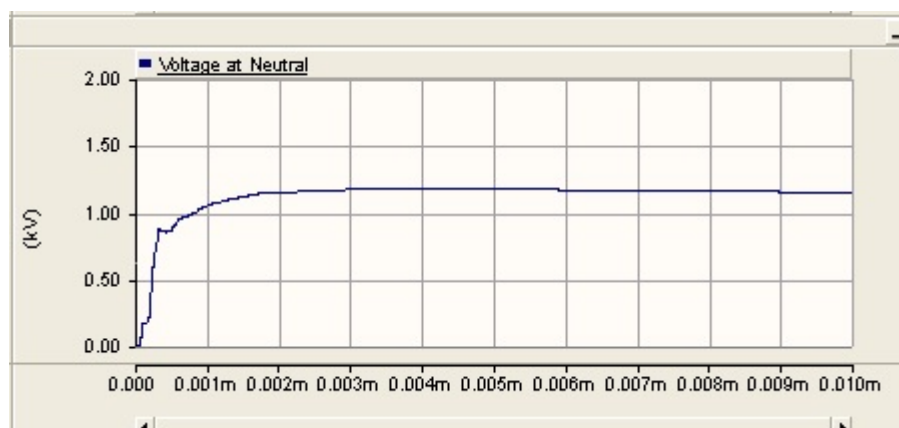
Figure 4.19 Voltage rises in (a) at same phase (b) phase to neutral (c) at neutral (d) at separate phase (e) at load - for secondary surge arrester installation at phase to ground

In this simulation we can see the voltage around phase get dropped to around 0.75kV as shown in Figure (a), (d) and (e). At neutral it is around 1.25kV as shown in Figure (c). A remarkable feature in phase to neutral is that at the beginning we can see a

voltage spike and then it became to zero as shown in Figure (b). Therefore we can see that the phase to ground surge arrester works effectively to reduce voltage rise due to the lightning surges.

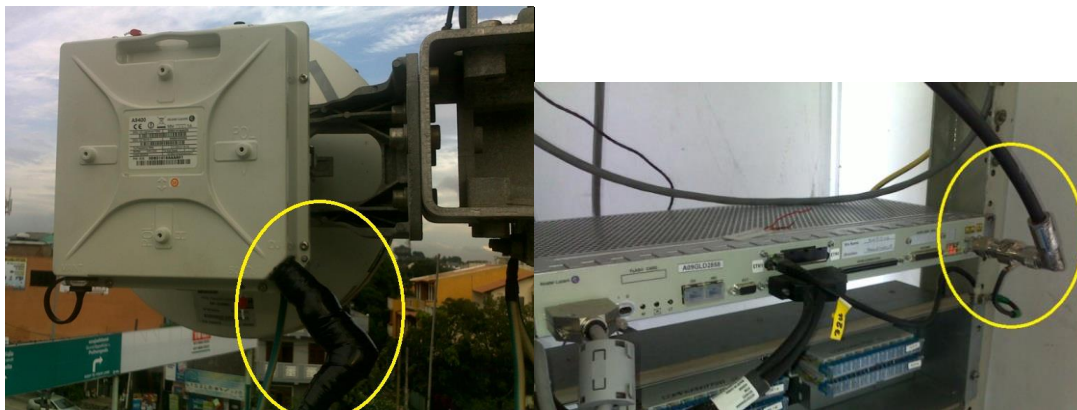
Figure 4.26: Base band arrester installation (a) at ODU mounted on tower structure (b) at IDU mounted in equipment cabin

This has happened due to the voltage different between the tower structure and the coaxial cable. Irrespective of the resistance, the inductance alone will contribute to a very high potential difference between the coaxial cable and the tower structures which are essentially at ground potential. But as per the past experience we do not have noticed and spark-over through insulation breakdown.

As a preventive action we have installed base band arrester to both end of the transmission path of all microwave antenna link in the network.

We have observed ODU and IDU failure rate after the installation during last three years and it has successes 100%. The MW links located in high iso keraunic level areas such as Rathnapura get hanged, but no equipment failure reported. This has been happed due to exceed of no of hits can be managed by the arrester.
