**COMPREHENSIVE GUIDELINE FOR SUSTAINABLE
INVOLUNTARY RESETTLEMENT**

Degree of Master of Science in Environmental Management

Department of Civil Engineering

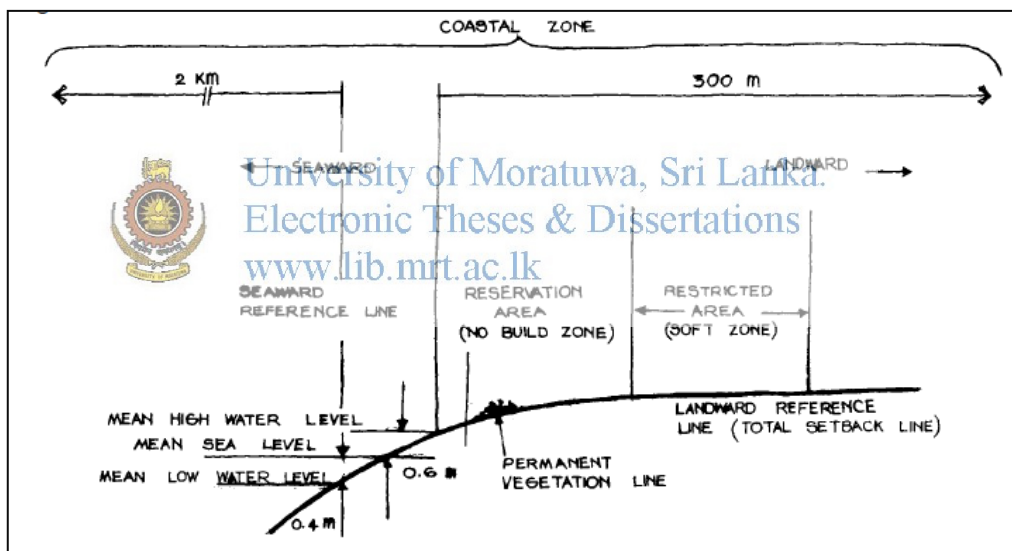
Figure 2.1 -Coastal Zone

The Coast Conservation Act No 57 of 1981 Srilanka, defines “coastal zone” as the “Area lying within a limit of three hundred meters landward of the mean high water line and a limit of two kilometers seaward of the mean low water line, and in the case of rivers, streams, lagoons or any other body of water connected to the sea either permanently or periodically, the landward boundary shall extend to a limit of two kilometers measured perpendicular to the mean low water line.”

According to the Coast Conservation Act No 57 of 1981 Srilanka, this coastal area is divided into two. First one is the “reservation area” it is the no build zone. Second one is the “restricted area”. Some development activity is allowed within this area .The seaward reference line of this sensitive area is fixed (i.e. 0.6meter above the mean sea level). The landward reference line varies, according to the sensitivity of a given coastal area to sea erosion and other natural hazards.

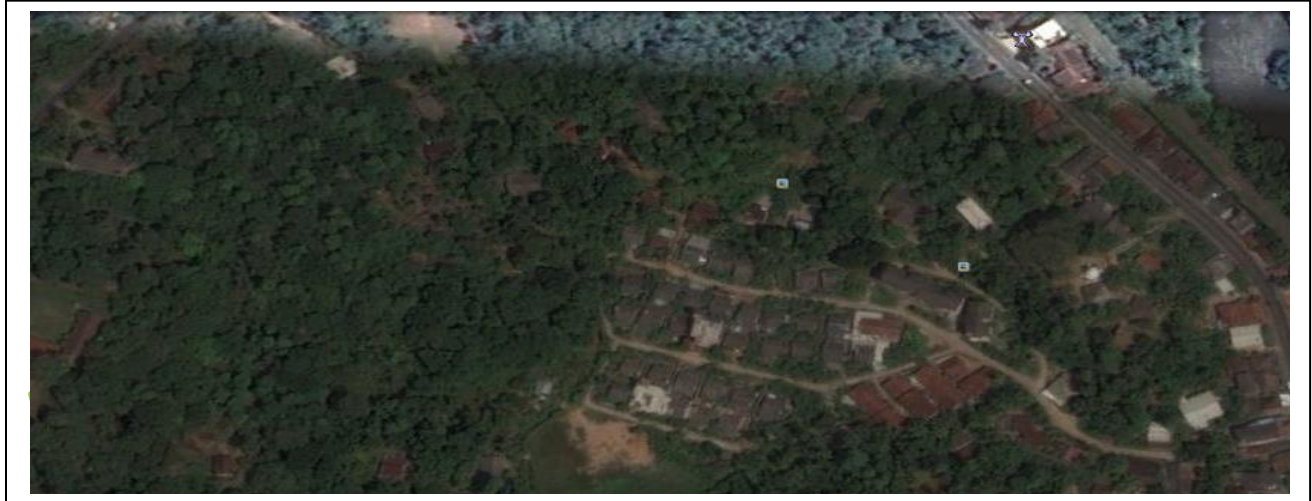
(Satellite image: 4.1.1.1 Kesbepana Tsunami Resettlement Site)

Kesbepana Tsunami village is located adjacent to the “Rumaswala” Cultural and heritage site. According to the Regulations and Legislations, whether it is ok, people who are living in the resettlement site can easily access to that area. If it is like so, it is caused to happen bad impact on medicinal plants and species. At present people are using this area to for find some medicinal plants. When people frequently visit this area it will be reason to occur unfavorable conditions to this ESA.

This type of environment should not exist to the adjoining lands which have been declared as important sites by the government. There should be a legal provision for control the land uses of adjoins lands which are environmental sensitive areas.

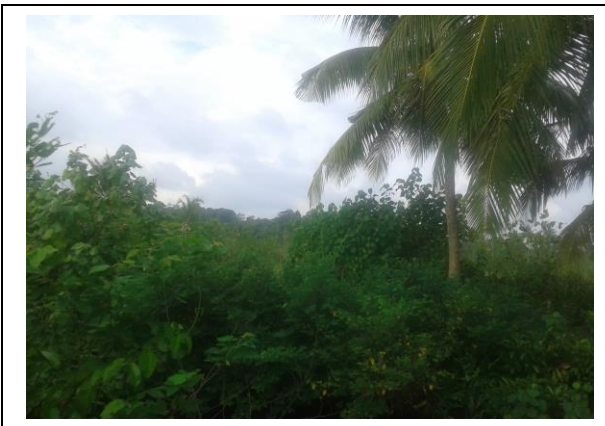
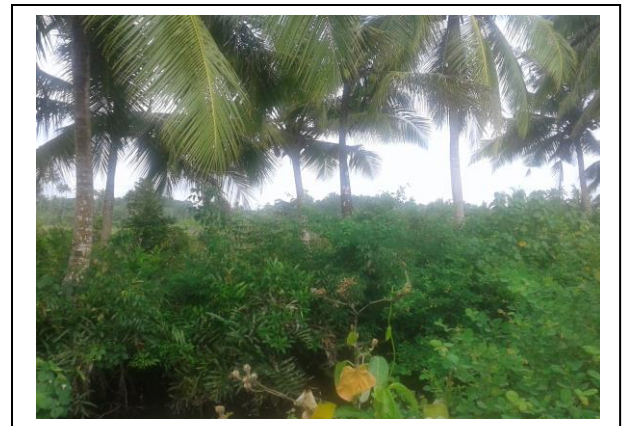
Image: 4.1.1.1 Paragon Estate Adjoin Marshy land 4.1.1.2 Paragon Estate Adjoin Marshy land

Earlier this land was part of the marshy land. During the very early period the land owner of this land began to cultivate coconut by erecting plots on marshy and they excavated canals beside the plots.

Another important issue is the area adjoining to the marshy land gets gradually filled by the non biodegradable waste and domestic waste. Another important issue is people live in these sites to earn additional income from coconut fiber production. For that industry so many “Husk pits” have been built in the marshy area. As a result bad odor, unpleasant, unfavorable hydrogen sulfide gas is generated from this industry.

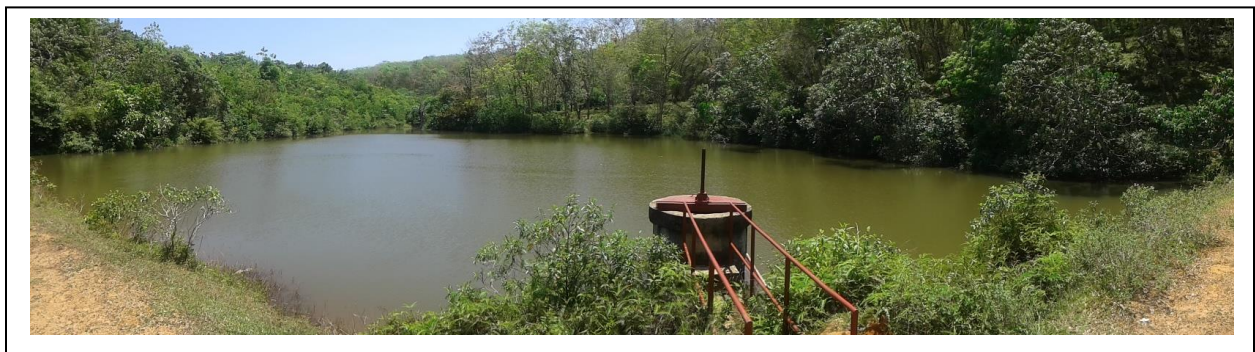
Image: 4.1.1.3 Godadenikanda Man made water detention lake

The tank was constructed after constructing the housing scheme. At the stage of setting out to construct the tank, attention should have been made on the surrounding land uses in prospective manner.

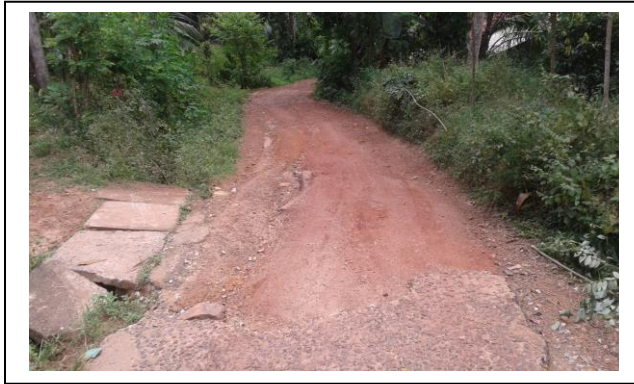
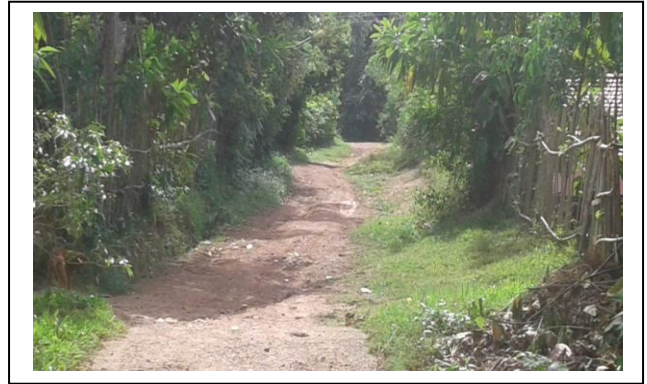
When looking out the table site no 134, 137, 86, 87 shows negative responds. Site no 134 – korahedigoda watta, Eddunkele Ahangama is really problematic site under this section. This site not satisfies the NHDA guideline requirement at all in land utilization. This site is located in mountain slope around 5 km away from the earlier residences of the resettles. The people in this site are too much suffering because of the poor infrastructure facilities. Accessibility to the public infrastructure specially transportation is dominant problem prevailing here.

Image: 4.1.2.1. Access road –Addunkele H.S

Image: 4.1.2.2. Internal road –Addunkele H.S

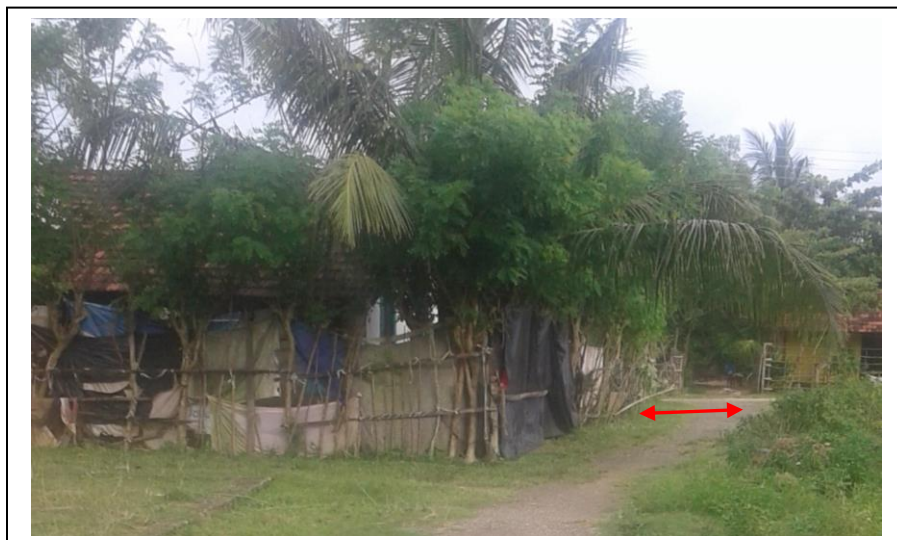
Image: 4.1.2.3. Acquired road space –Paragon village Housing Scheme

Sub section 6(iii) and 6(iv) show number of negative responds form several sites. Section 6(iii) discuss regarding the space allocated for the roads and drainage facilities. At the planning stage of the site it appears here space allocation for those facilities was followed properly, although it was not seem now. The main reason for this is people expand their legal boundary by altering their boundaries by acquiring the lands allocated for roads.

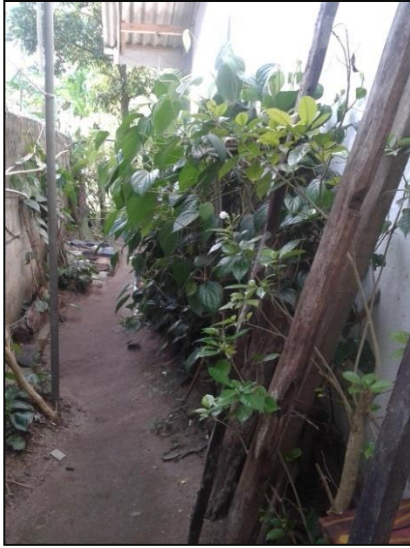
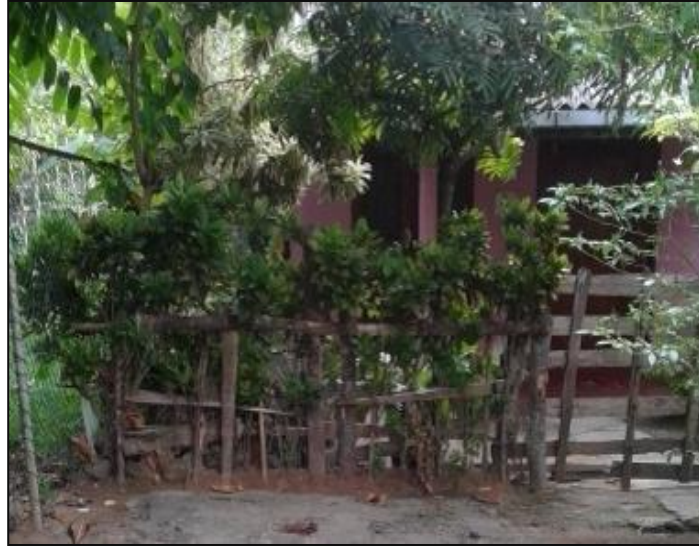
Image: 4.1.2.4,5. Limited front and side space Galgegedara watta Hosing scheme, Habaraduwa

When land plots are very smaller, another big issue is houses are located very closer to each other. This affects the privacy of the families in bad manner. As a result unacceptable relationships, conflicts between families occur.

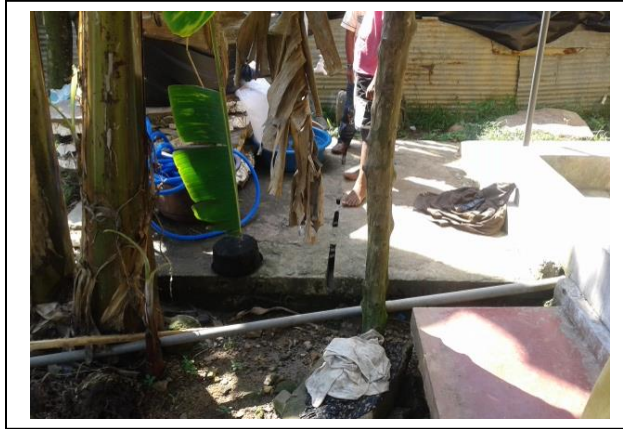
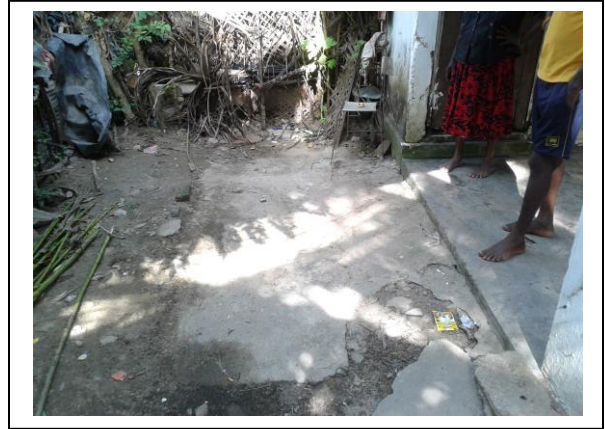
(Image: 4.1.2.7 Rare Space – Malapal Watta H.S) (Image: 4.1.2.8 Rare Space- Addunkele H.S)

section 9(i) in the table shows that out of fifteen four sites were showed the negative respond. Section 9 (ii) in the table shows four negative responds. This part discuss regarding the rear space.

Front space is very much important for this people for parking and for front vegetation to reduce environmental heat. Rear space is important for handling solid waste and stock fire woods, water, materials need for their employments. The rear space is important for Specially for fishing community to handling fishing nets. Normally six perches land plots are suitable for urban areas. The income of the urban people is higher than the income earned by the people in the village. Urban people mostly use L.P gas and electricity for cooking and pipe born water for drinking. Therefore additional space is not necessary stock material. This resettled people can't afford this cost like urban people. These housing sites don't have continuous water supply. Therefore each house has to stock when water supply is available periods. So when deciding the front and rear spaces, the living pattern, employment and income level of people should be taken in to consideration.

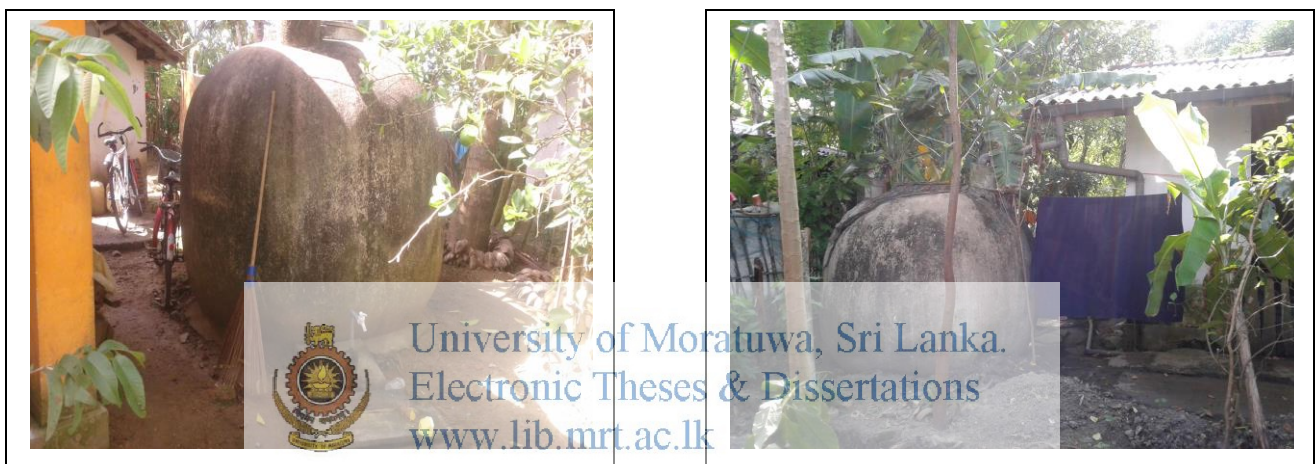
(Image: 4.2.1.3,4. Rainwater Harvesting Tank Addunkele & Korahedugodawatta H.S)

Rain water harvesting is good a solution for water scarcity in hilly sites where ground water table is lower or ground water is not suitable for even secondary uses. Even of it is not mentioned in the NHDA guide line, fifteen out of three sites have rainwater harvesting vessel made of cement. The availability of rain water harvesting tank in sites as percentage from total number of sites it is 27%.

Harvesting rainwater in the vessel is used for washing purpose specially to use for toilets, watering home gardens and ornamental plants.

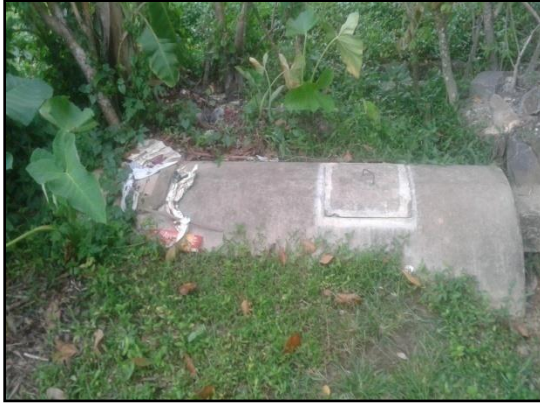
(Image 4.2.4.1: Soakage Drain Field)

Except the septic tank followed by soakage drain fields, evaporation mounds are practiced in those site. The same problem mentioned above method also prevailing in these two methods also. All the sites which use soakage drain fields, evaporation mound has higher water table.

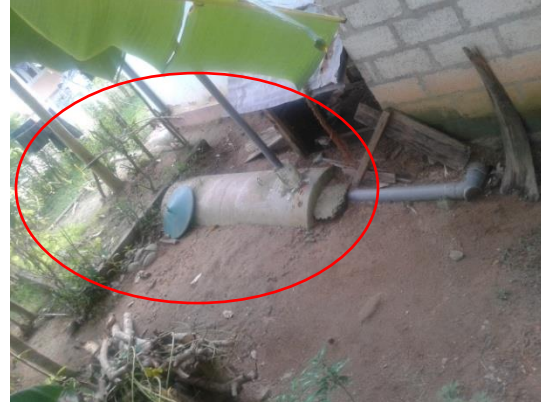
(Image 4.2.4.2: Evaporation Mound)

In Kesbepna Tsunami housing scheme, a rear type of evaporation mound was found. That mound is cultivated with fruit and vegetable trees.

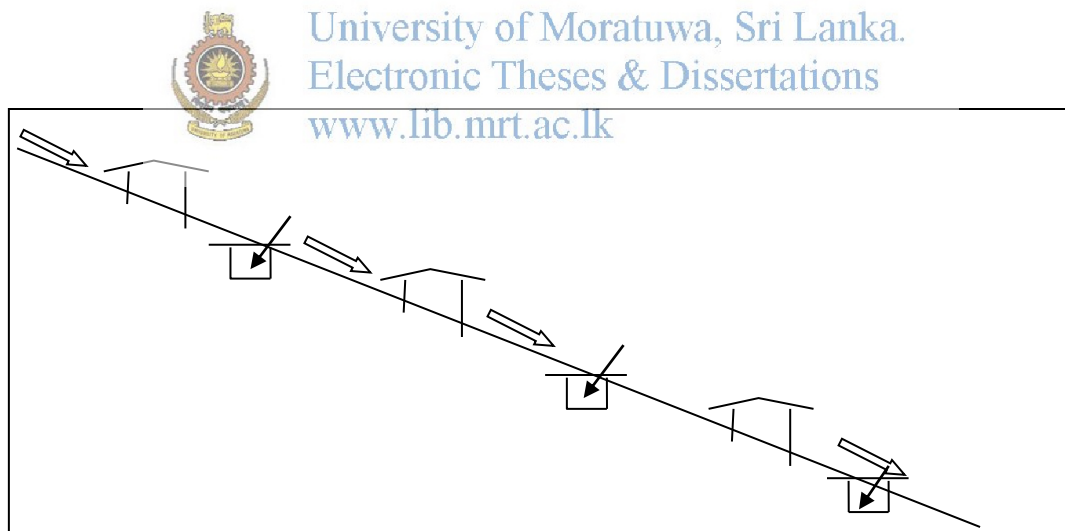
(Figure 4.2.4.1- Water draining pattern in KorahedigodaWatta H.S)

Except the above cases, another problem is found in the housing schemes which are located on slope of the hilly area. As example , Addunkele- Ahangama can be considered. Because there is no proper drainage network, storm water collect in top of the hill totally drains out through the home gardens. When it is flow, because soakage pits are not properly capped, suddenly it is filled and over flow. When water stock starts form the top and goes down to the bottom of the hill, soakage pits overflow and mixed with that storm water.

According to the terrain design of the soakage pit should be changed. If high water flow through the terrain, soakage pit should have concrete cover inside from top to bottom with properly sealed top cover.

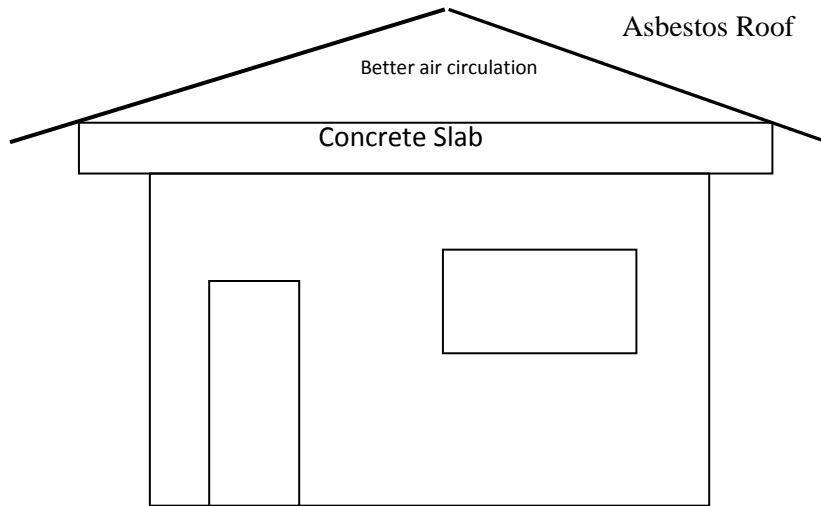
(Figure 4.3.1.1- Two Roof Covers on Houses of Mihiranwatta Hosing Scheme)

Site no 130- mihiranwaththa also doesn't followed planting programs. They are not affected by heat. Because these homes has two roof. The down concrete slab is roofed by asbestos roof. Site air circulation is better. Better air circulation between asbestos roof and concrete slab lower the heat of the house inside.

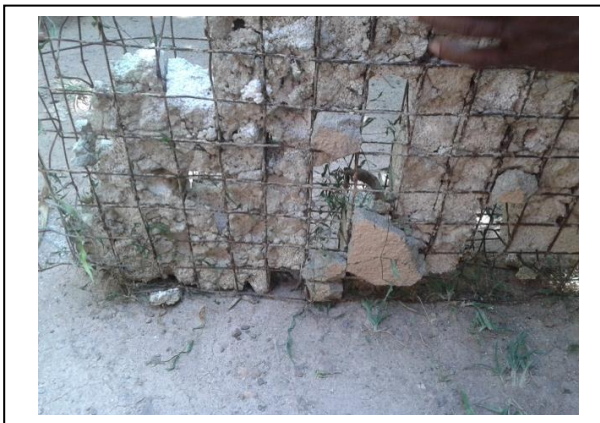
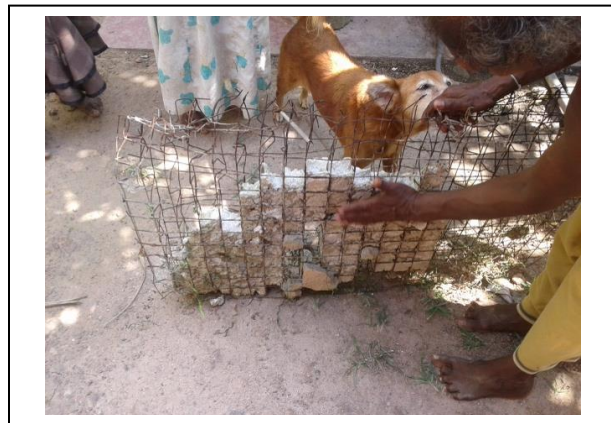
(Image 4.3.1.4 & 5: Wall Constructed using Rig form Coated GI Mesh in Malapalawatta H.S)

For house construction, two sites site no 137 and Turkey village are the sites. Turkey village used clay brick and cement motor for wall construction. Site no 137 – Malapala andarawatta, used totally different new method which is new for Srilanka. The house walls of the site was constructed using panel which is made of GI mesh and rig form. That panel is motored by cement.

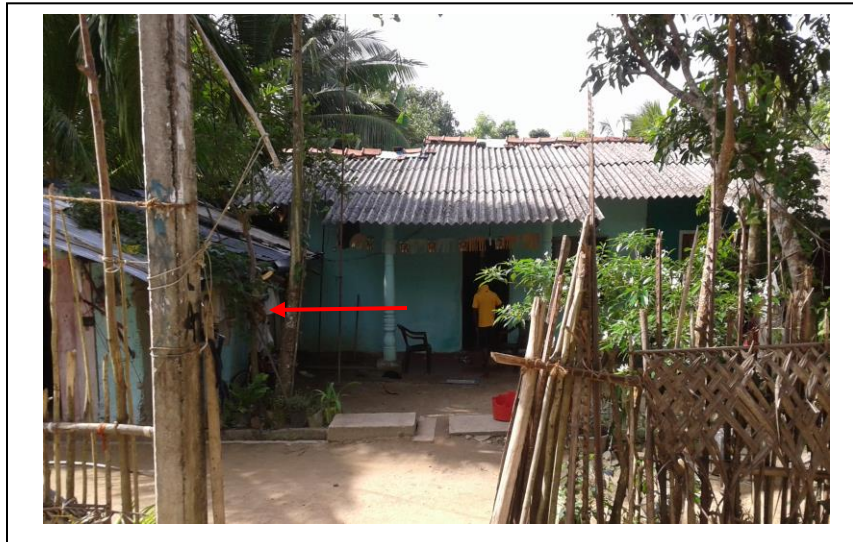
(Image 4.3.1.4: Temporary House Build in House Premise- Addunkele H.S)

Section 4.2.1.(i) of the above table from the total of fifteen sites (20%) only three site have the road network to meet the demand of the traffic flow. At the beginning there was proper road width available according to the UDA regulations. But after several years, people built more housing units with temporary materials at the same space when their families are expanded. This is common in site no 176- Addunkele , Atanikitha Imaduwa. It is obvious that people encroached space allocated for road by altering boundary because of the scarcity of space in their housing premises. This phenomenon was found in the other site as well.

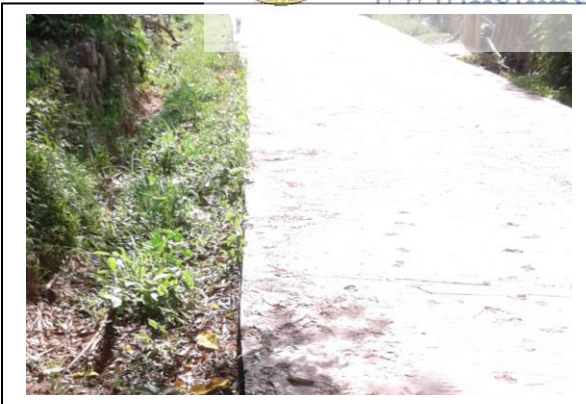
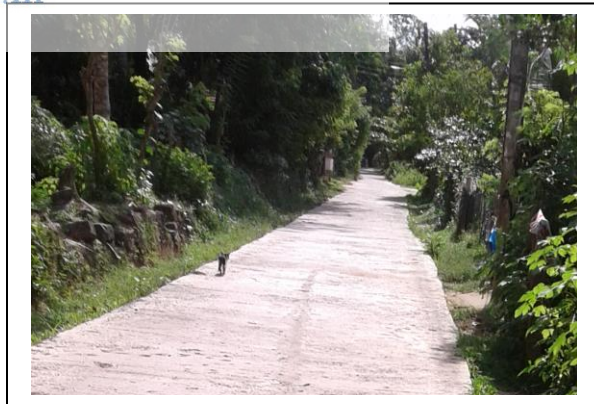
(Image 4.3.1.5 & 6 : Not Backfilled Road sides in Addunkele H.S)

Another problem in these sites is road sides are not back filled after road concreting. As a result there is a big gap between concreted part and ground level. This is caused to occur accidents when people travel by motor bikes and bicycles at nights. Further this reduced the width of the road also. Normally concrete length is 8ft – 10 ft. The allocated land width for road is 15ft – 20 ft. Because of this situation at present even two vehicles can't cross each other in most locations of internal road network.
