ARCHITECTURAL EVALUATION OF HISTORIC SITES THROUGH SITE SURVEYS IN NINGBO CHINA

Abstract

Table 2. An example of the building value evaluation based on site survey

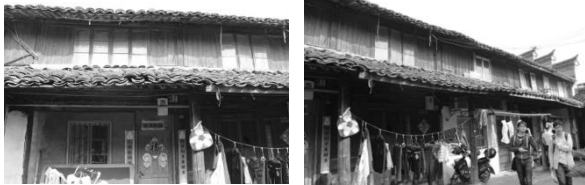
<p>A residential house consisting of identical units, built in The Qing Dynasty (from 1636—1912), partly renovated after 1912, is representative of the residential house over a century ago, with certain historic values. The historic value was evaluated as in Category C.</p>

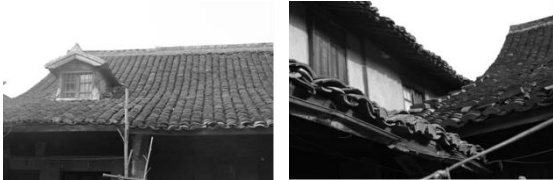
<p>This building was designed in the courtyard style, with tight layout, consisting of the hall, and flats on both sides as well as the centre as displayed in Figure 1. The architectural style was evaluated as B.</p>

<p>The courtyard, front door, and roof were mostly well maintained. The wood beam, column, and their joints were built with traditional features. The construction quality was evaluated as B.</p>

Apparent cracking occurs in the north side of the internal walls. Some wood columns have decayed with weak connections to the concrete support. The status of damage was evaluated as C, damaged at certain level.

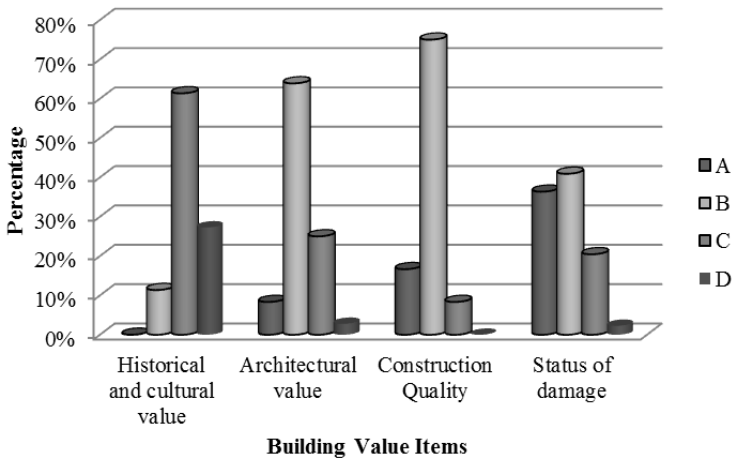
Figure 5. Statistical summary of buildings' evaluation results

Note: for evaluation of the historic and cultural value and status of damage, all the 44 surveyed sites were included. For the evaluations of architectural and construction quality, only the 35 buildings were included for the data analysis.

Apart from Table 2 describing the categorization of an example surveyed site's evaluation results, images for different categories in Figure 5 were further added in the appendix. The majority of the surveyed sites were categorized as B or C level in terms of historic and cultural value, and architectural value. Over 70% of the surveyed sites were found falling into the category of B in terms of construction quality. Only 36% of the surveyed sites were found with the minimum level of damage, and over 60% of surveyed sites were in the Levels B or C considering their damage status. Noticing that most surveyed buildings were being used as residential flats, there should be concerns raised on renovating the existing buildings for the safety and comfort living conditions for residents. Some of the surveyed residential buildings were found with inappropriate window orientations or lacking shading devices in the summer, which resulted in high indoor temperature in the summer and low solar gain with high humidity in the winter.
