ARCHIVING 'NAGAR KASHBA'

A study on the present condition and the architectural features of an evanescent historic settlement

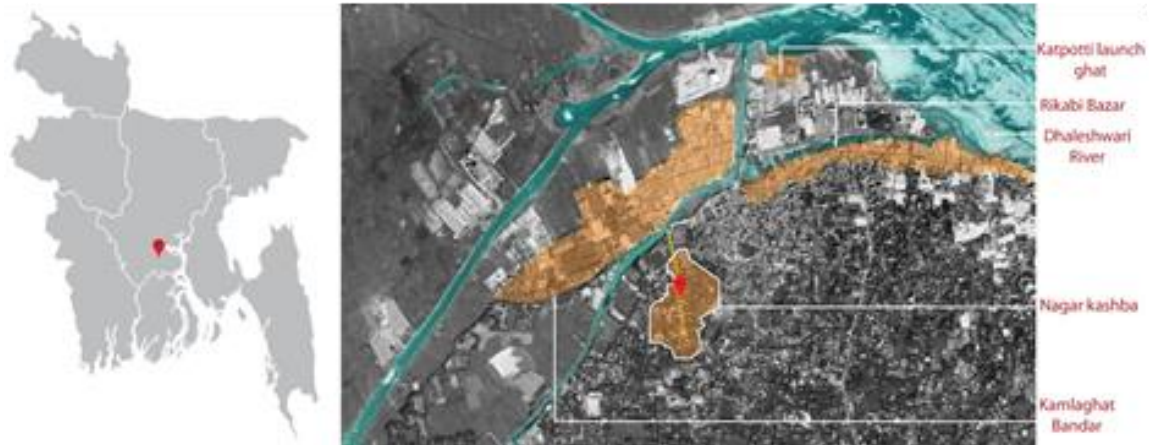
Figure 1, Location of Nagar Kashba (Source: Google map, Author)

Nagar Kashba is located at Mirkadim *Pourashava* of Munshiganj District (officially known as Bikrampur until 1986). Bikrampur, the first capital of ancient Bengal (from early 10th century AD to mid 13th century AD) started to lose its administrative value, as Sonargaon became the capital of Bengal in the 13th century. The importance of Sonargaon lasted for a long period even after the capital shifted to Dhaka in the 17th century. Similarly, Bikrampur also continued to hold an important position among the traders during the Sultanate, Mughal and Colonial period due to its favourable geographical location. It was bounded by the rivers *Dhaleshwari*, *Ichamati* & *Padma* merging with the *Meghna* River and acted as a trade centre for the then businessmen.

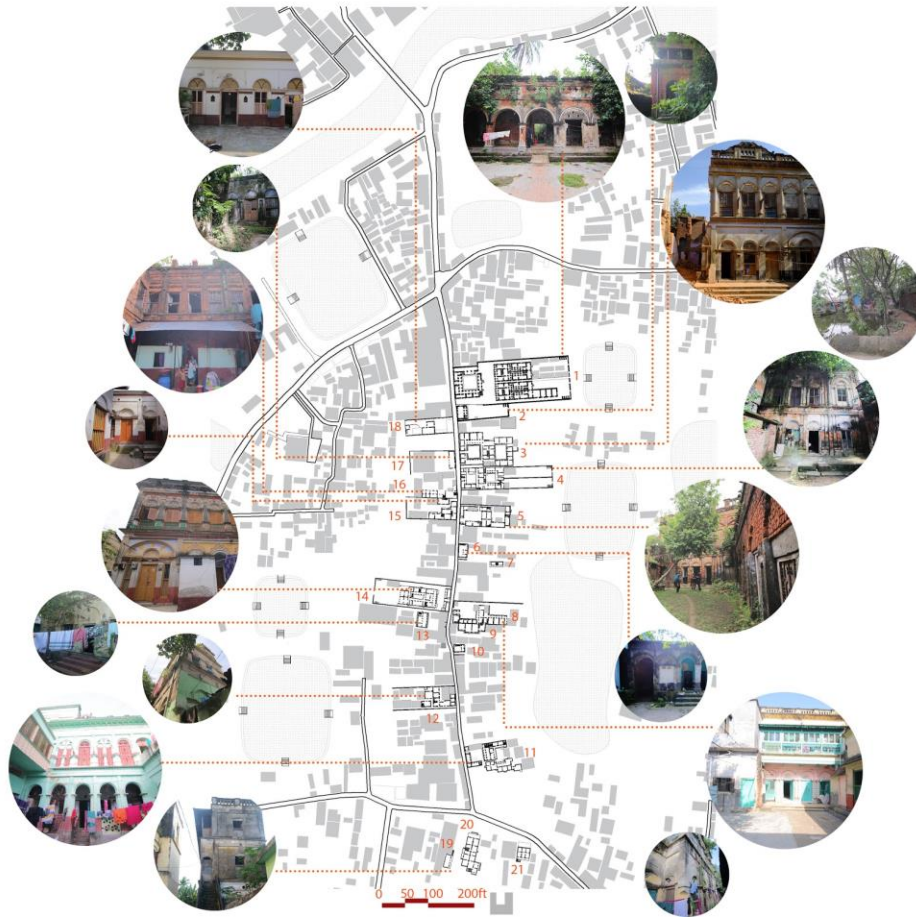
Figure 4, Location of the heritage buildings in the settlement of elite Hindu businessmen of Nagar Kashba (Source: Author)

The actual number of heritage buildings remaining in the study area could not be traced completely due to the lack of evidence. Twenty-one buildings could only be found in Nagar Kashba during the study period in extreme dilapidated conditions (Figure 4).

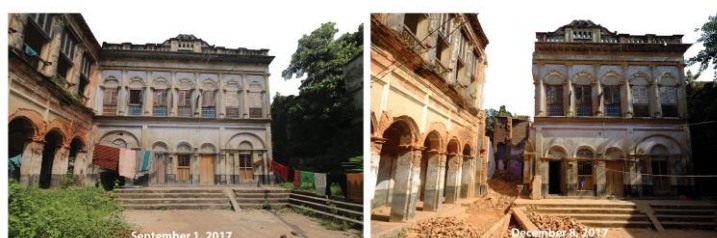
Figure 5, Demolition of house 3 in 2017 (Source: Author)

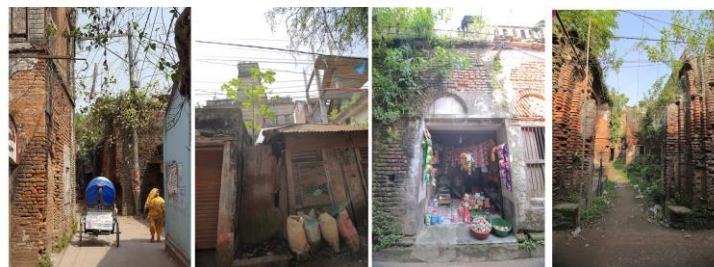
Figure 8, Images from road representing poor conditions. (Source: Author)

The historic road of Nagar Kashba is 358 meters long and the width varies between 1.8-3 meters. This narrow alley is used by the vehicles like rickshaw, tempo and CNG autorickshaws and acts as a short-cut road to reach other *mahallas* making the road adverse to the pedestrians. Because of this situation, the facade of the heritage buildings are defacing. Open electric wires, poor system of storm water drainage and littering are making the area chaotic. The whole fabric is now in endangered condition and will be vanished soon.

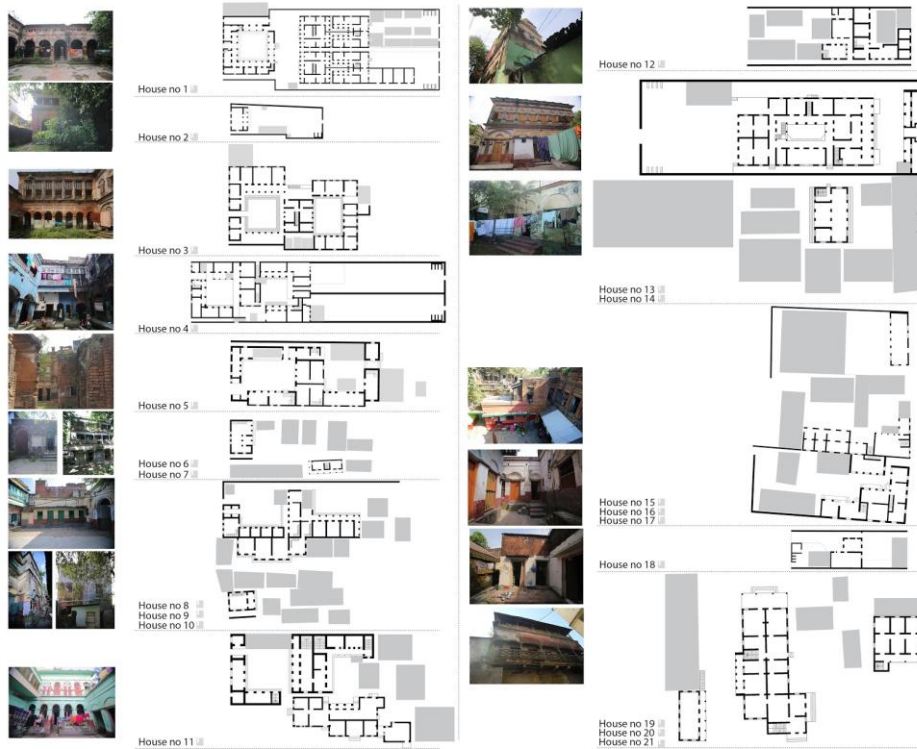
Figure 9, Ground plan of the houses (Source: Author)

The houses in Kashba consist of two courtyards- the outer court for public activities and the inner court for private activities. Building no. 1, 3, 4, 5, 8, 11, 14, and 18 consist two courtyards (Figure 9). From the trace of the previous locations of the foundation, it is assumed that building no. 12, 13, 16, 17, 18 also had two courtyards.

These types of houses have no courtyard. These are of one or two-storied buildings having yards in the front or in the back. No uniformity is found in the organization of the rooms among the buildings. Building no. 2, 6, 7, 9, 10, 15 are considered to be bungalow type houses (Figure 9).
