# Investigation of suitable methods to protect main Roads adjacent to Water bodies

\*Logeswaran<sup>1</sup> J and Kulathilaka<sup>2</sup> SAS

<sup>1</sup>Road Development Authority, Sri Lanka

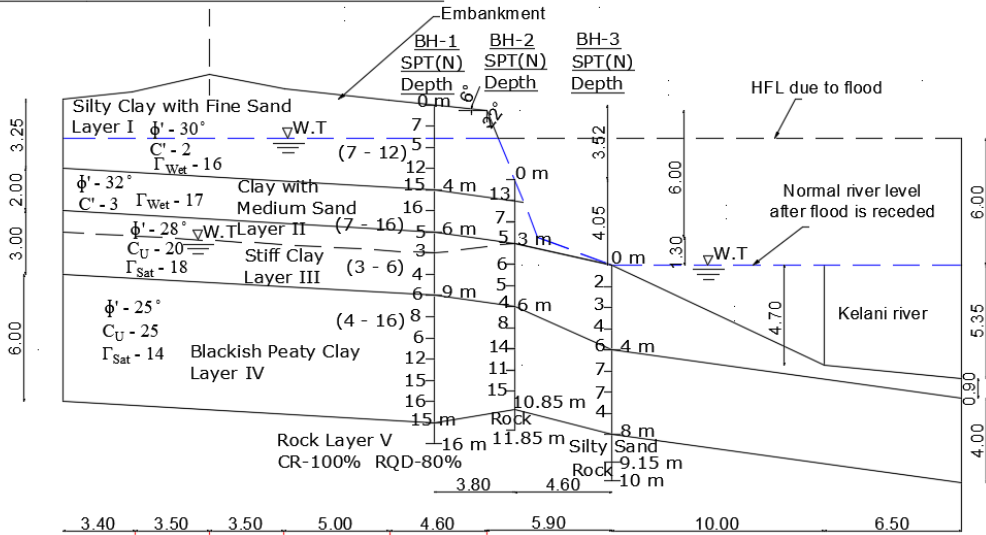
Colombo - Hanwella low level Road centre line

Figure 3 Subsoil profile with soil properties at location 1

Interpreting the geotechnical investigation, a geotechnical (ground) model was developed for stability analysis and design at the relevant problematic locations. Geotechnical design parameters were derived from the results of the geotechnical investigation, pertinent references, laboratory test results, and the author's previous experience with similar ground conditions. The geotechnical models used in the analysis, along with the geotechnical shear strength parameters, are illustrated in Figures 3 to 6.

The results of the analysis at location 1 (Table 1) indicate that the existing slope is marginally stable ( $FoS = 1.029$ ) during low tide periods and stable during high flood levels. However, there is a risk of collapse ( $FoS = 0.59$ ) due to the sudden drawdown of water level in the river within 6 hours after the flood recedes, owing to the rapid discharge of river water flow. Additionally, erosion resulting from floods, toe scour, and mass wasting of trees has been observed.

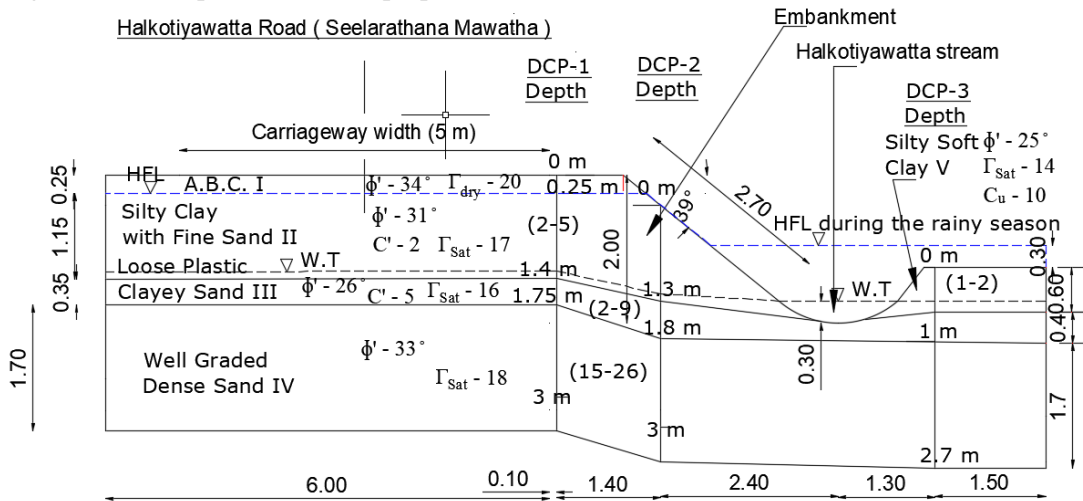
Halkotiyawatta Road ( Seelarathana Mawatha )

Figure 5 Subsoil profile with soil properties at location 3

Based on the analysis results at location 3 (Table 3), it is evident that the existing slope is stable during low tide periods (FoS = 1.455) but only marginally stable during high flood levels (FoS = 1.115). This instability is attributed to the closure and filling of the existing drain on the hillside with soil. During the rainy season, rainwater flows across the road to the other side, with the LHS having a higher elevation than the RHS, causing a rise in the groundwater table, which could potentially render the slope unstable.

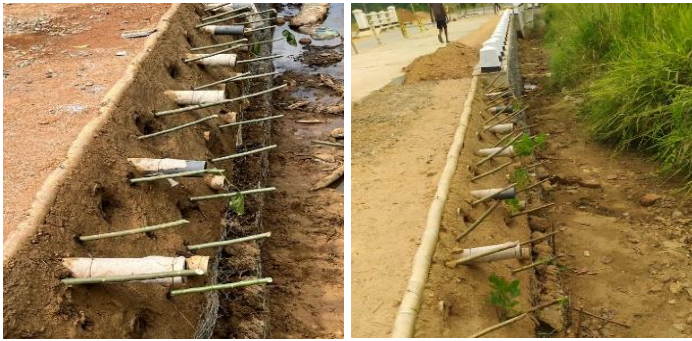
Figure 14 Photographs taken at Location 2 on 21.03.2024 after the stabilization technique

The above results show that the calculated Factor of Safety (FoS) satisfies the design criteria (i.e., FoS = 1.5). The photo of the Bioengineered wall the selected option, immediately after construction is shown in Figure 14.

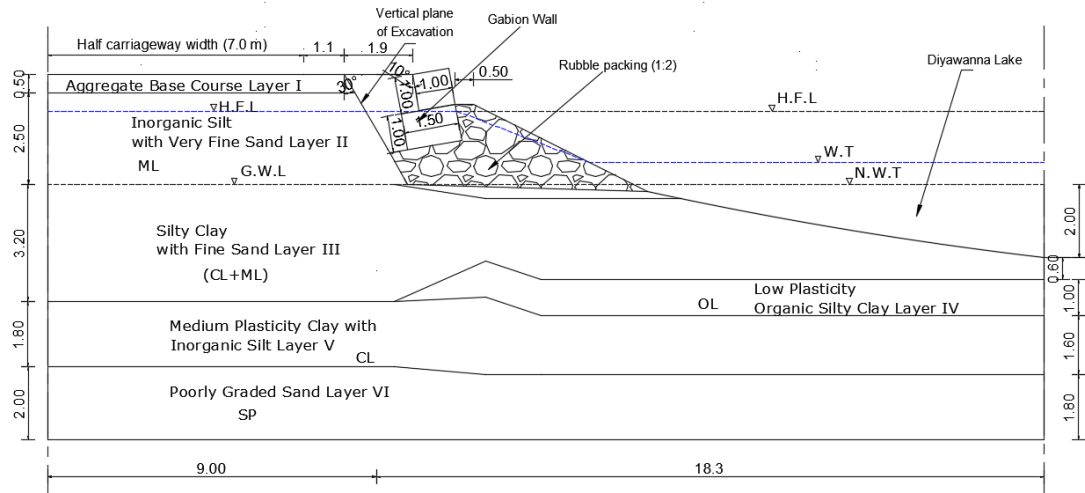
Figure 19. Proposed Gabion Wall section with Rubble packing at the toe

The two alternates proposed, considering the water flow conditions are represented in Figure 19 and Figure 20. The results of the analyses are summarized in Figure 21 and Table 8.

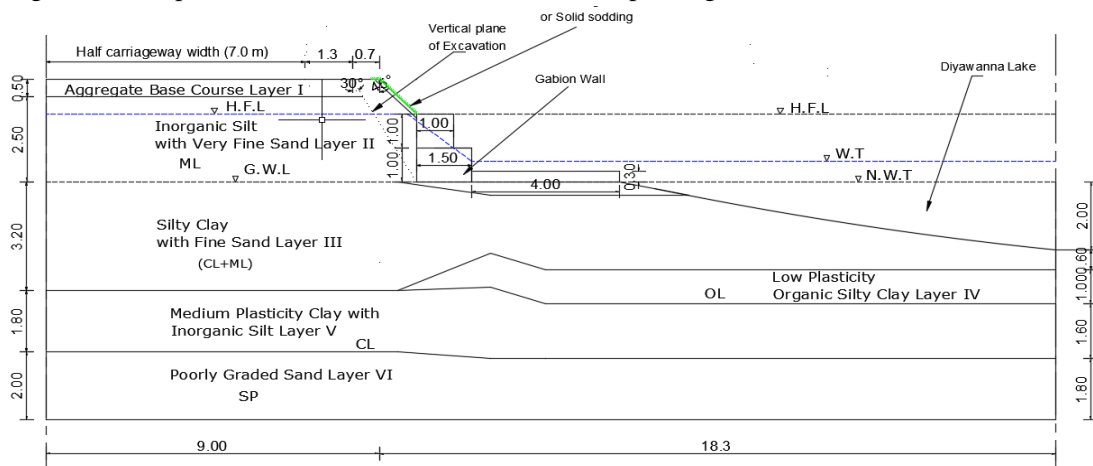
Figure 20. Proposed Gabion Wall at the toe, Reinforced with Solid Sodding

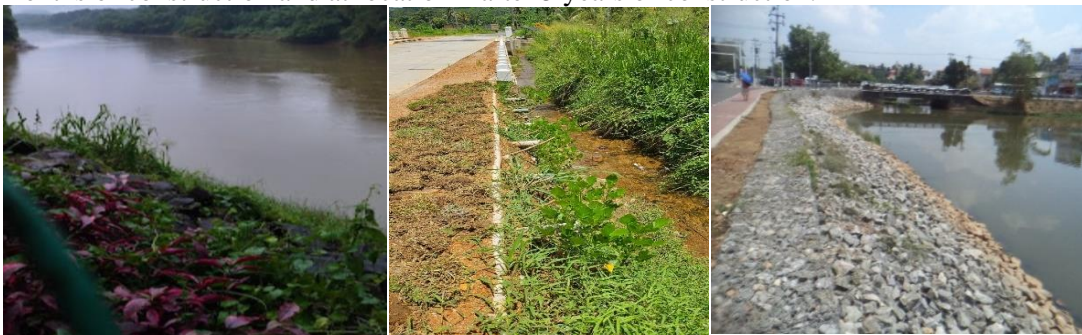
Figure 22. Photographs taken at Location 1, 2 and 4 showing the post-construction performance of the adopted stabilization techniques

The findings, as illustrated in Table 9 by the author, underscore the effectiveness of the Gabion wall with Boulder packing at toe approach in stabilizing road embankments near large rivers or lakes, particularly for structures with a maximum height of 8 meters and a boulder packing slope behind the gabion of 1:1.5. This approach offers several advantages, including ease of construction, environmental friendliness, permeability, sustainability, erosion protection, enhanced structural bearing capacity, and control over flow dynamics. By leveraging these attributes, this approach represents a dependable solution for mitigating erosion issues and ensuring the durability of riverbank infrastructure, thereby safeguarding the RDA road network. The implemented solutions have been performing very satisfactorily over the past 10 years. Figure 22 illustrates the post-construction performance of the adopted stabilization techniques at location 1 after 10 years of construction, at location 2 after 3 months of construction and at location 4 after 5 years of construction.
