### 3.0 OBSERVATIONS AND DATE COLLECTION

This research conducted in high lightning zone in Sri Lanka. Few Telecommunication base stations are selected in Rathnapura, Horana, Galle, Ambalangoda, Kaduwela, Weliweriya, etc for the analysis.

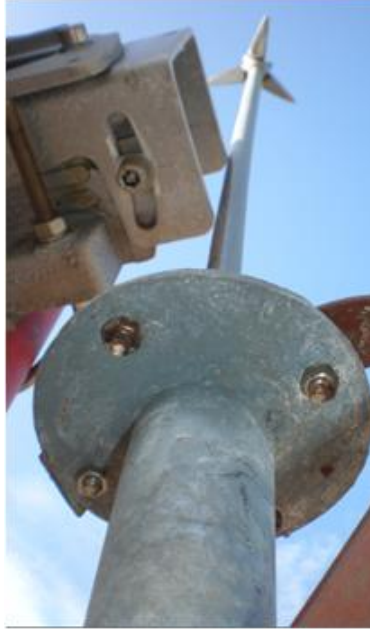
Figure 3.2: Air Terminal system

The air terminals are typically arranged on the top of the telecommunication tower to intercept with lightning stepped leader. Generally, Air Terminal covers all antenna structures in the tower within a cone of vortex angle 45 [5]. Here we can see the Air terminal type which we have installed on the towers. And no tower installed with ESE lightning rods. Tin plated solid round conductors which is having 10mm diameter are using for the air termination and that is in accordance with the IEC 62305-3 (2006). See **Annexure III**.

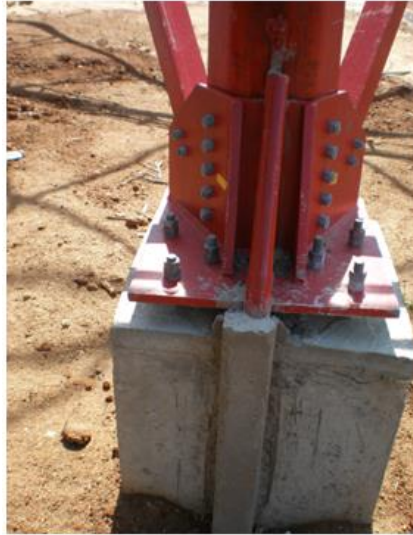
Figure 3.3: Tower structure connected to the ring earth

Some of our base stations do not have CU down conductor from air terminal to the ground. This is because; it cannot be protecting form steeling. Therefore, Stainless steel tower structure itself use as the down conductor (3 legs behave like 3 down conductors) which having average of  $800 \text{ mm}^2$  cross section. The tower structure connected to the ring earth by using CU tape at the bottom of the tower. All three legs are connected to the ring earth as shown in Figure 3.3.

Out of 18 sites, 10 sites having separate 25mmx3mm (75 mm<sup>2</sup>) copper down conductor from air terminal to ring earth while same structure grounding also exists.

Therefore the down conductor system in accordance with the IEC 62305-3 (2006).

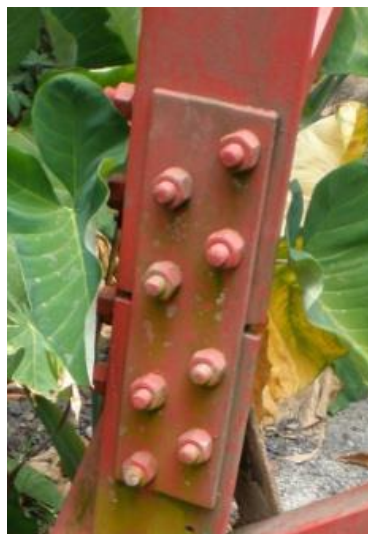
Figure 3.4: Tower leg joint

Also one tower leg contains around 6 joints and those are arranged in order to make good contact between each other. Therefore we have not observed more than 0.1 Ohm resistance in between them.

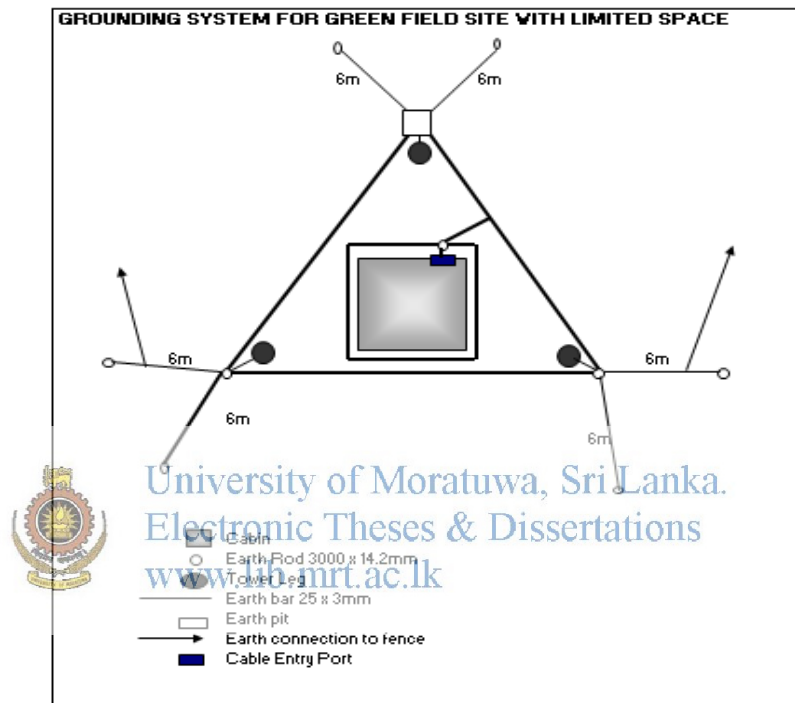
Figure 3.5: Grounding system for green field site with limited space  
(Source: Author )

Typical grounding conductor arrangement observed is shown in Figure 3.5. That is a basic crow foot arrangement. There are two earth rings. One is through the tower legs and one is around equipment cabin. The earth electrode using for the grounding system is solid round and having 16mm diameter and it is in accordance with the IEC 62305-3 (2006). See **Annexure IV**

Earth resistance will be measured after this installation. If measured earth resistance is more than 10 ohms, further improvement will be done to reduce earth resistance. But for a particular site we cannot find the exact locations where earth rods are buried, as several improvements may take place since the tower erection date.

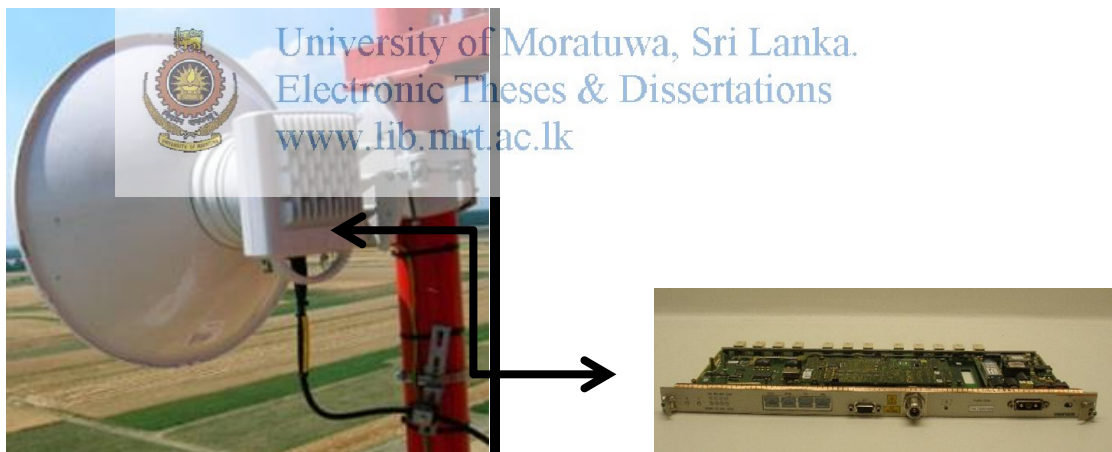
We observed that there are lots of electrical and electronic equipment damages after the lightning incidents. This is not only for the telecom equipment, but also for the neighbourhoods electrical and electronic equipment. Also we have observed that there are some incidents where the Tower mounted equipment such as Microwave Antenna Outdoor unit and indoor units of them also got failed.

Figure 3.13: MW Outdoor and Indoor units connected through IF cable  
(Source: Author)
