**BACK ANALYSIS OF SLOPE FAILURE AT
WALIPANNA, SOUTHERN EXPRESS WAY**

Degree of Master of Science in Foundation Engineering and Earth
Retaining Systems

Cut slope at chainage of 42+340 to 42+400 in Walipanna at southern expressway failed after few days of rain. The back analysis of failure indicated that the safety margin is less than unity when saturated shear strength parameters of soil were used in the analysis. Infiltration of the rainfall that was recorded in nearby rain gauges was modeled using the SWCC and permeability function derived from the tests conducted on undisturbed samples recovered from the site.

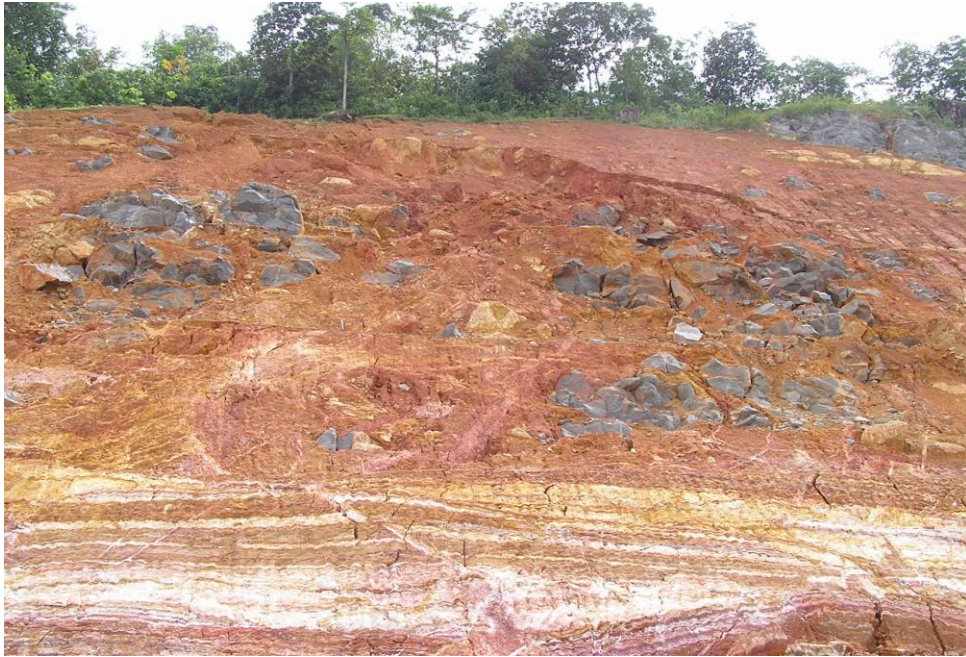
Figure 2.6: Degree of Weathering and the Nature of the weathered product varies within a short distance

Sometimes Charnokitic rocks in the original formation remain unweathered while Gneissic rock has completely weathered. This leaves boudinage structures (unweathered rock) in a matrix of soil in the slope. If the original rock has a high Feldspar content the weathered product would be clay; weaker in shear strength as shown by the whitish zone in Figure 2.6.

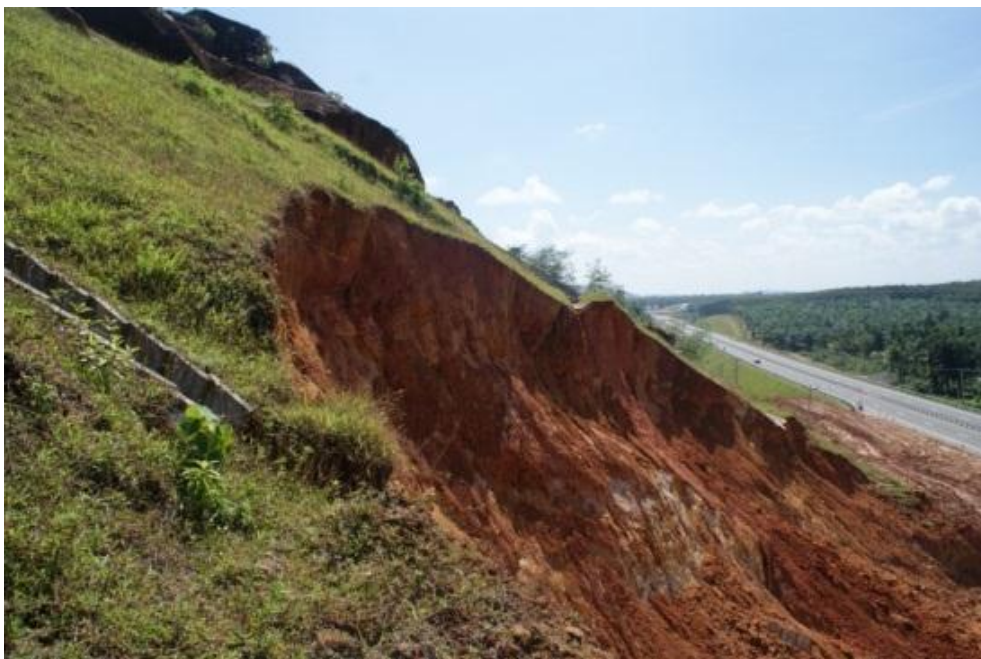
A whitish zone is seen in the failure surface in Figure 2.7 also.

Figure 2.7 : Whitish zones encountered in a failure mass

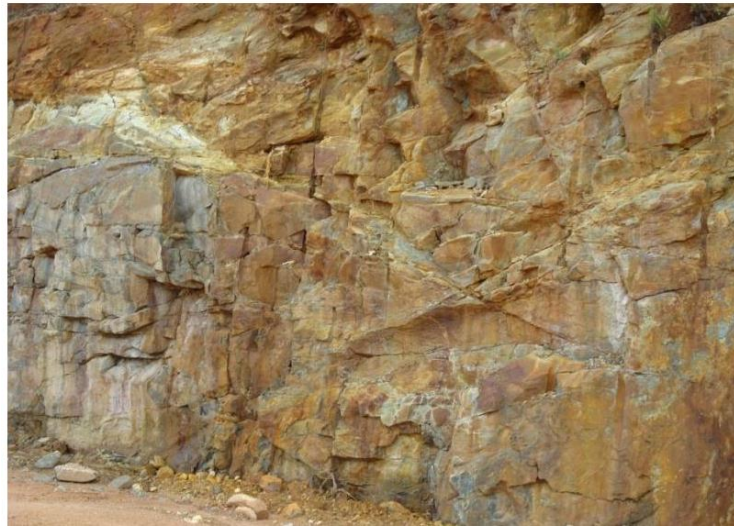
Another feature to be note is that, the initial systems of joints that exists in the parent rock remain as it is in the weathered product of residual soils, (figure 2.8). These joints are then referred to as relict joints. The initial joints could be either clean and tight or opened up and in-filled with loose material. Accordingly similar condition would exist in the relict joints present in residual soils.

Figure2.8: Closely spaced rock Joints-remain as “Relict Joints” after weathering

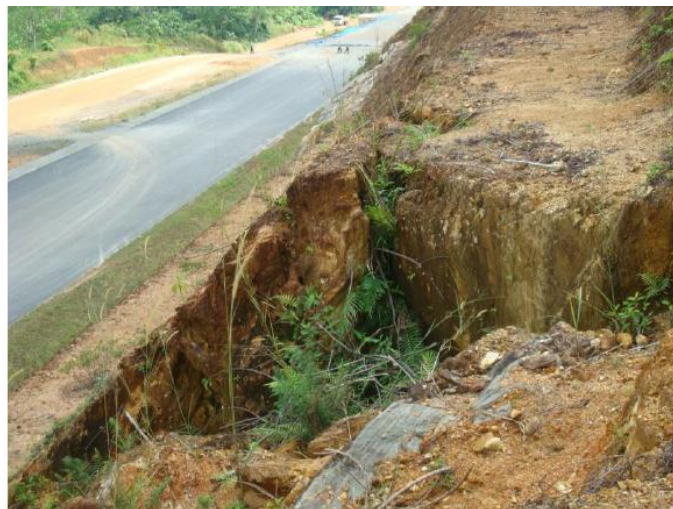
Water could also be present there. Therefore, the relict joints in residual soils are the planes of weakness. Failures in the form of falls – block of residual soils bounded by adversely oriented system of joints can be seen slopes of residual soil. The soil forming the block that has fallen is of high shear strength, but the failure has taken place along the relict joints (Figure 2.9).

Figure 2.9: Toppling (Fall) Mode of failure could take place through relict joints

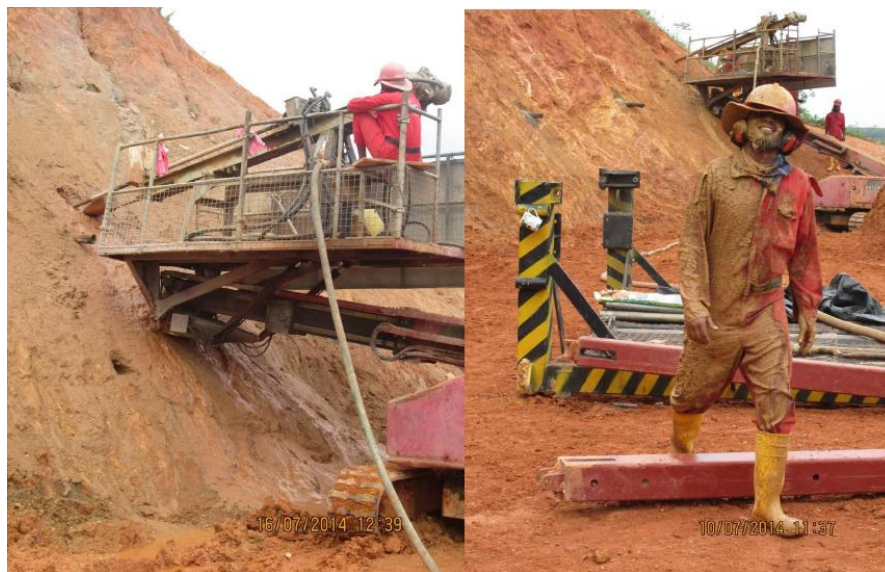
Figure 3.4 – Water oozing out of relict joints during drilling

Adversely oriented relict joints filled with water were identified during the rectification process. During the drilling for soil nailing for rectification, the water trapped in the relict joints released under very high pressure covering the workers in mud. This implies that there is water under high pressure in relict joints. This water will move into the soil around making it saturate. The presence of pore water under higher pressure itself is having adverse effects on stability. (Figure 3.4).

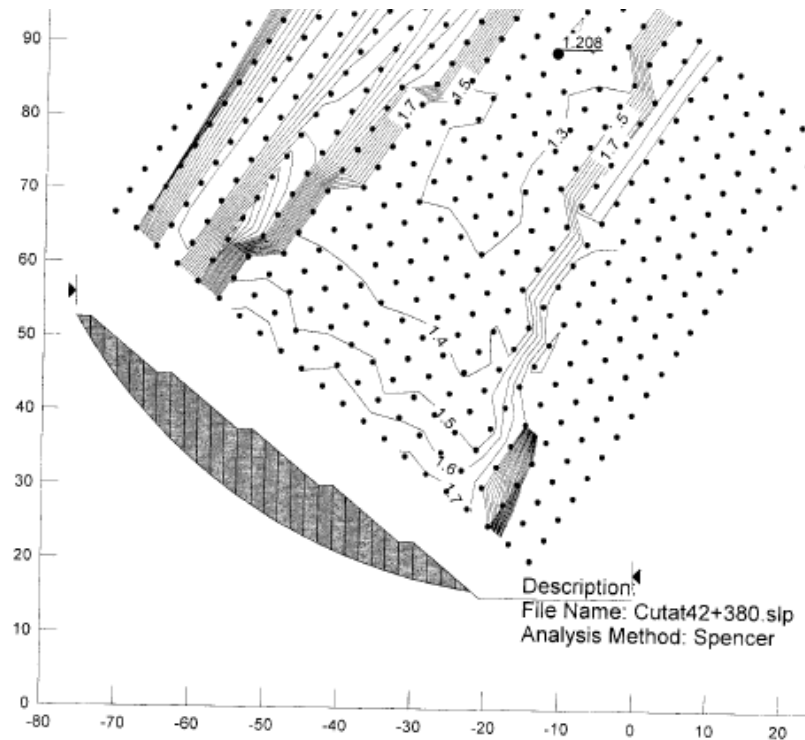
Figure 3.6: Stability of the cut slope at 1:1.2 gradient – Section at 42+380 Critical failure surface (Design report – STDP)

Design of the cut slope was done using the sub soil parameters derived based on the SPT N values of five boreholes, laboratory testing data, visual descriptions of the soils, and the experience on similar type of soils. Accordingly the slope was analysed at shear strength parameters of; $c'=10 \text{ kN/m}^2$ and $\phi'=32^\circ$.

Geoslope SLOPE/W 2004 software was used in the analysis and several proposed geometries of, cutting the slope at gradients of 1:1.2, 1:1.3 and steep cut with soil nailing were checked. Consequently, it was designed to cut the slope at the gradient of 1:1.2 keeping berms at every 7.5m height difference as Figure 3.6. This yields a Factor of Safety of 1.2.

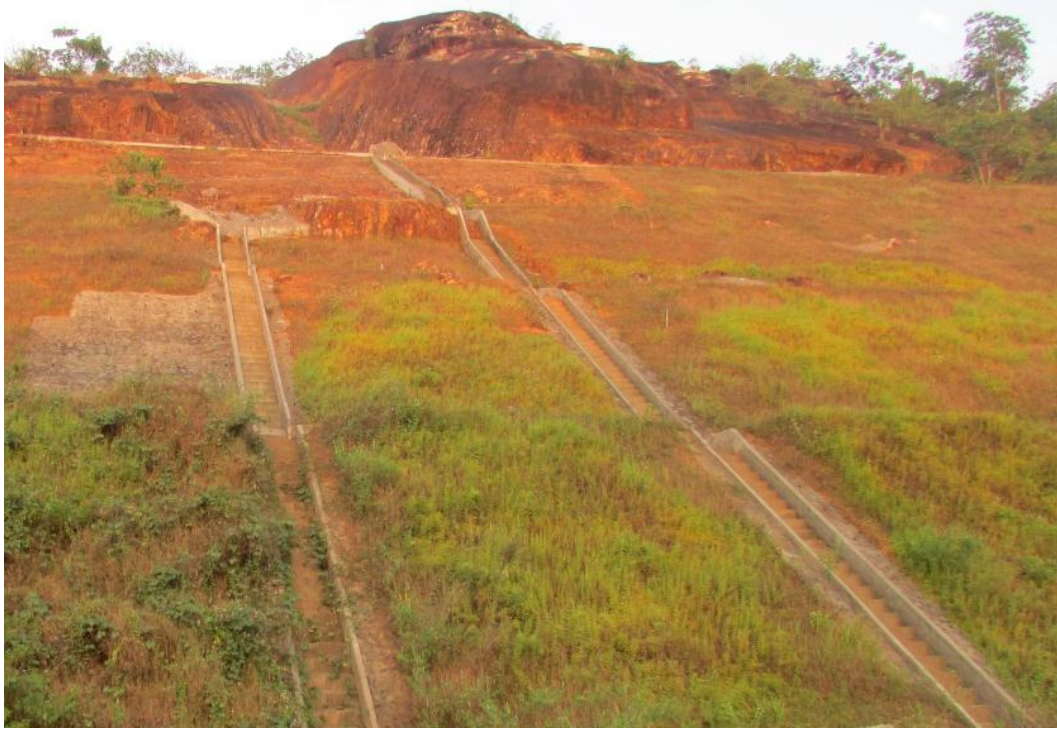
Figure 3.7: Berm drains and cascade drains

In order to minimize the infiltration and the loss of matric suction or development of perched water table, surface drainage of the area had been well developed with concrete paved berm drains on each berm and cascade drains to collect water from berm drains and free flowing of water runoff down the slope. Together, the slope is covered with grass cover to control the erosion (Figure 3.7). The grass cover also deflects the water flow as runoff while minimizing infiltration.

The failure that occurred in this slope was triggered by the excessive rainfall that prevailed in the area over the days preceding the failure. Some cracks that existed in the drainage system (cascade drains) could be detected only after the catastrophic failure. As a result of heavy rainfall, significant infiltration has taken place. Water has seeped through the cracks making the soil nearly saturated. Thus the shear strength of soil has reduced.

Surface drainage improvement was done by repairing all failed berm drains and cascade drains.

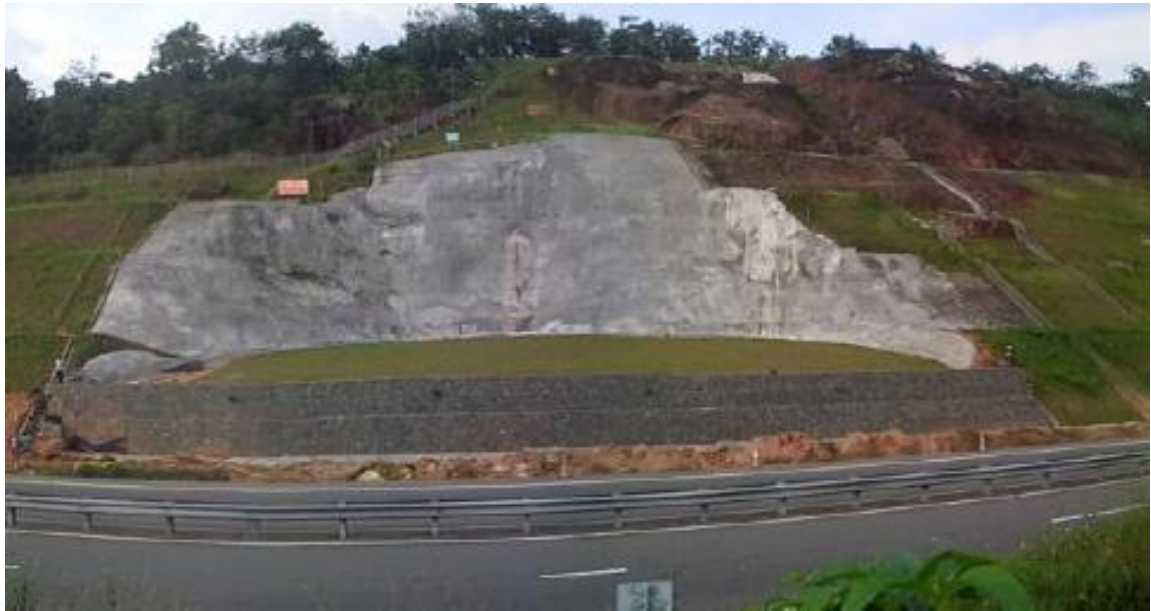
Figure 3.16: View after completing the rectification (After Dharmasena et.al 2015)

During the grouting for soil nailing there was further evidence about the inter connection of drill holes through the system of relict joints. The grout forced into one

hole was seen coming out from another non grouted holes. As such, special attention was paid to the construction sequence. The drilling for sub horizontal drains were done only after the completion of Soil nailing. If sub horizontal drains were done initially they could have got filled up with the grout impelled to soil nailing holes. The slope after completion of all rectification measures is presented in Figure 3.16

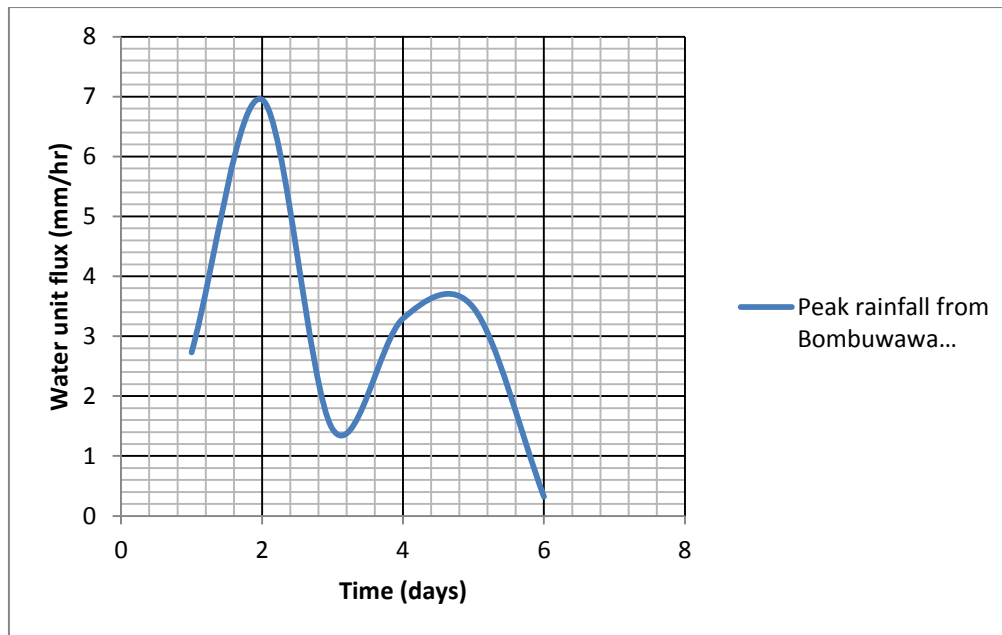
Figure 4.1: Peak rainfall from Bombuwawa and Beddegama Rain Gauges

The rainfall data over a week preceding the failure was obtained from the Meteorology department. Data of the rain gauge stations closest to the location as Bombuwala and Beddegama are presented in Annex D. Based on the data total accumulated rainfall at Bombuwala rain gauge station during the week preceding the failure was 431.5mm. At the Baddegama rain gauge station this value was 245.3mm. At both locations no heavy rain was recorded on the day of the landslide, 2nd November. At the landslide location itself no rainfall was recorded on that day.

For the back analysis, actual peak rainfall measured on five days preceding the failure at each rain gauge stations have been idealized and applied using appropriate slope boundary conditions. Figure 4.1 shows the idealized rainfall. Rainfall is not extreme during the failure, but prolonged rainfall with low intensity, where maximum recorded rainfall was 7mm/hr.

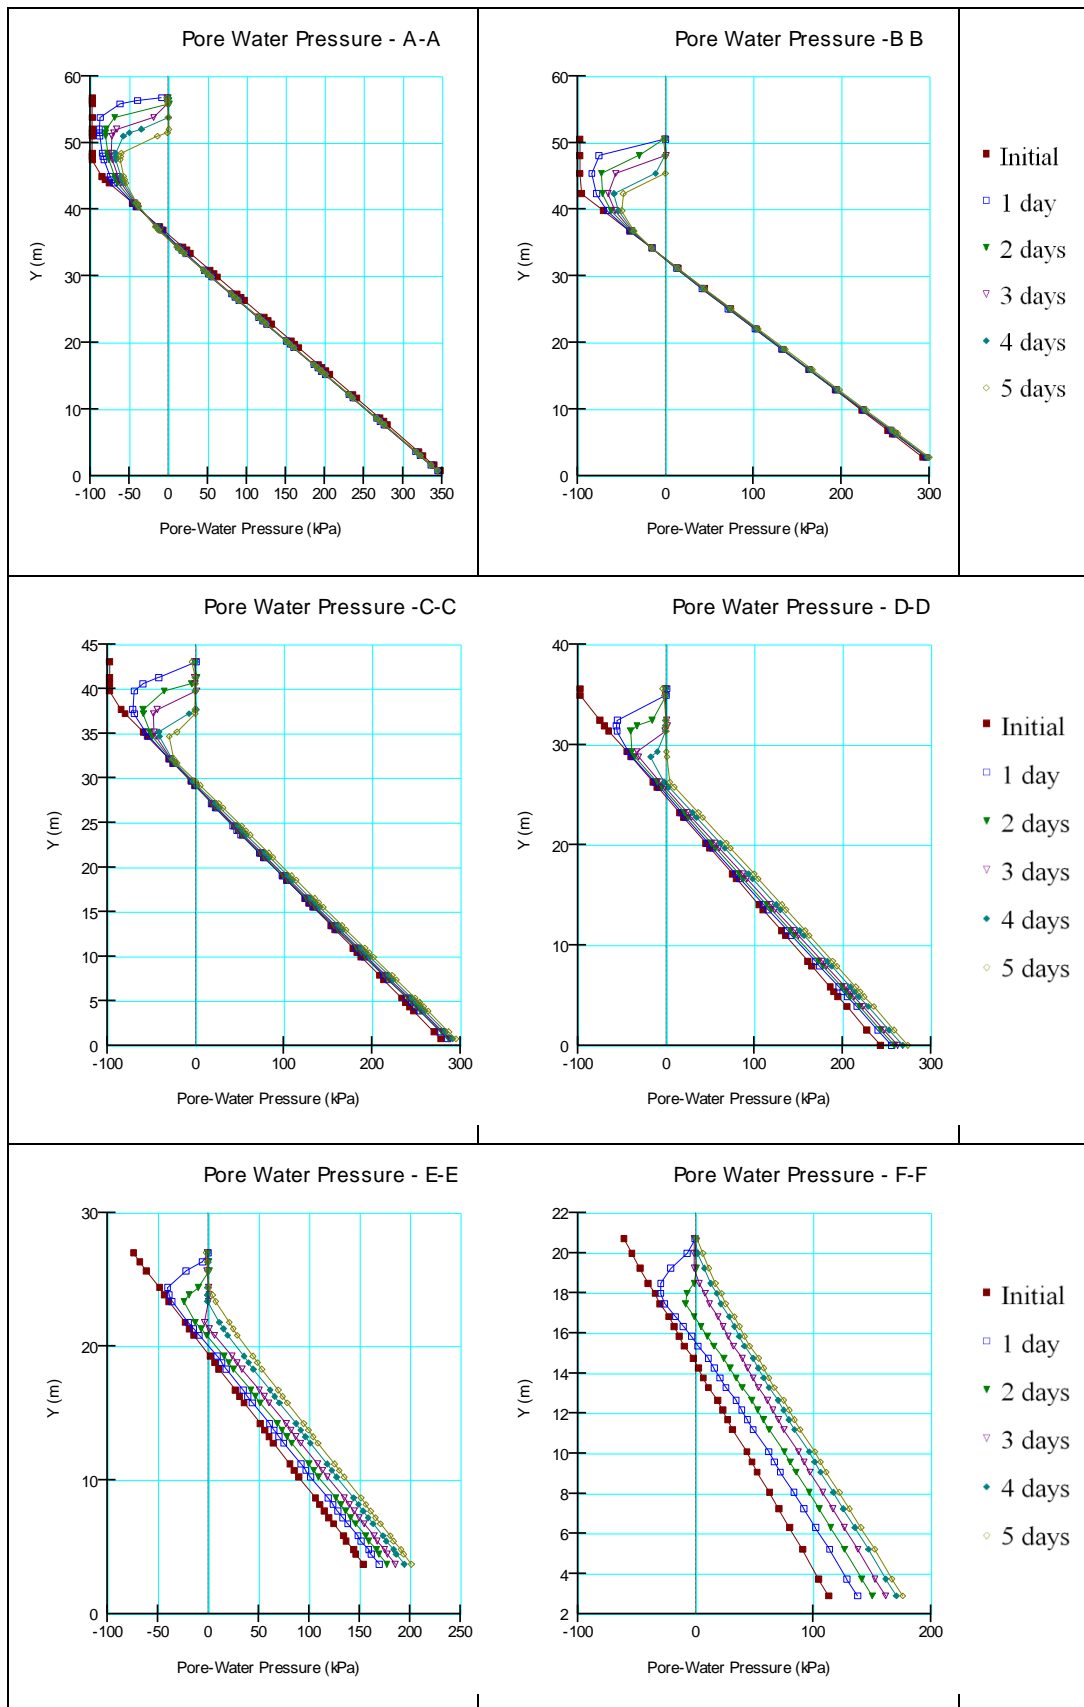
Figure 4.6: Pore water distribution vs depth in sections A-A to F-F for the idealized rainfall

With the infiltration of the rainwater the soil gets saturated near the surface and water moved to deeper levels of the slope. The changes to the pore pressure regime with the prolonged rainfall is illustrated by the pore water pressure distributions plotted along Section A-A to Section F-F. (Figure 4.6).

The result of the analysis shows that as rainfall continues the matric suction values are gradually eliminated and pore water pressure become zero or just positive (negative pore water pressure). It reveals the development of thin perched water table at the surface (Figure 4.7). As rainfall continues the loss of matric suction advances to greater depths. (The wetting front progresses downward).

In the meantime the water table also moves upwards. Effect of progression of wetting front and the rise of ground water table is more prominent towards bottom levels of the slope, in section D-D, E-E and F-F.

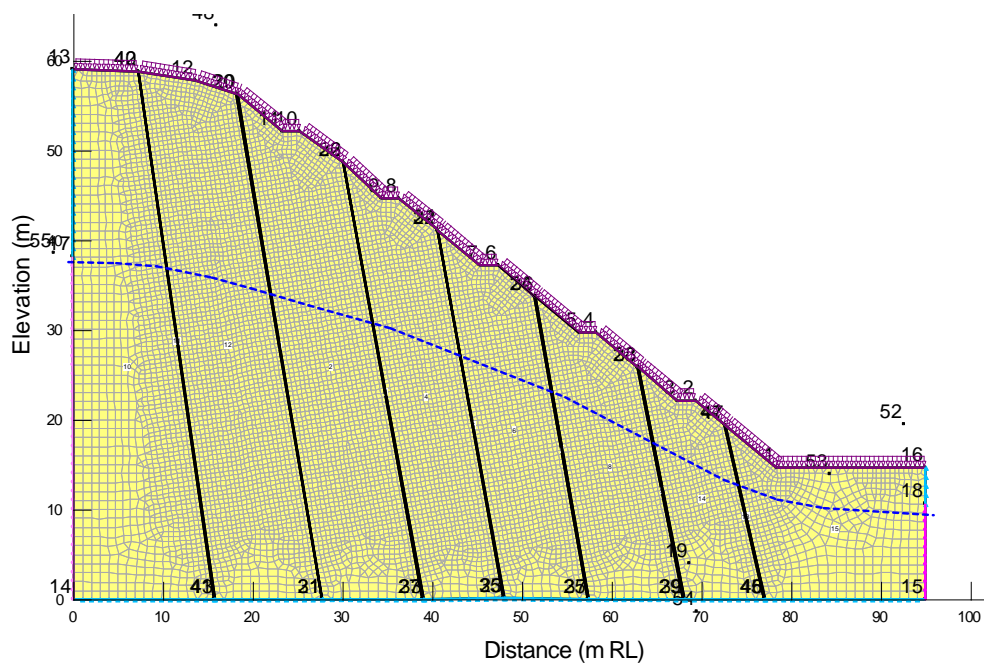
Figure 4.8: Analyzed slope with relict joints

Presence of relict joints is incorporated into the analysis thereafter as shown in Figure 4.8. The result of the analysis is presented in the form of plot of pore water pressure distribution along the vertical sections A-A to F-F for the idealized rainfall. The relict joints were assumed to be of width 100mm and filled with loose material. The SWCC and Permeability functions assumed for the material in relict joints are presented in Figure 4.9 and Figure 4.10 respectively.

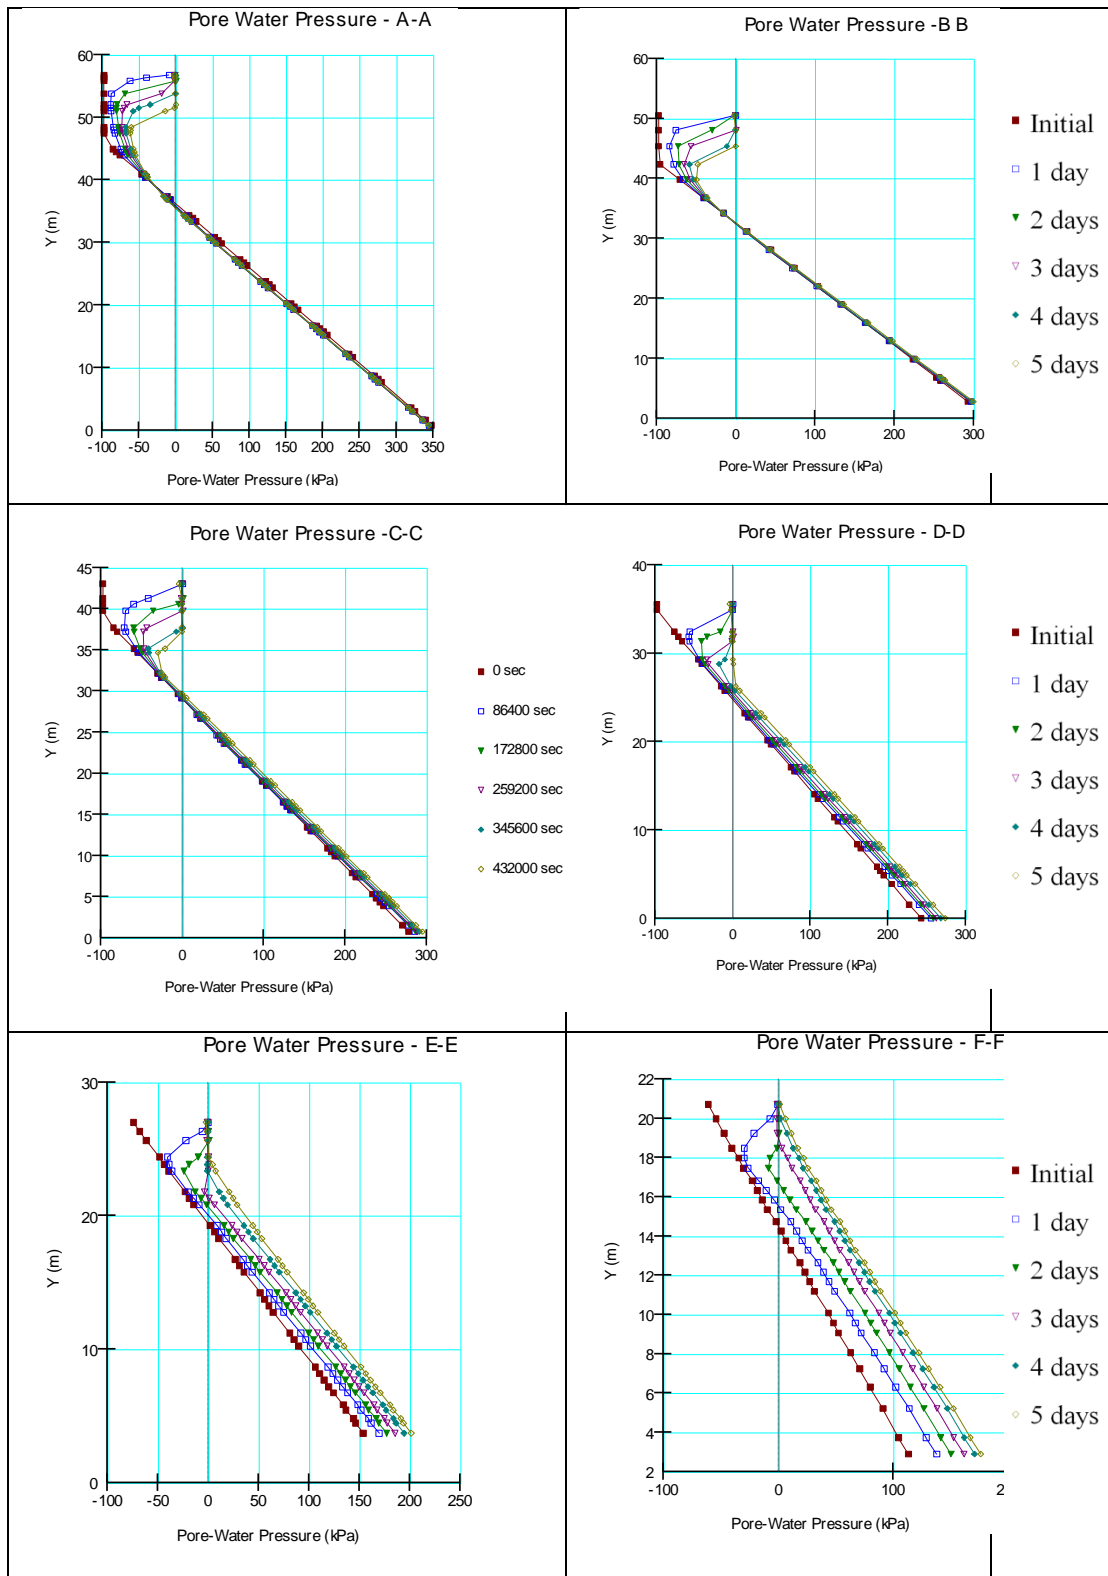
Figure 4.11: Pore water distribution vs depth in sections A-A to F-F

The result of the analysis shows that as rainfall continues the matric suction values (negative pore water pressure) eliminated and pore water pressure become zero or just positive. It reveals the development of thin perched water table at the surface. As rainfall continues the loss of matric suction advances to greater depths. (The wetting front progresses downward). It is more significant towards the lower end of the slope. Matric suction is completely destroyed there.

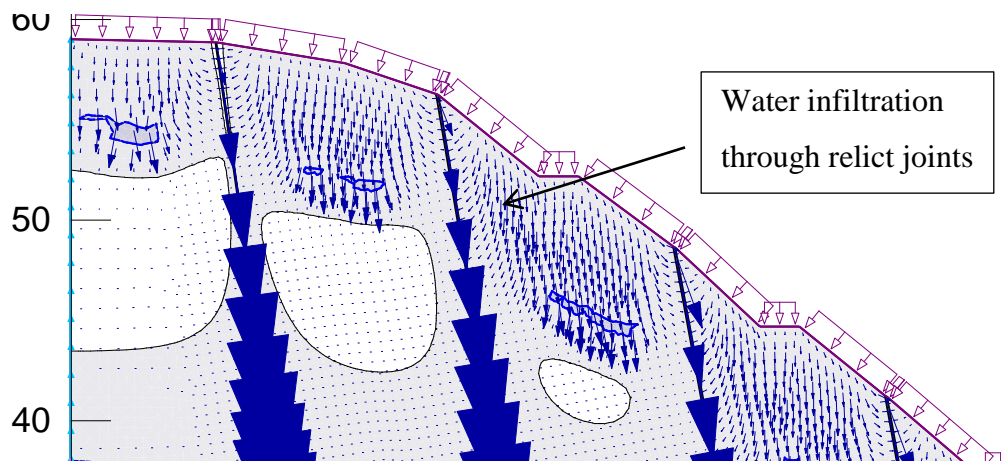
Figure 4.12: Rain infiltration through slope profile and relict joints

In the meantime the water table also moves upwards. Rising of ground water table is more prominent in infiltration model prepared with relict joints than in the model without relict joints. This is due to the presence of high permeable loose filling material in relict joints, water penetrates into the deeper level of the slope without stagnating at the surface as Figure 4.12. When relict joints are not present, the excess rainfall could not infiltrate further and contributed to runoff. It will not contribute to changes in propagation of wetting front or loss of matric suction. This emphasize that, presence of relict joints is a significant feature in slope satiability analysis.

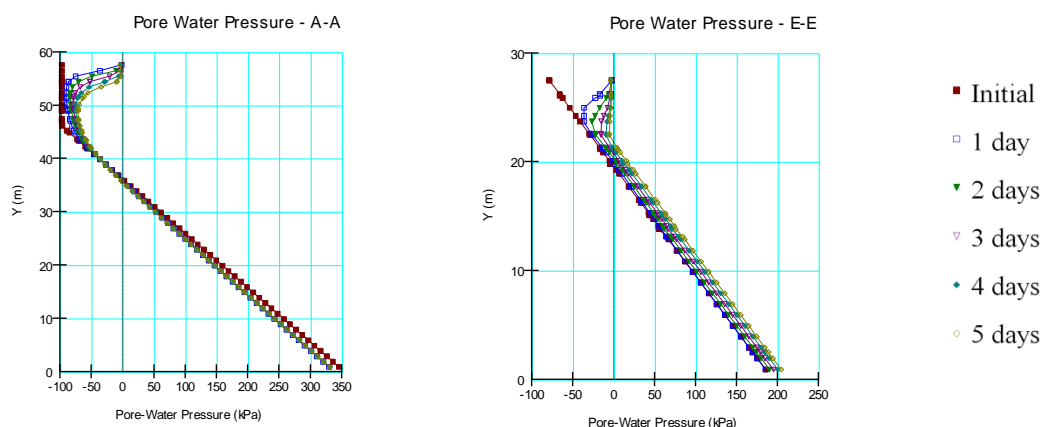
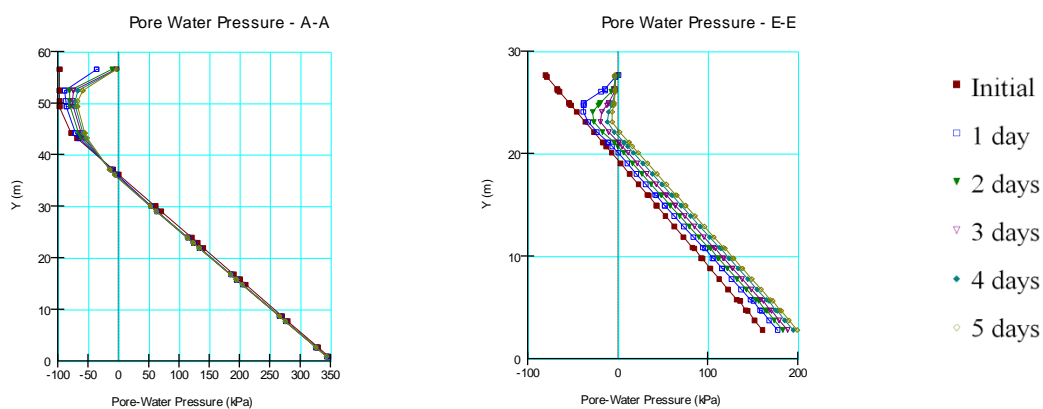
Figure 4.13: Pore water distribution vs depth in sections A-A and E-E for slope without relict joints and with surface drainage improvement (Permeability of vegetation layer = 10^{-7} m/s)

Figure 4.14: Pore water distribution vs depth in sections A-A and E-E for slope with relict joints and with surface drainage improvement (Permeability of vegetation layer = 10^{-7} m/s)

The result of the analysis shows that as rainfall continues under the conditions of improved surface drainage, complete loss of matric suction is prevented at both section A-A and section E-E. Some matric suction remained even after 5 days of rainfall. In the meantime, rise of water table at section E-E is also reduced.

This implies, with the presence of a vegetation layer of low permeability, the infiltration of water is restricted and excess rainfall has contributed to the runoff.

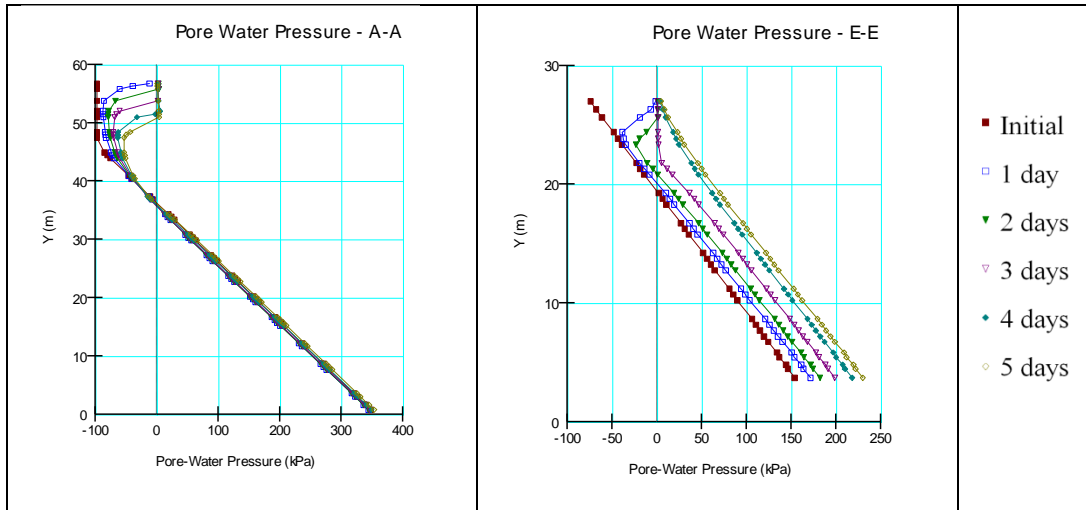
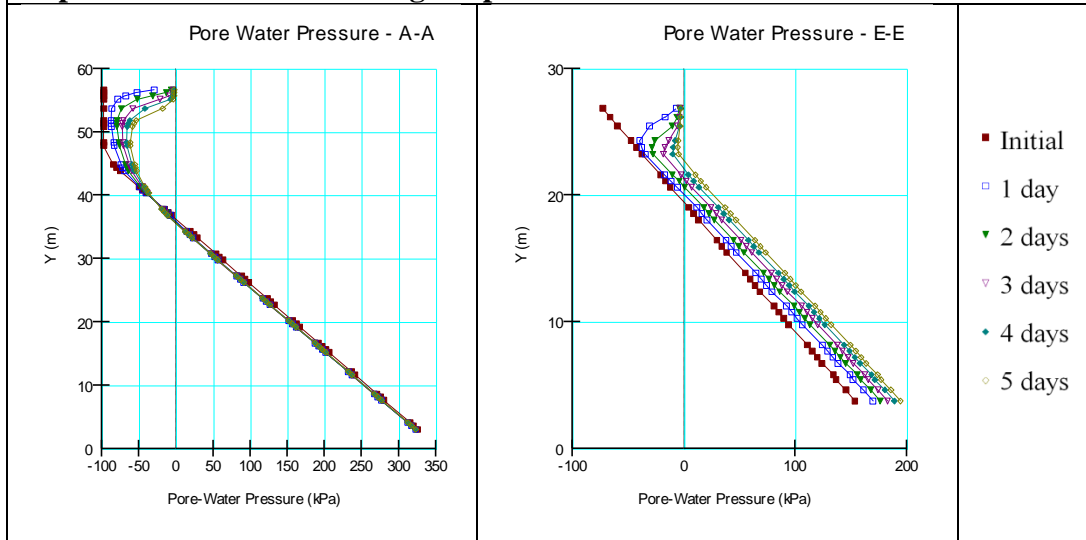
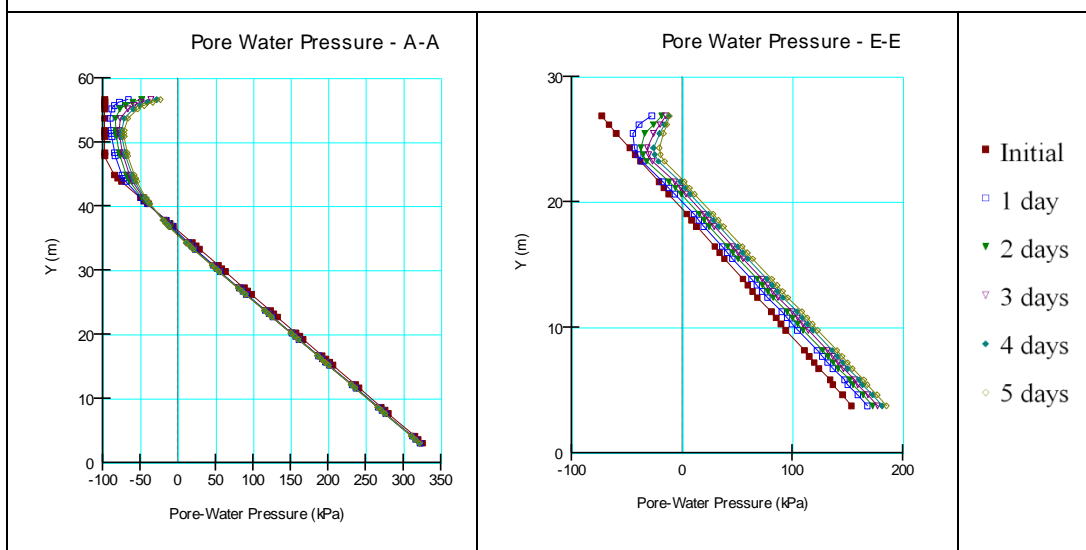
Figure 4.15: Pore water distribution vs depth in sections A-A and E-E for slope without surface drainage improvement and 20mm/hr rainfall

Figure 4.16: Pore water distribution vs depth in sections A-A and E-E for slope with 10^{-7} m/s permeable vegetation layer and 20mm/hr rainfall

Figure 4.17: Pore water distribution vs depth in sections A-A and E-E for slope with 10^{-8} m/s permeable vegetation layer and 20mm/hr rainfall

The result of the analysis of slope with drainage improvement shows that as even with high rainfall intensity, complete loss of matric suction is prevented at both section A-A and section E-E (Figure 4.16 and Figure 4,17). Some matric suction remained even after 5 days of rainfall. The rise of water table at section E-E is also retarded but higher than for the low intensive rainfall. The effect of progression of wetting front and the rise of ground water table is lesser when the permeability of the vegetation layer is lower.

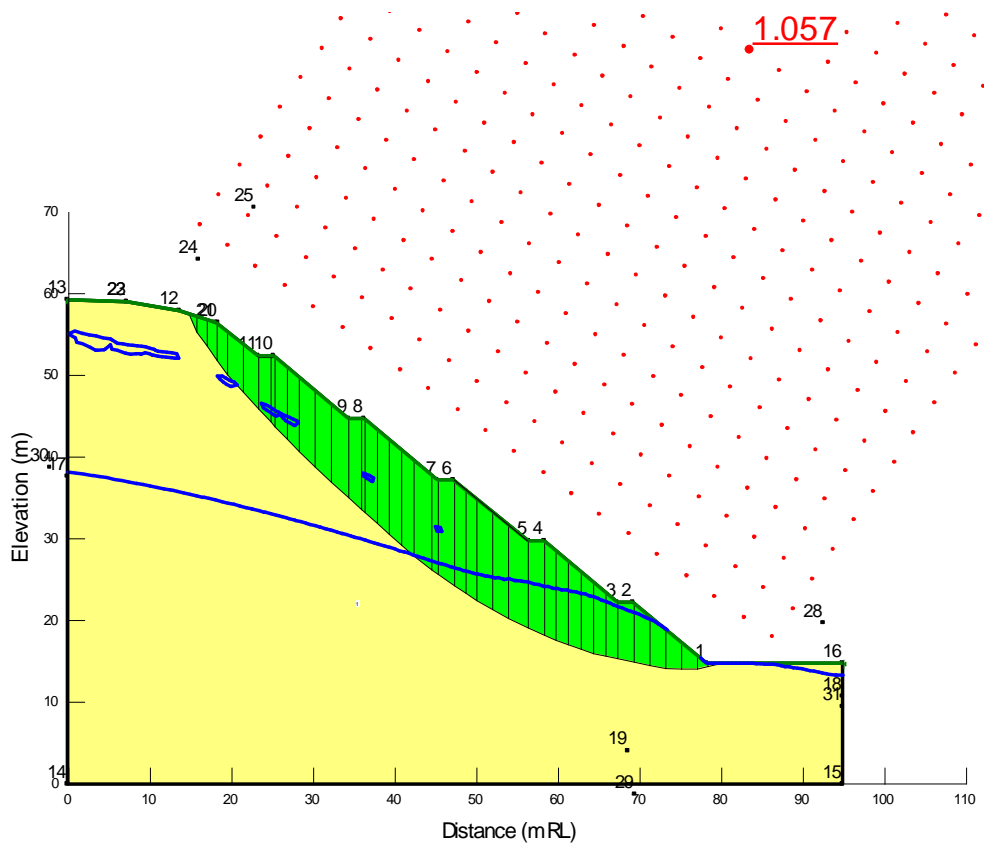
Figure 4.23: Slope stability analysis of the 5th day

Thus the slope is gradually moving towards instability and factor of safety is reduced to a value almost equal to unity, 1.057 by the fifth (Figure 4.23) day indicating closeness to failure. However, the shape of the critical slip surface corresponding to this stage is quite different to the observed failure. The upward movement of the ground water table and development of a slight perched water table could be identified when the series of figures are compared.

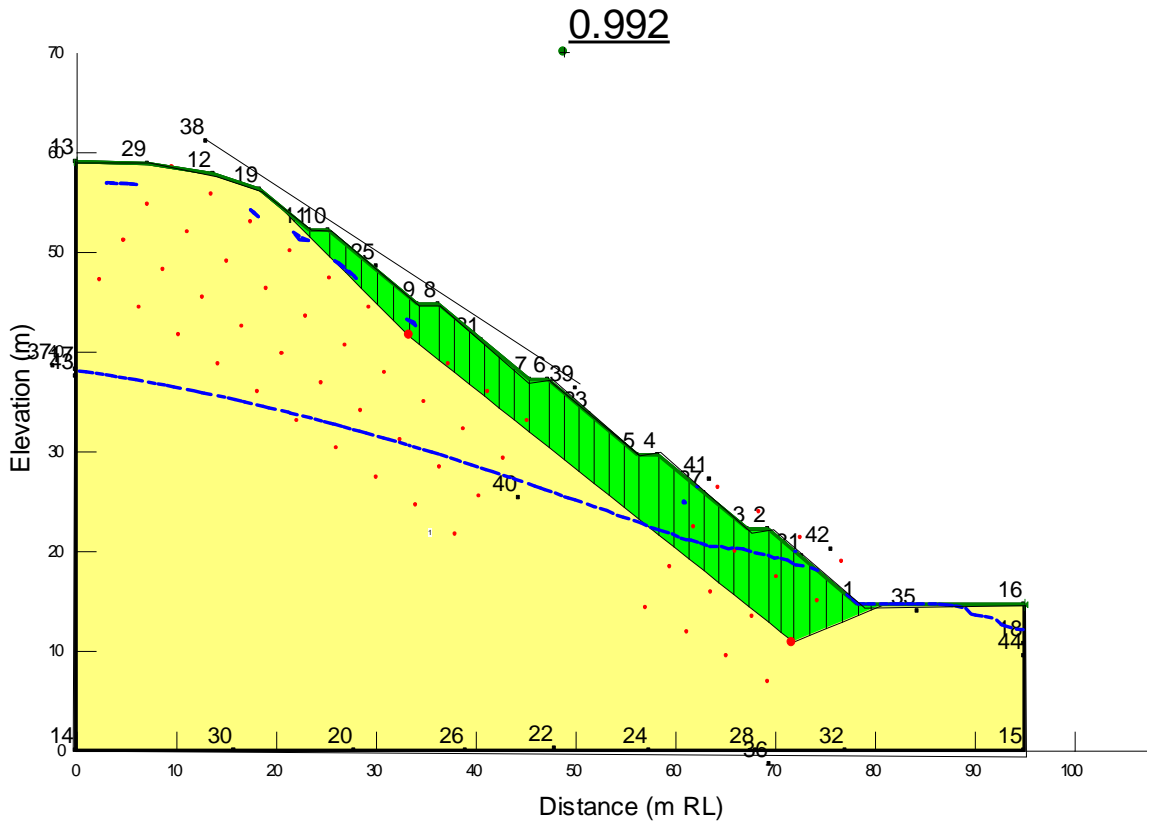
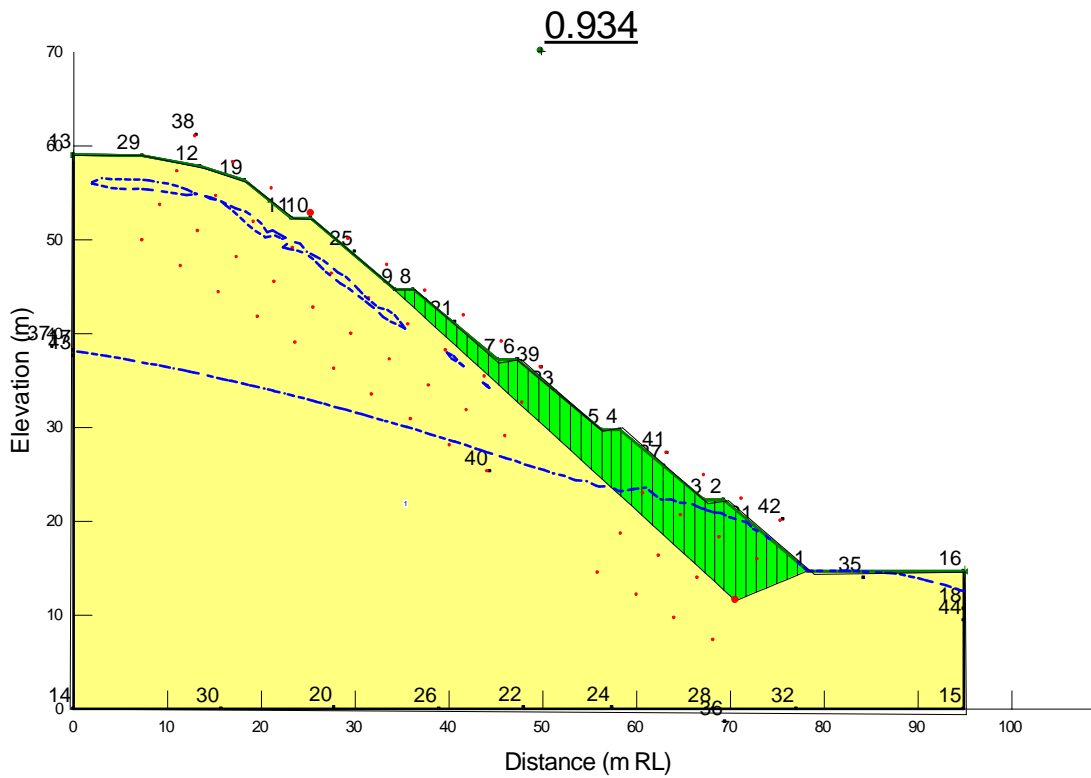
The factor of safety values obtained for the early staged of the rainfall are slightly larger than for the corresponding stages of circular failure surface analysis. But on the 4th and 5th day the values are much smaller compared to the circular failure surface analysis. On the 4th and 5th day the FOS values are lower than unity indicating the slope should have failed. However, the failure take place only on the 5th day. A closer examination of the failure modes on 4th(Figure 4.28) and 5th day (Figure 4.29) indicates this is not feasible kinematically.

Figure 4.28: Slope stability analysis of the 4th day

Figure 4.29: Slope stability analysis of the 5th day

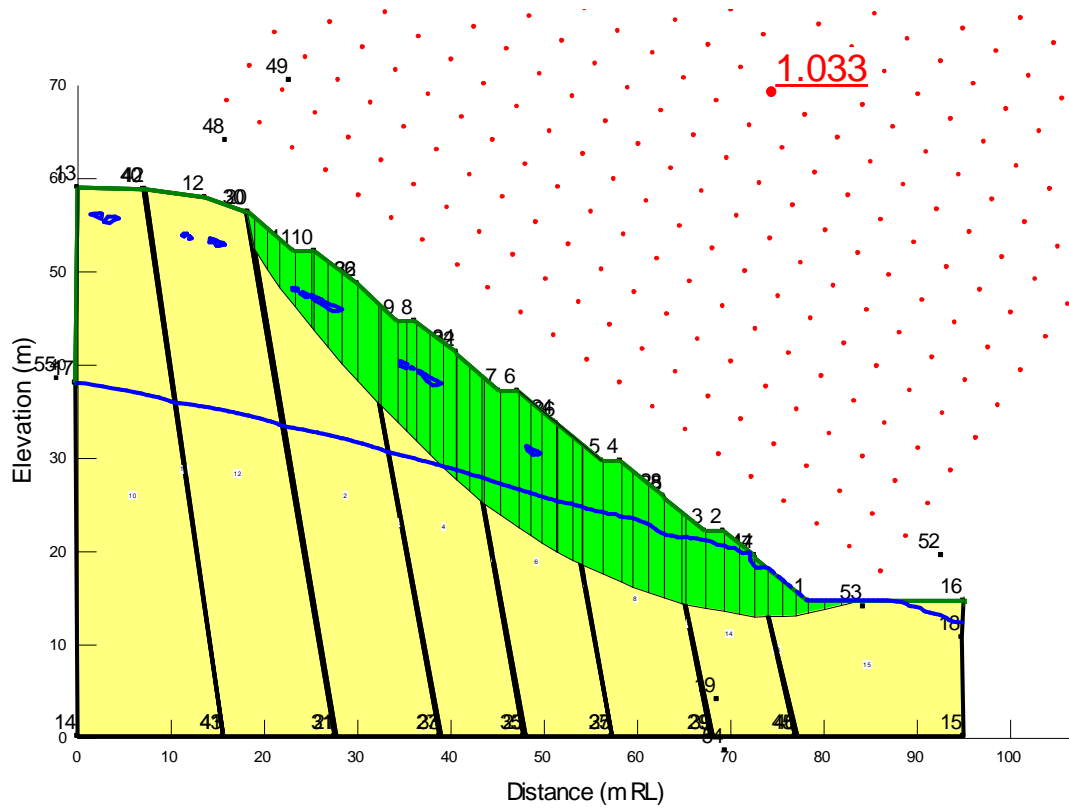
Figure 4.34: Slope stability analysis of the 4th day

The infiltration analysis performed earlier indicated that the destruction of matric suction and/or increase of positive pore water pressure is more significant when relict joints are present. The FOS approached unity (1.033) by the 4th day (Figure 4.34) and went below unity slightly on 5th day. The actual failure was seen on the 5th day. The critical failure surface with FOS greater than unity on earlier days are quite deep. The failure surface on the 5th day is much shallower and corresponds closely with the observed failure surface (Figure 4.35).

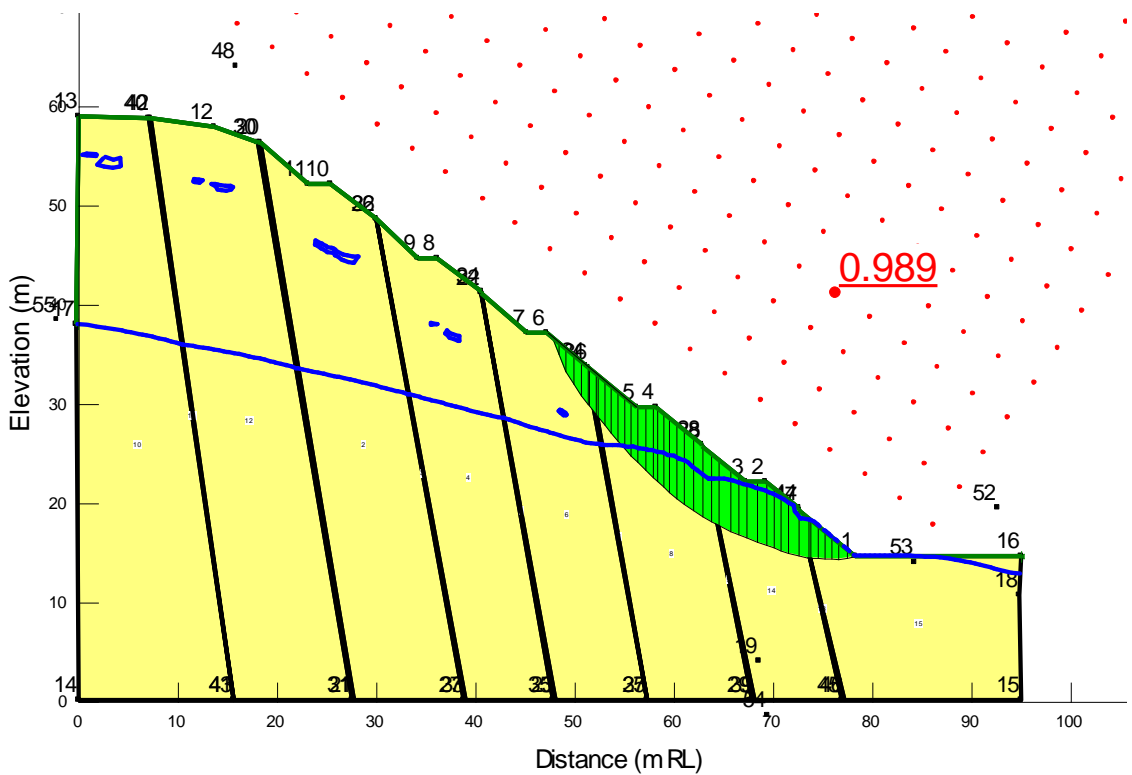
Figure 4.35: Slope stability analysis of the 5th day

The analysis closely simulates the actual event of failure at the site. Actual failure occurred at 42+340 to 42+400 in Walipanna at southern expressway has length of around 50 m along the road and extends over a height of around 20 m. Berm drains at three levels and a cascade drain were damaged by the slope failure. The failure surface is quite shallow.

On the 5th day of this analysis where the safety margin is lower than unity, failure surface has height of 22m and berm drains at three levels were failed.

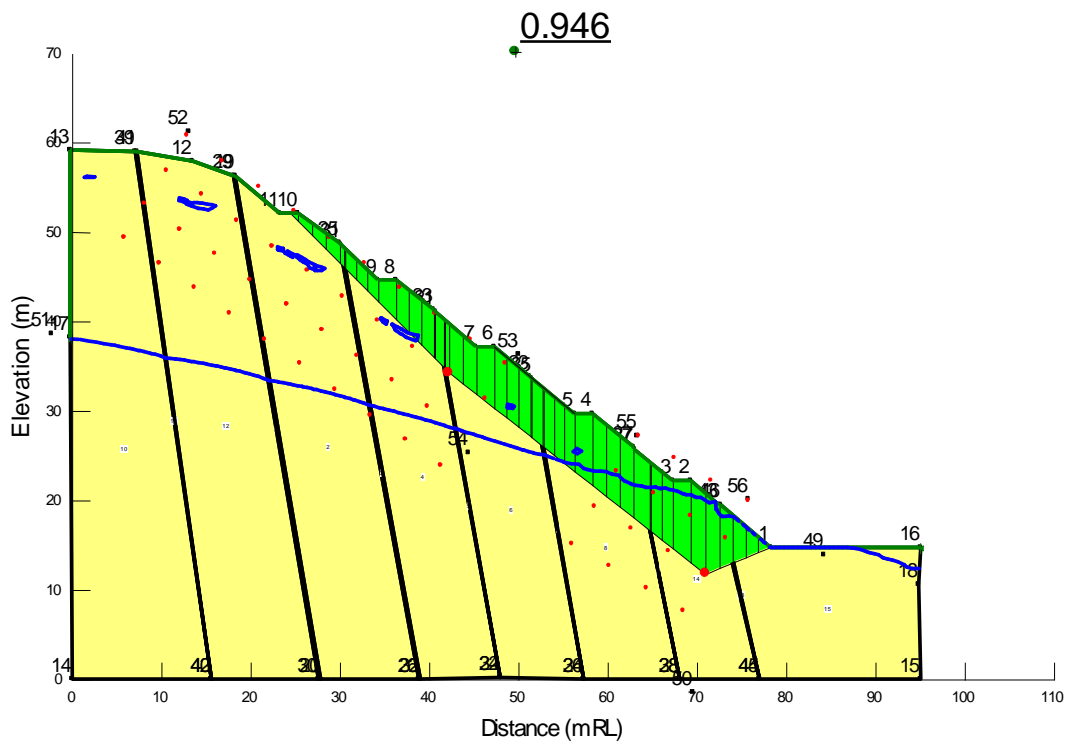
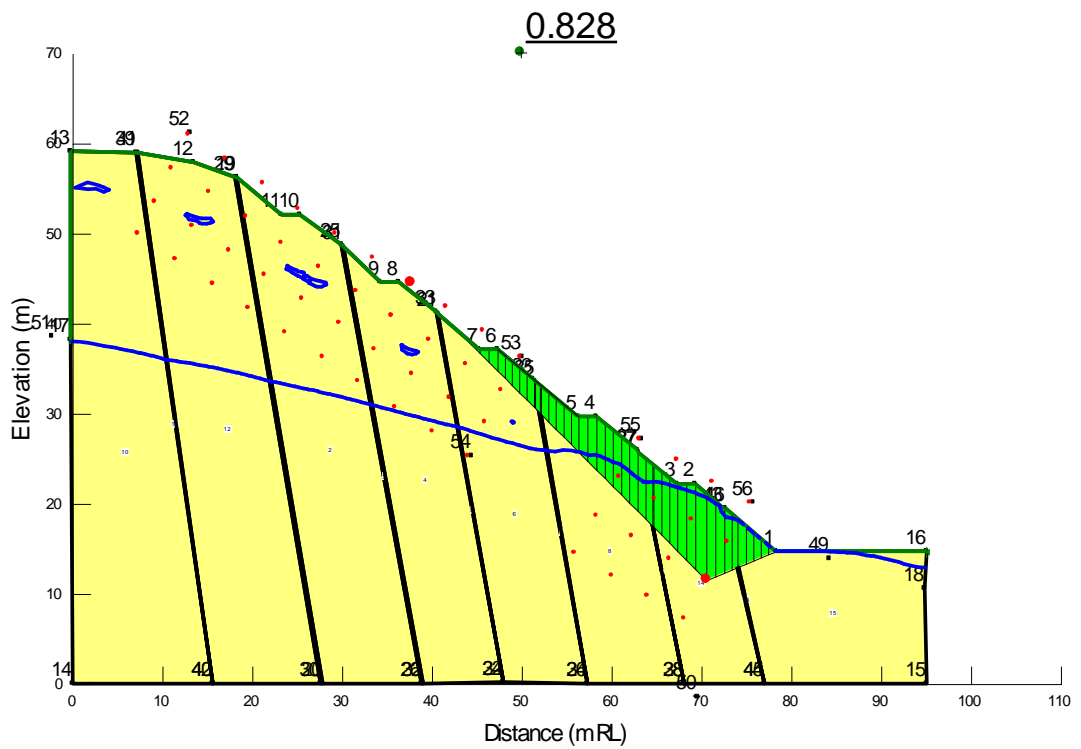
The factor of safety values obtained for the early staged of the rainfall are slightly larger than to the corresponding stages of circular failure surface analysis. But on the 4th and 5th day the values are much smaller compared to the circular failure surface analysis. On the 4th and 5th day (Figure 4.40 and Figure 4.41) the FOS values are lower than unity indicating the slope should have failed. However, the failure take place only on the 5th day. A closer examination of the failure modes on 4th and 5th day indicates this is not feasible kinematically.

Figure 4.40: Slope stability analysis of the 4th day

Figure 4.41: Slope stability analysis of the 5th day
