**BACK ANALYSIS OF SLOPE FAILURE AT
WALIPANNA, SOUTHERN EXPRESS WAY**

Degree of Master of Science in Foundation Engineering and Earth
Retaining Systems

Cut slope at chainage of 42+340 to 42+400 in Walipanna at southern expressway failed after few days of rain. The back analysis of failure indicated that the safety margin is less than unity when saturated shear strength parameters of soil were used in the analysis. Infiltration of the rainfall that was recorded in nearby rain gauges was modeled using the SWCC and permeability function derived from the tests conducted on undisturbed samples recovered from the site.

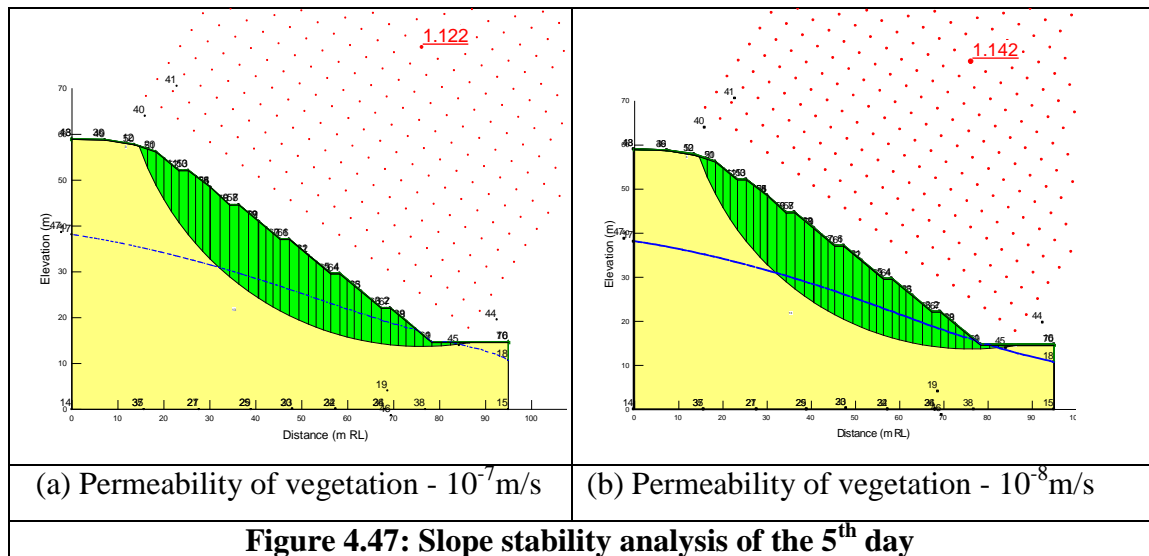
With the improvement of surface drainage, no development of perched water table condition could be identified. The matric suction has been gradually destroyed decreasing the shear strength and factor of safety reduced to a value of 1.122 (Figure 4.47(a)) and 1.142 (Figure 4.47 (b)) for vegetation layer of 10^{-7} m/s permeability and 10^{-8} m/s permeability respectively. It indicated by the fifth day slope is still in a stable condition.

This indicates that the surface drainage improvement by vegetation cover and berm drains along with cascades reduced the infiltration and loss of matric suction, which had been effective in maintaining a significant margin of safety during the prolonged rainfall.

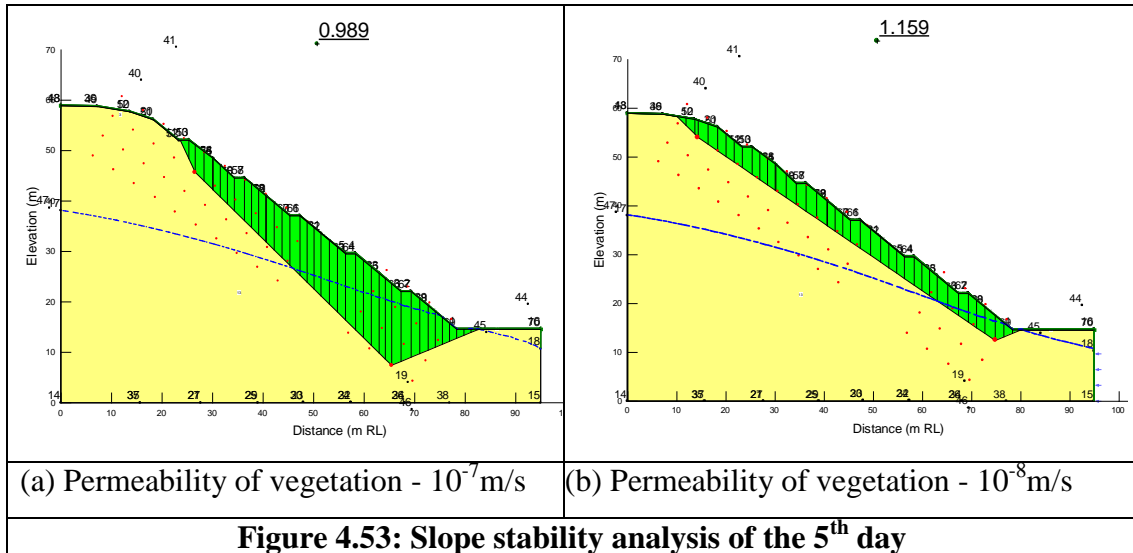
Figure 4.52: Slope stability analysis of the 4th day

With the vegetation cover of permeability 10^{-7} m/s the factor of safety values obtained until the 4th day of the rainfall under non circular condition (Table 4.8) are slightly larger than to the corresponding stages of circular failure surfaces (Table 4.7). But on the 5th day the value is much smaller compared to the circular failure surface and it is lower than the unity indicating the slope should have failed. However, closer examination of the failure modes on 5th day indicates this mode of failure is not feasible kinematically (Figure 4.53).

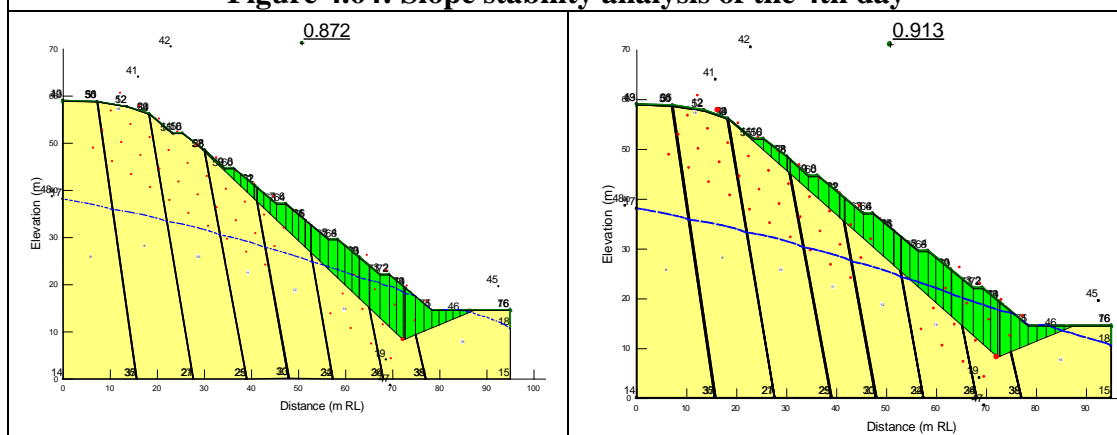
Figure 4.65: Slope stability analysis of the 5th day

The factor of safety values obtained for the early staged of the rainfall are slightly larger than to the corresponding stages of circular failure surface analysis. But FOS reduced with time and became much smaller compared to the circular failure surface analysis on the 5th day. FOS values on 4th and 5th day have become lower than unity indicating the slope should have failed. However, a closer examination of the failure modes indicates this mode is not feasible kinematically (Figure 4.65).

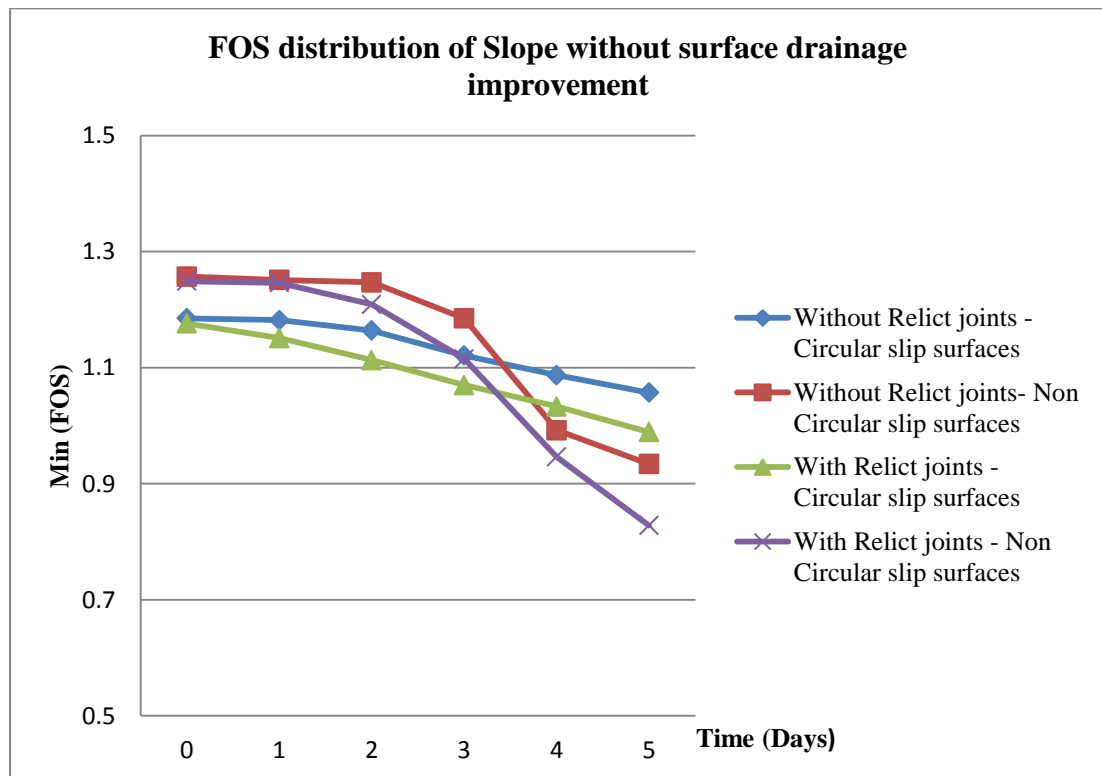
Figure 4.66: FOS distribution of Slope without surface drainage improvement

The factor of safety variation with the progression of the rainfall under different condition is summarized for the case without any surface drainage improvement in Table 4.11. The same values are graphically presented in Figure 4.66.

The comparison of results indicate that the factor of Safety values obtained for the non circular slip surfaces are lower than the corresponding stages of circular failure surfaces on later staged of the rainfall. But, when the shaped of the critical failure surfaces are compared some of the non circular failure modes appear to be not feasible kinamatically.

The FOS values for each day is lower when relict joints are present for the cases of both circular and non circular failure surfaces. The seepage analysis also indicated

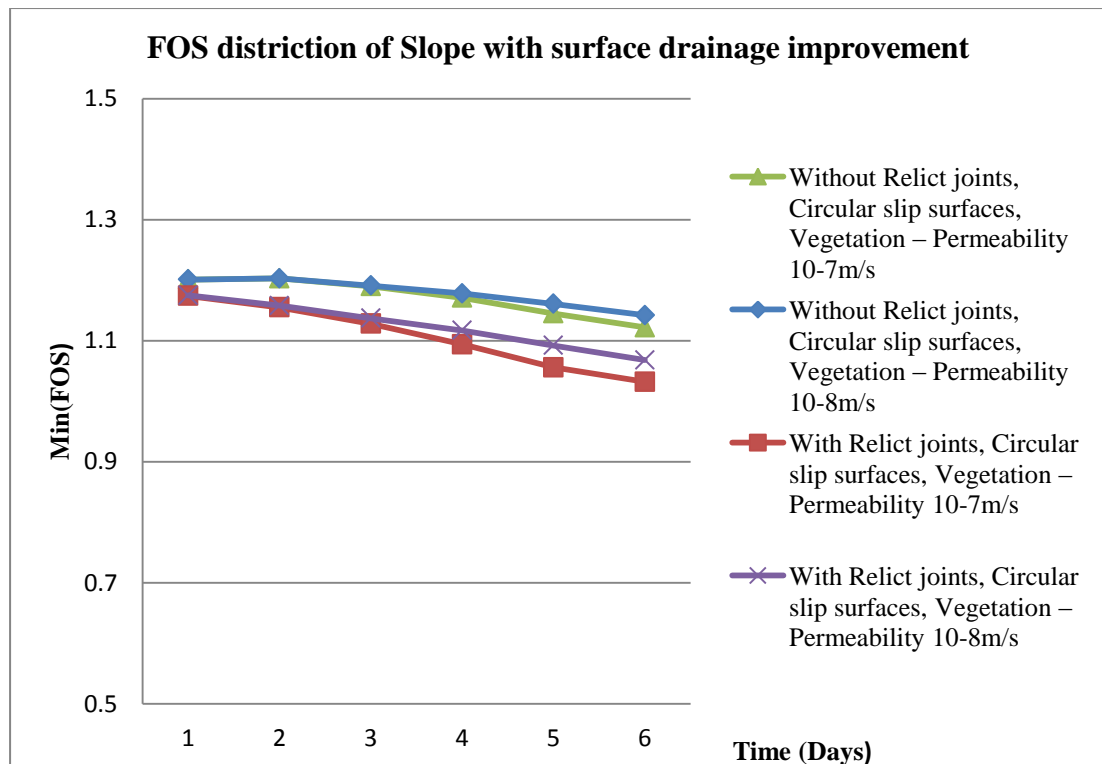
Figure 4.67: FOS distribution of Slope with surface drainage improvement

The variation of the factor of safety with the progression of the rainfall when surface drainage measures and surface protection vegetation is provided for different conditions with and without relict joints is summarised in Table 4.12. The data are graphically presented in Figure 4.67.

The comparison of the factor of safety values with the case without surface drainage improvement and with surface drainage improvement proved that on each day FOS is slightly higher where there is surface drainage improvement.

This indicates that, if properly functioned berm drains and cascade drains along with a vegetation cover had been maintained it would help the slope to remain stable. At the field the cracking of the cascade drain just above the failure surface and possible leakage of water to the slope could be observed. That would have contributed to the initiation of failure.

With the improvement of surface drainage and use of a vegetation cover of lower permeability infiltration could be further reduced and a further increasing of FOS could be obtained.

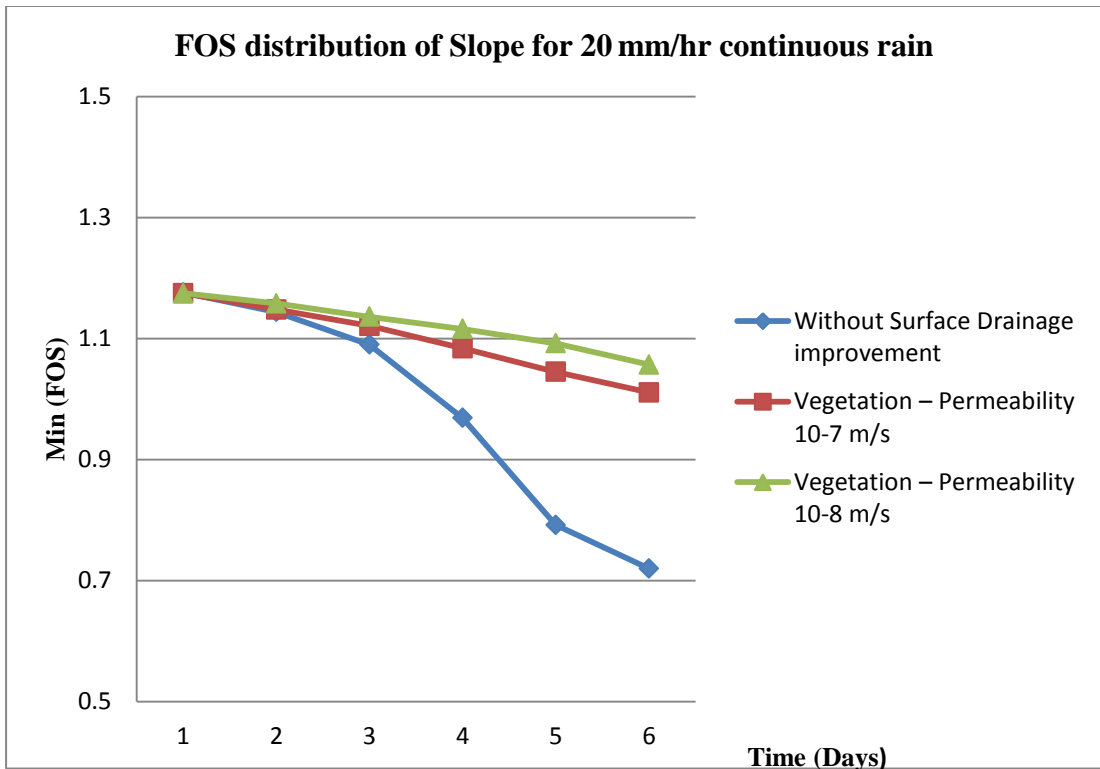
Figure 4.68: FOS distribution of Slope for 20mm/hr continuous rain

The critical failure surfaces corresponding to each day, for circular slip surfaces with the surface drainage improvement of berm drains and vegetation cover of 10^{-7} m/s and 10^{-8} m/s permeability are analysed. Minimum factor of safety values obtained through the analysis are summarised in Table 4.13. the values are graphically presented in Figure 4.68. Critical failure surfaces are presented from Figure 4.69 to Figure 4.73.

When surface drainage improvement is not present, safety margin of the slope reduced significantly with the rainfall of high intensity. Just after the 2nd day FOS value become lower than unity. On 3rd day critical failure surface is quite shallow and kinamatically feasible.

When surface drainage improvement of the slope is applied, even on the 5th day FOS value is close to the unity which indicates the slope remains sill stable. The critical failure surfaces are quite deep. This indicates that, surface drainage improvement of the slope is providing the positive impact on slope stability even with rainfalls of high intensity.

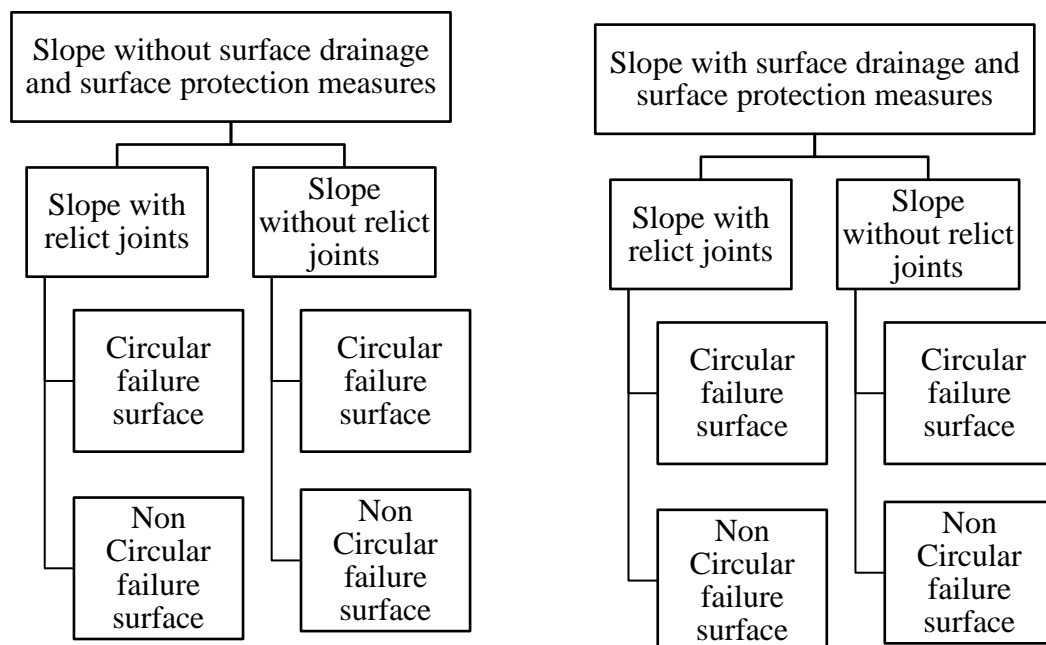
Figure 5.1: Different forms of analysis done

The infiltration analysis was done under different possible alternate conditions. The different forms of analysis done are illustrated in the figure 5.1. A wide range of analysis of this form was necessary in this back analysis due to the presence of many uncertainties.
