INVESTIGATION OF STRUCTURAL DEFECTS IN GOVERNMENT HOSPITAL BUILDINGS IN SRI LANKA

Degree of Master of Engineering in Structural Engineering Designs

Department of Civil Engineering

September 2017

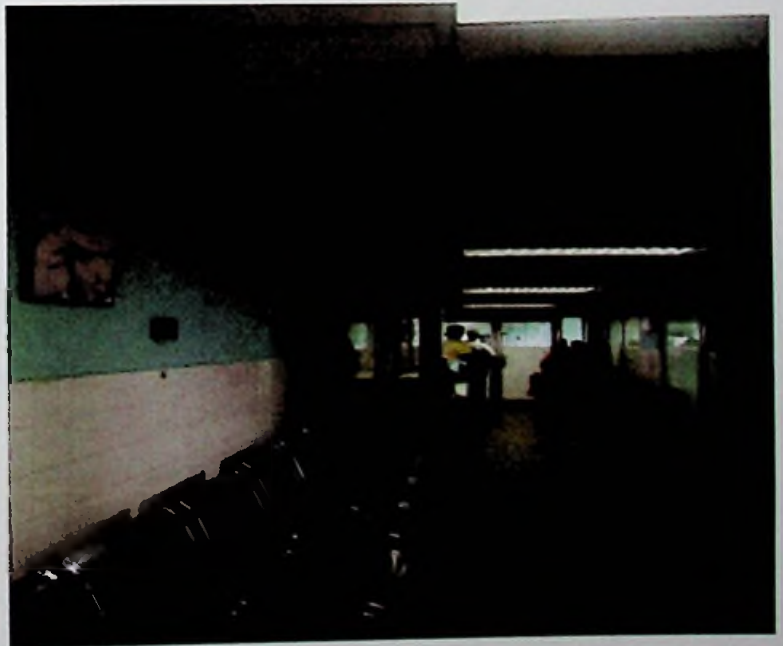
Figure 3. 19: A Lobby area finished with imported tiles in recently constructed nine-story building in LRH renovated with foreign funds

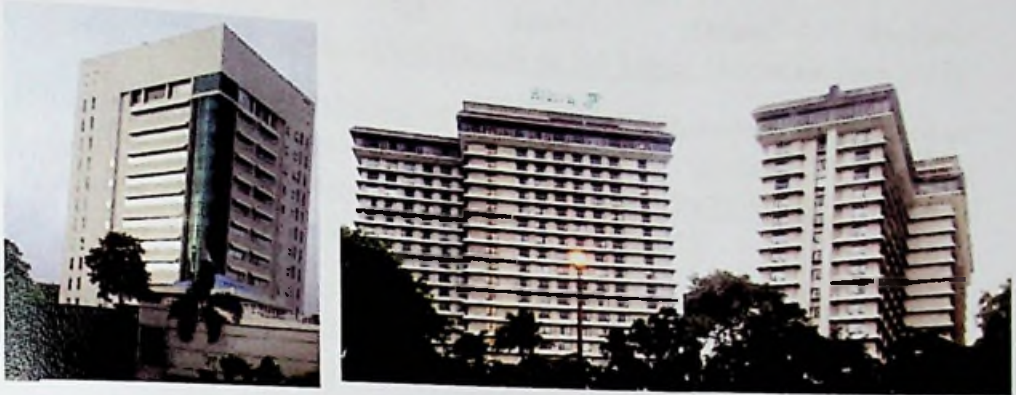
Figure 5:1 Example for angle canopy slabs

- 12) Designing balconies and concrete canopies with a considerable slope for avoiding accumulation of water as shown in figure 5.1
